Addendum to the May 2018 Report “Moisture Performance of High-R Wall Systems” by Home Innovation Research Labs

September 2018

Purpose

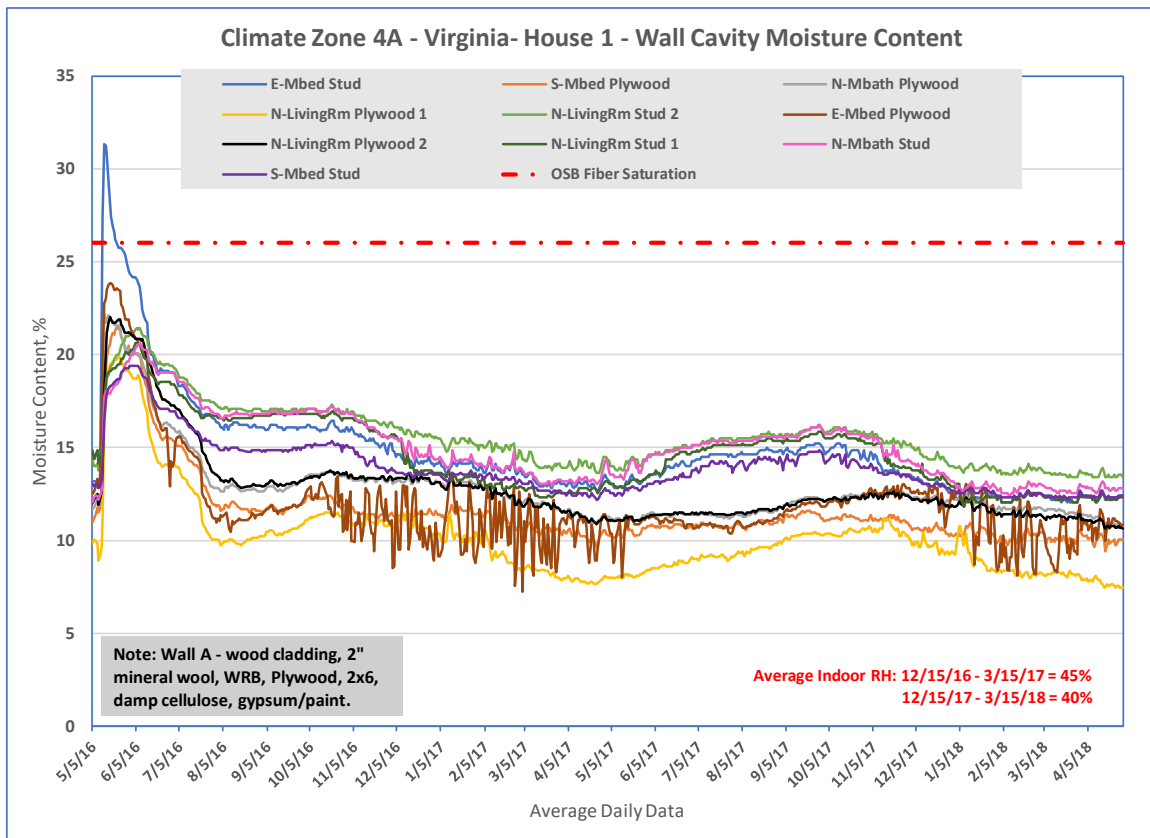
Figure A2. Plywood sheathing and stud moisture content for Climate Zone 4A, Virginia, House 1

Figure A2 shows the summary results for the wood sheathing moisture content for House 1, located in Virginia, Climate Zone 4A. The following observations can be made:

- For most of the monitoring period, the plywood moisture content was significantly less than the 26% threshold for all sensors. The initial spike in moisture content is attributed to the placement of damp cellulose in the wall cavity. The insulation installation was completed around mid-May of 2016, which is consistent with the spike in the graph. Note that the builder was operating a construction dehumidifier starting in the middle of July after the building was enclosed.

- The initial higher moisture content dissipated during the course of 45–60 days after the installation of damp cellulose, and the moisture content remained stable, ranging from 10%–15%, throughout the following three seasons remainder of the monitoring period.

- It is notable that this wall configuration did not have a winter trend of increasing moisture content as is typical for many walls in climates with heating seasons. After the initial drying, moisture content

remained stable over the next two years. Therefore, the wall was effective at controlling vapor drive from the interior during the winter with temperatures as low as 16°F in 2017 and 13°F in 2018. The following wall characteristics help with vapor drive control: (1) R-8 exterior insulation keeps the wall cavity warmer, (2) 2x6 cavity insulation with moisture storage capacity modulates moisture load, and (3) interior paint reduces vapor movement across drywall (specific vapor-retarder properties of paint for this site are unknown).

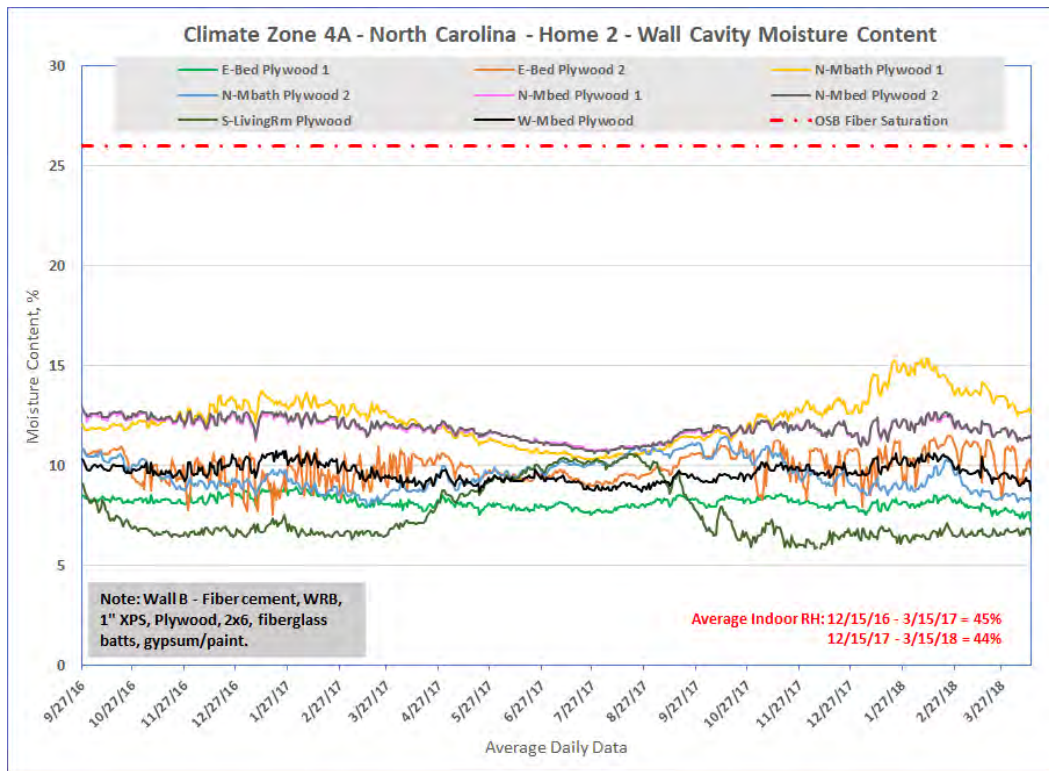
Figure A3. Plywood sheathing moisture content for Climate Zone 4A, North Carolina, House 2

Figure A3 shows the summary results for the plywood sheathing moisture content for House 2, located in North Carolina, Climate Zone 4A. The following observations can be made:

- For the whole monitoring period, the plywood moisture content was less than and did not exceed 14.5% for all sensors. The wall did not exhibit elevated initial moisture content, suggesting that the wall construction was complete and that the building was enclosed without subjecting materials to significant rain events.

- Throughout the entire 719-month monitoring season, from September 2016 through April of 2017/2018, the moisture content remained stable and low. This observation is consistent with solid wood members (studs), as shown in Appendix. Therefore, this wall assembly was effective at controlling the interior vapor drive during the winter with temperatures as low as 14°F in January of 2017 and 16°F in 2018.

- Interior RH averaged 44-45% during the winter seasons. This level of interior RH during heating season is in the upper range of levels observed in previous studies for this climate zone. An HRV was used, and it was effective at controlling the RH levels in this airtight house (1.5 ACH50).

- As typically observed in wall monitoring studies, the north-facing walls had a slightly higher moisture content (up to 13.5%) compared to walls facing south (as low as 7.6%). The following difference can be attributed to the lack of solar vapor drive in north-facing walls.

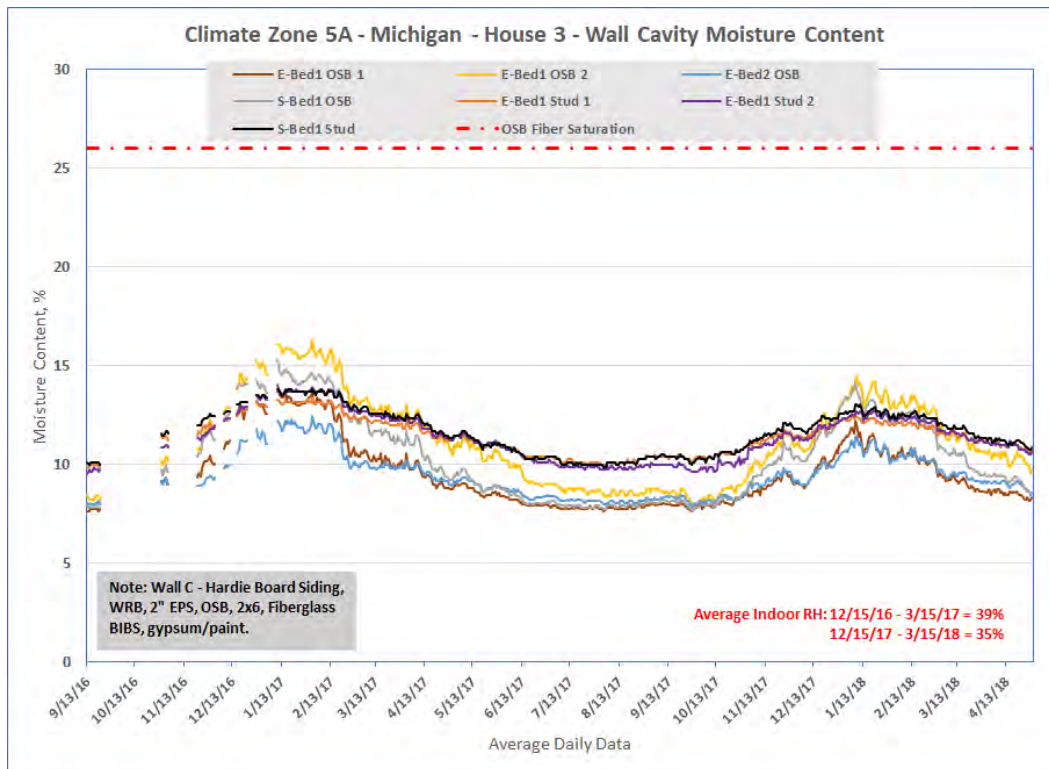
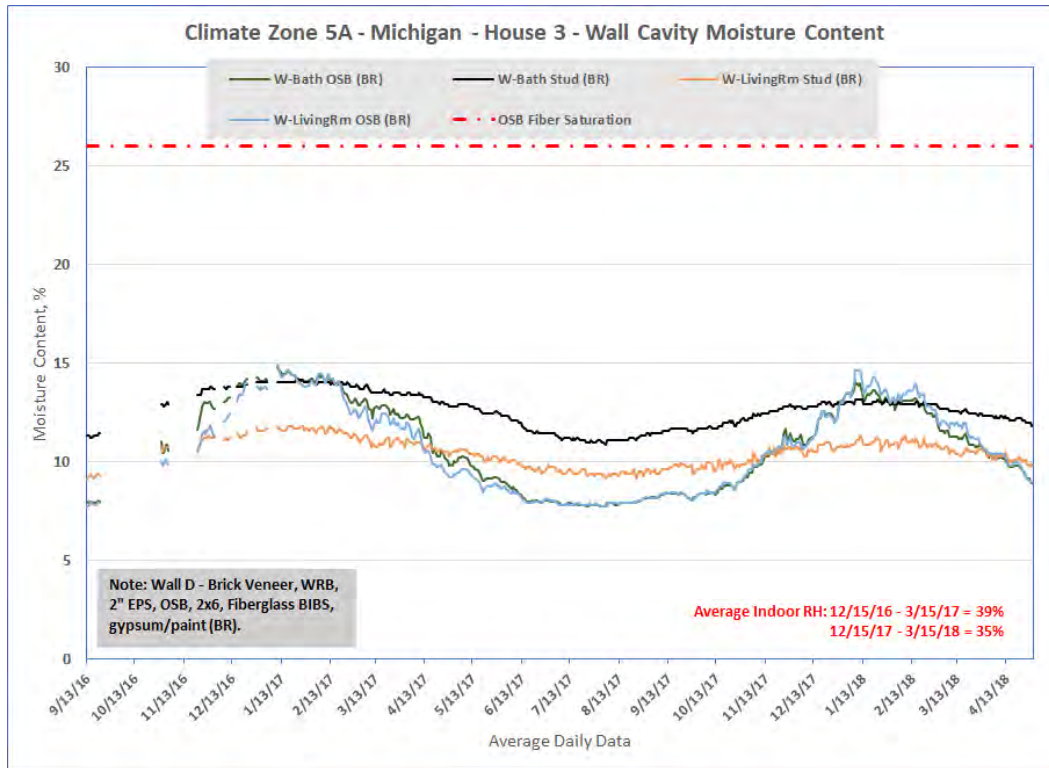
Figure A4 and Figure A5 shows the summary results for the OSB sheathing moisture content for Wall C and Wall D, respectively, in House 3, located in Michigan, Climate Zone 5A. Wall C and D use different claddings—fiber cement over furring strips and brick veneer, respectively; the two walls are identical in all other aspects. Data during the fall period (September–November 2017) is limited for this house because the gateway was disconnected during construction until occupants moved into the house. Although limited to only a few days, the initial data points from early readings are included to provide information on the starting moisture content levels following construction of the wall. Consistent data acquisition began in November. The following observations can be made:

- Moisture content remained low for both walls C and D throughout the entire monitoring period, with the highest recorded levels of 16% during the first winter season (outdoor temperatures as low as 10°F). The second winter showed nearly identical trend with the moisture levels 1-2 percent lower. With outdoor temperatures as low as -2.8°F compared to 10°F a year before, the results suggest that the wall performance is less sensitive to the winter conditions – an attribute of walls with exterior insulation.

- Both walls experienced a mild upward trend in moisture content during the heating season. During the first winter, this trend was somewhat more pronounced in walls with fiber cement siding, but the difference was not sufficient to suggest a specific pattern caused by the cladding type. Because both claddings were installed with a vented gap, the walls were expected to perform similarly. Note that Wall C was predominantly east-facing and Wall D was west-facing—the difference in orientation is the more likely explanation for any observed difference in moisture levels. During the second winter, the walls performed nearly identically.

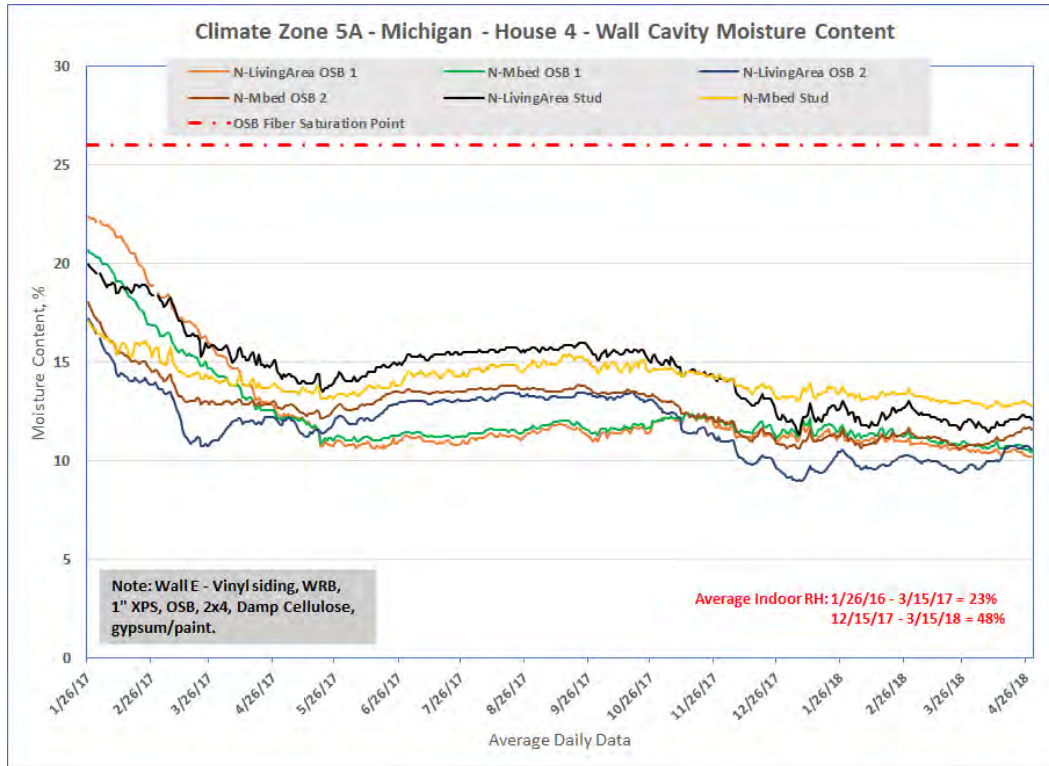
Figure A6. OSB sheathing and stud moisture content for Climate Zone 5A, Michigan (2), House 4

Figure A6 shows the summary results for the OSB sheathing moisture content for House 4, located in Michigan, Climate Zone 5A. Because of the construction schedule, the data period for House 4 starts in the middle of winter. The house has a limited number of sensors because of the limited amount of wall area available—the house is a narrow townhouse with a large area of openings. Wall E meets the minimum IRC prescriptive code provisions for Climate Zone 5A for the R-value of exterior foam sheathing for walls with a Class III interior vapor retarder (R-5 over 2x4 wall). The following observations can be made:

- As expected with the placement of damp-sprayed cellulose insulation in the wall cavity, the initial moisture content of the OSB and framing ~~ranged from~~ reached or exceeded 20%–25% at three sensor locations. These high moisture content levels were sustained throughout the winter, with a drying trend starting in April was observed from the beginning of the monitoring period. The drying was most likely to the inside of the house. The low indoor RH level (23%) facilitated the drying and was added by warmer temperatures in the cavity.

- The house was not occupied during the first winter, and the interior RH was low, averaging 25%. A longer monitoring period is needed to better understand the long-term moisture management characteristics of the wall, particularly during the second winter season when the house is occupied, the RH level increased to nearly 50%. This townhouse relies on exhaust fans for ventilation. A combination of occupant activities with this type of ventilation lead to levels of RH that represent the upper range for Climate Zone 5 based on observations from previous studies. A more typical average RH for Climate Zone 5 is in the 30-40% range.

- The elevated interior RH level in the second winter didn't lead to an increase in OSB moisture content. The combination of exterior foam sheathing and cellulose cavity insulation was effective at keeping OSB moisture content levels at or below 15% throughout the winter. The second winter was substantially colder than the year before with outdoor temperatures dropping to -3.1°F.

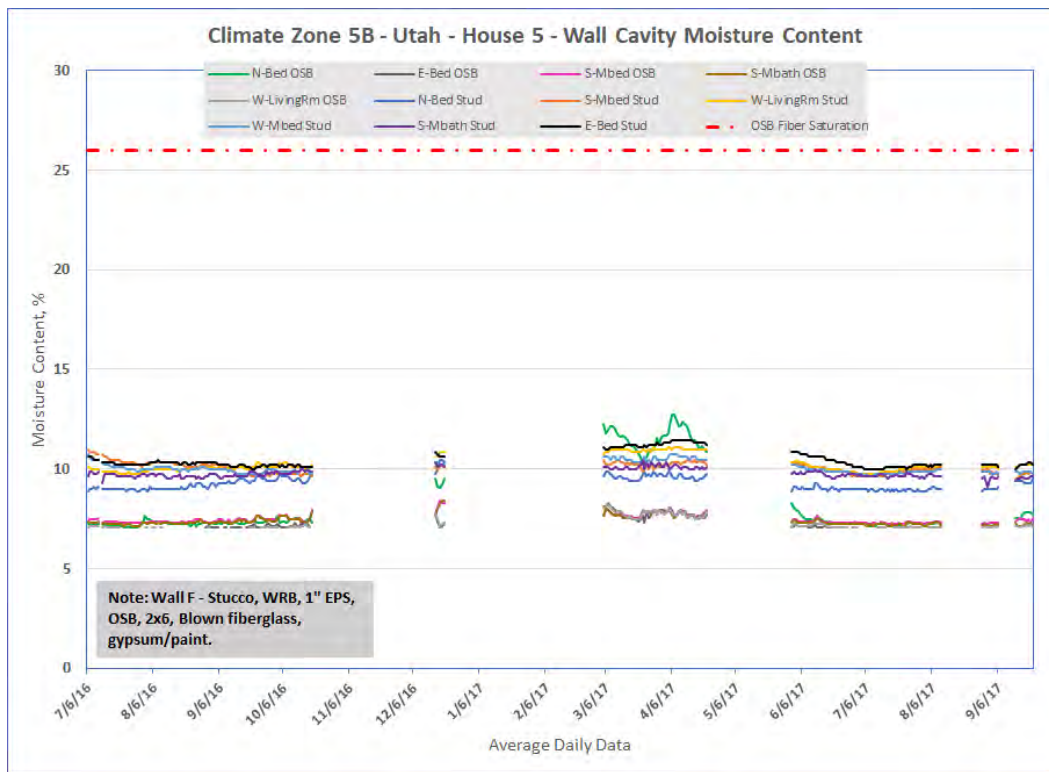
Figure A7. OSB sheathing and stud moisture content for Climate Zone 5B, Utah, House 5

Figure A7 shows the summary results for the OSB sheathing moisture content for House 5, located in Utah, Climate Zone 5B. This is the only house included in the study from an area designated as dry on the climate zone map. The cladding is one-coat stucco over 1-in. expanded polystyrene foam and an acrylic topcoat. Data for the winter period were not collected because the data acquisition system was turned off by the occupant except during 2 days at the end of December. The interior sensors were removed by the occupant. The following observations can be made:

- The initial moisture content of the OSB sheathing was low (7%) and remained low (less than 13%) based on available data during the monitoring period. The low moisture levels in the walls can be attributed to the dry climate region, summer construction, benefits of adding exterior insulation to stucco, and dry installation method for the cavity insulation (blown fiberglass). The exterior winter temperature was as low as 2°F.

- Evidence shows some winter increase in the OSB moisture content for the north orientation. The level of the increase is unknown because of the data acquisition interruption, but it appears to be small, with an onset sometime after December. Moisture content trends remained flat in all other orientations, suggesting that solar drive is an important factor for drying. It is also expected that the foam sheathing limits the entrance of solar-driven moisture from the stucco.

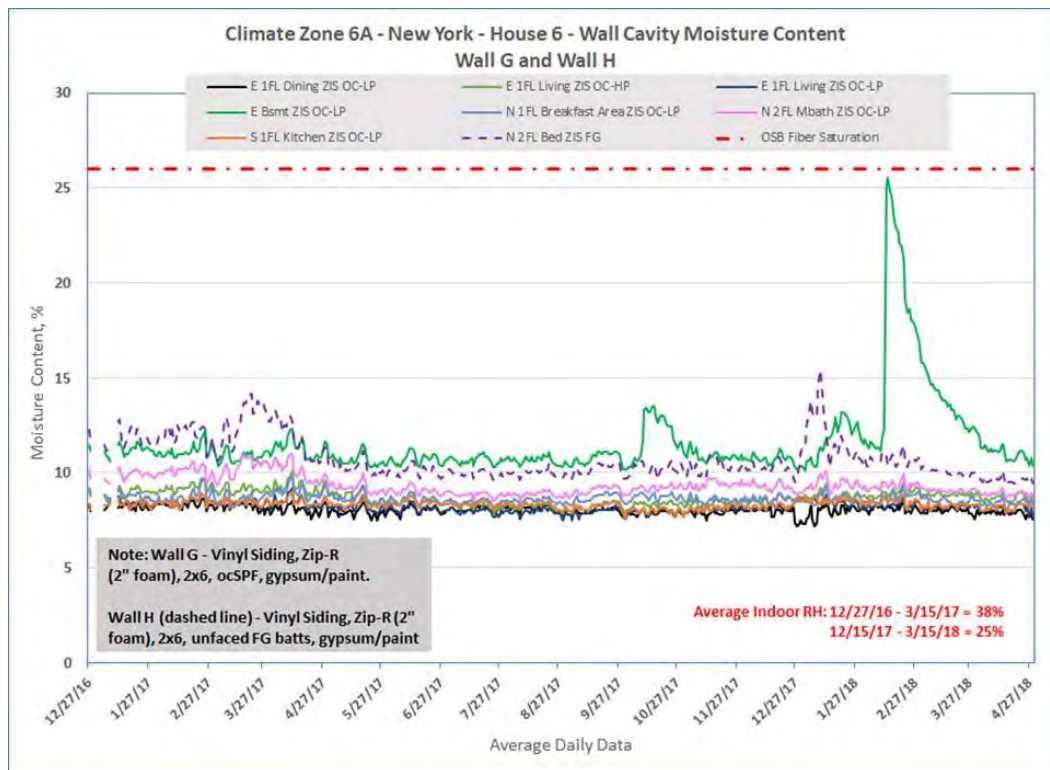
Figure A8. ZIP sheathing moisture content for Climate Zone 6A, New York (1), House 6

Figure A8 shows the summary results for the ZIP sheathing moisture content for both Wall G and H for House 6, located in New York, Climate Zone 6A. Note that two types of open-cell spray foam was used with Wall G: low-perm (LP) with specified permeance of 5 perm at total thickness and high-perm (HP) with specified permeance of 30 perm at total thickness. The type of spray foam used is noted for each sensor on the graph legend. The following observations can be made:

- The OSB moisture content was trending primarily flat at less than 145% or less for all-most sensors in all orientations with many trending below 10%. One conspicuous exception was a sensor in the walk-out basement wall that spiked precipitously during the second winter season reaching the fiber saturation level for a short period of time. Given the rate of increase, this spike was mostly likely caused by a short-

term water leak event from the outdoors. Two moderate spikes in October and January at the same sensor suggest that this location is associated with a minor breach in the water resistive barrier that gets penetrated when events reach a certain level of intensity. It's noted that this wall is below a deck and it's possible that the observed vulnerability is at the deck-to-wall joint area. It is less likely that the moisture spikes were caused by an air leak from the indoors because the uptake in moisture would have been slower and the supply of moisture would have been more persistent. The data also shows that the moisture began drying immediately after the wetting event—an indicator of the wall's capacity for dissipating moisture. While the initial rate of drying was high, it took two months for the moisture content to return to its pre-spike level. Drying in this wall can occur in both directions, but the primary drying path is expected to be to the inside.

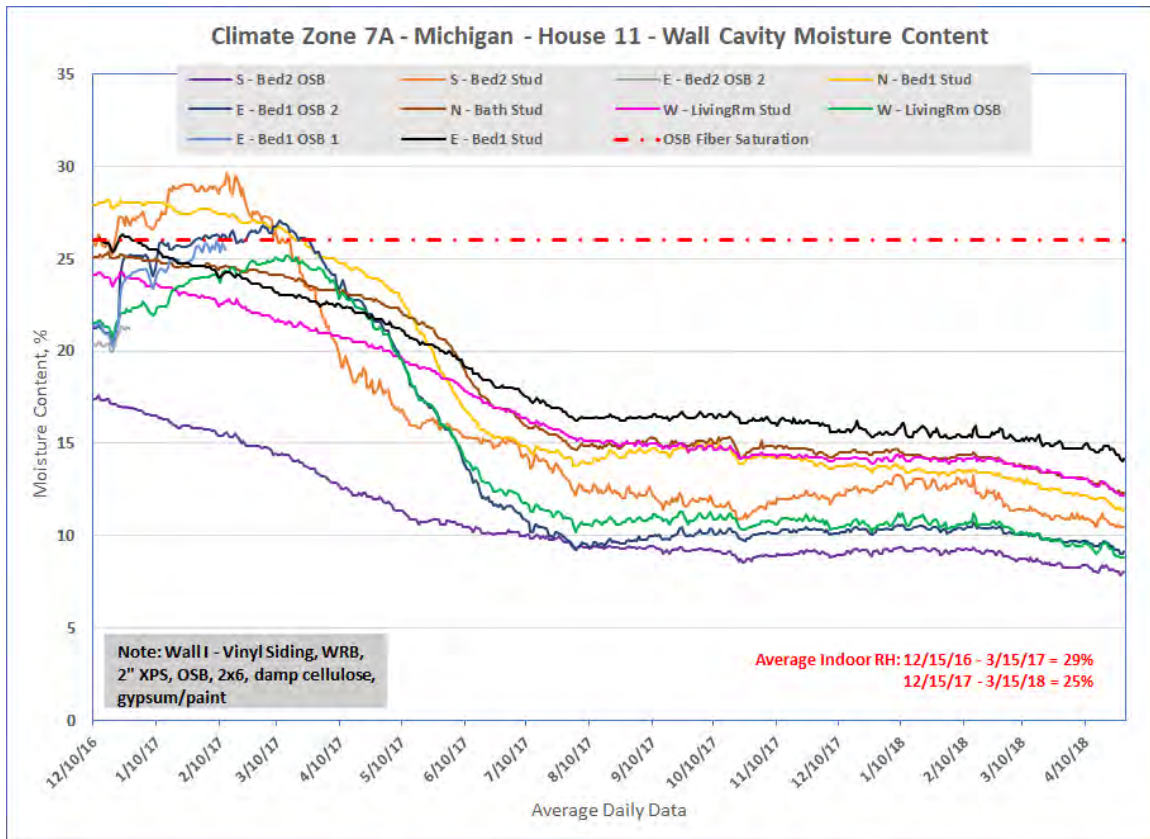
Figure A9. OSB sheathing and stud moisture content for Climate Zone 7A, Michigan (6), House 11

Figure A9 shows the summary results for the OSB and stud moisture content for House 11, located in Michigan, Climate Zone 7A. The following observations can be made:

- As a result of the construction moisture from the installation of damp cellulose, the OSB and stud moisture content remained high throughout the entire heating season. A definitive drying trend for all sensors began in March, with the OSB drying at a faster rate than the lumber. Several sensors remained at levels more than 20% at the end of April.

- All sensors dropped to below 20% by middle of June of 2017. Drying was complete by the end of July of 2017 as evidenced by the inflexion points on the moisture content chart for both OSB and lumber.

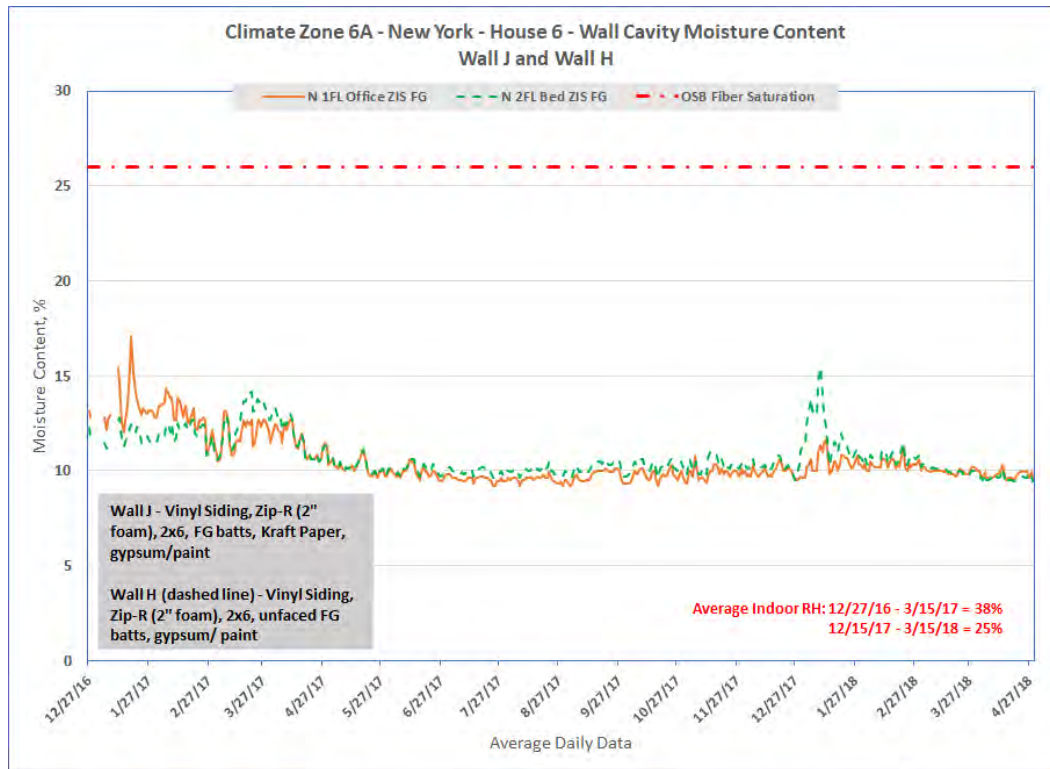
Figure A10. ZIP sheathing moisture content for Climate Zone 6A, New York (1), House 6

Figure A10 shows the summary results for the OSB moisture content for House 6, located in New York, Climate Zone 6A. Note that House 6 has three different wall types: G, H, and J. Walls G and H are addressed in Key Research Area 1 (See Figure A8). Figure A10 shows walls J and H. Wall J is classified as a hybrid wall because it uses Kraft paper as an interior vapor retarder. Wall H is shown for comparative purposes: it is identical to Wall J, but it does not have Kraft paper. The following observations can be made:

- The two wall types—with and without Kraft paper—trended closely together throughout the monitoring period. Both walls indicated good and stable performance with moisture content at less than 15% after initial drying and at about 10 percent for most of the monitoring period. Given that the sensors measured in wall sections at two different elevations in the building, the observed spread of measurements between the two walls types cannot be attributed to any specific wall characteristics. The more meaningful observation is that when both walls had a chance to start drying in April of 2017, the moisture content readings effectively converged around 10%. The performance of Wall J suggests that Kraft paper did not impede drying when the vapor drive reversed after the heating season was over.

- The average RH during the first winter season was within the typical range, at 38% in 2017 and somewhat lower at 25% for the second season. An ERV was used to provide outdoor ventilation and was effective at controlling the RH levels in this extremely airtight house (0.52 ACH50).

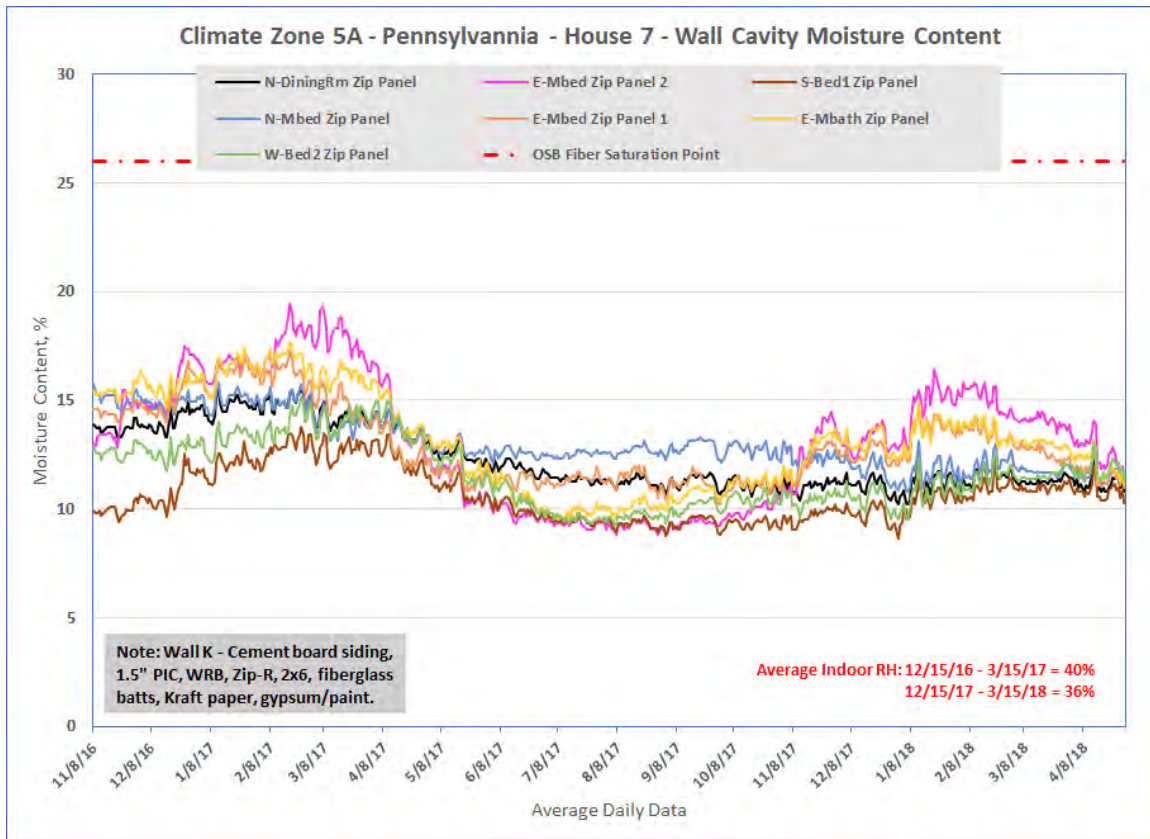
Figure A11. ZIP sheathing moisture content for Climate Zone 5A, Pennsylvania, House 7

Figure A11 shows the summary results for the ZIP sheathing OSB moisture content for House 7, located in Pennsylvania, Climate Zone 5A. The following observations can be made:

- The moisture content of the OSB sheathing was trending slightly upward throughout the first winter peaking, at about 19%, a reasonable margin from the fiber saturation point.

- Drying began around mid-March, with all sensors converging at less than 13% by the end of April, indicating good drying capacity.
- Moisture content remained flat and stable throughout the summer at below 13%. The second winter uptick was lower in amplitude and absolute value, peaking at or below 16%. This reduction in the second winter was observed despite lower winter temperatures (15°F in 2017 and 1°F in 2018). The key difference was the starting moisture level at the beginning of the heating season.

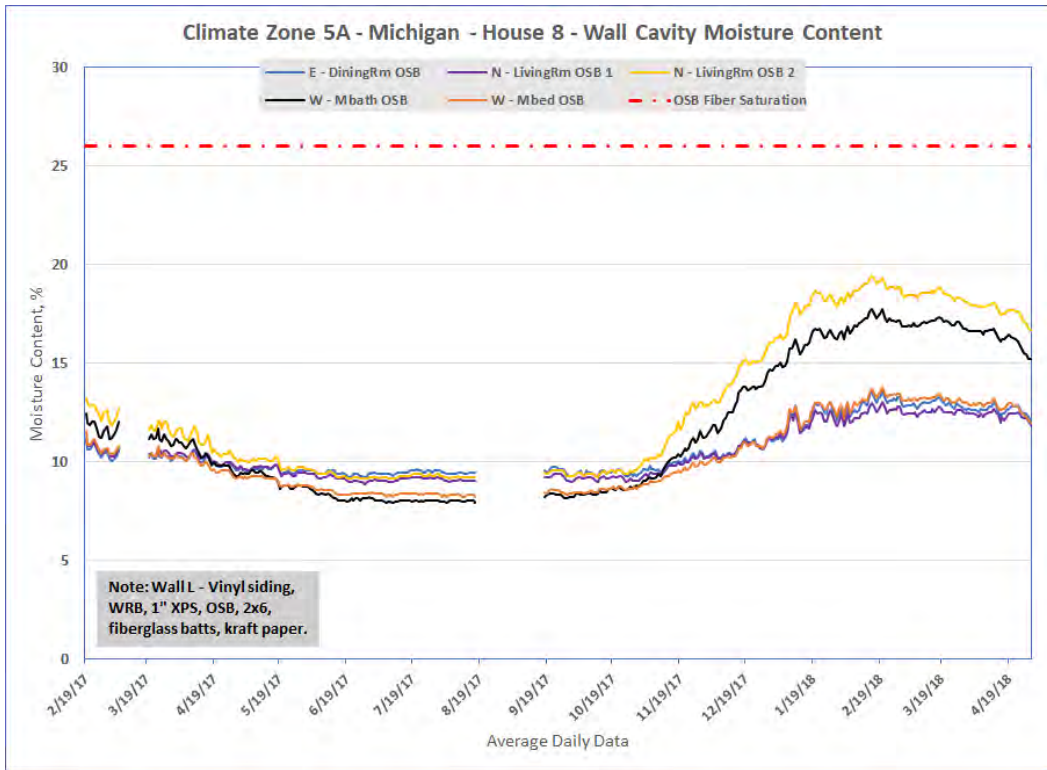
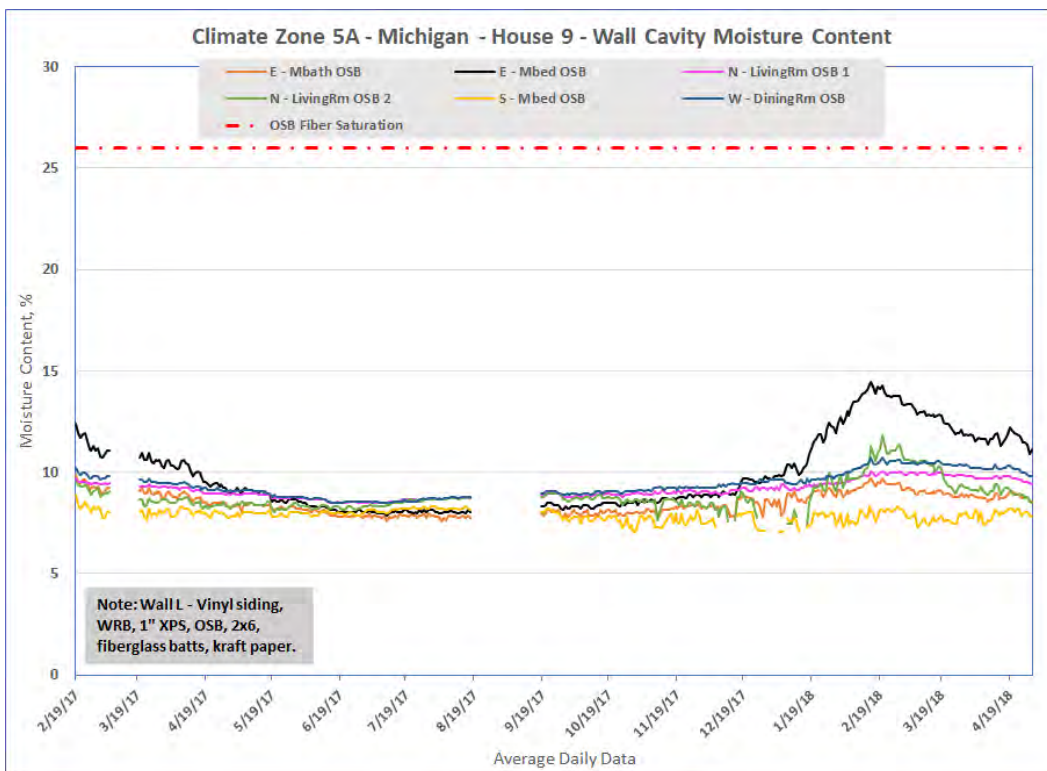
Figure A12 and Figure A13 show the summary results for the daily OSB sheathing moisture content for House 8 and 9, respectively, located in Michigan, Climate Zone 5A. The data are reported jointly for both houses because the wall systems are the same, the houses are located in close proximity, and the observed performances were similar. Because of changes in the construction schedule, the monitoring period for House 8 and House 9 started in the middle of winter. Both houses were unoccupied ~~for the entire monitoring period during the first winter.~~ ~~Additional monitoring is recommended for these houses.~~ ~~Indoor relative humidity data for these houses was not available.~~ The following observations can be made:

- The R-5 XPS exterior insulation in combination with the Kraft paper is effective at controlling interior vapor drive in the 2x6 walls in Climate Zone 5A. The initial results suggest indicate that this wall system can be an effective and practical option for walls achieving R-24. Where an additional margin of safety is sought to further minimize the amplitude of the heating season moisture content cycles, air sealing at the interior sheathing can be implemented to control the flow of air into the cavity from the indoors.

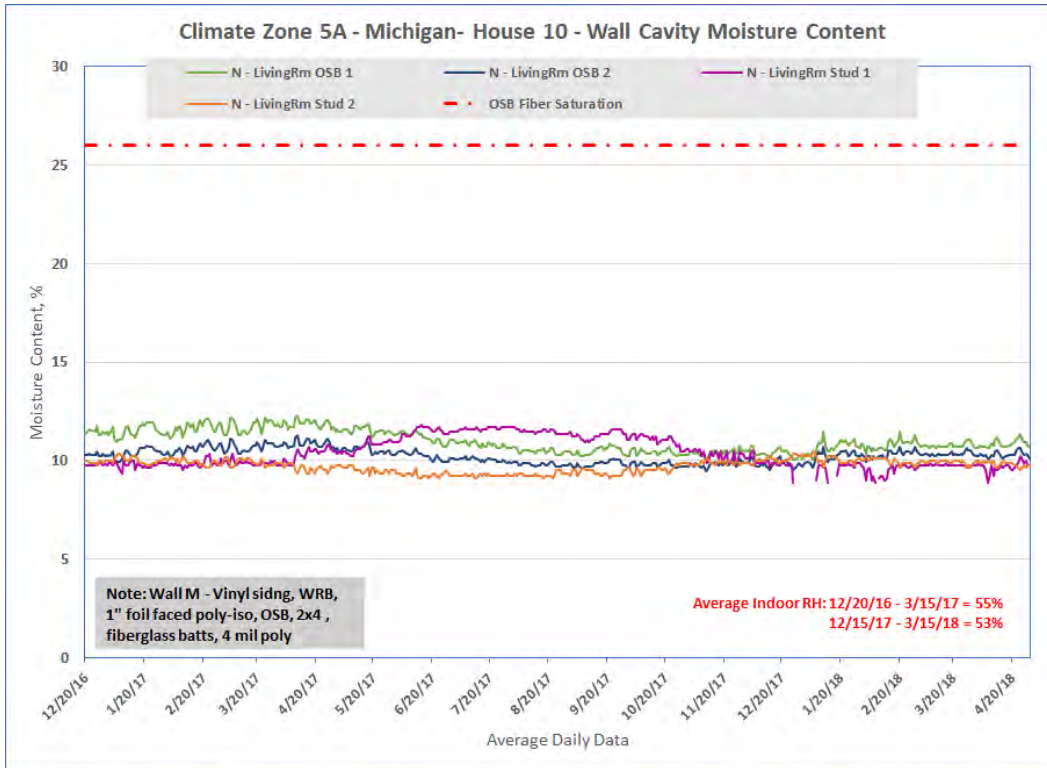
Figure A14. OSB sheathing and stud moisture content for Climate Zone 5A, Michigan (5), House 10 (Wall M1)

Figure A14 shows the summary results for the daily OSB sheathing moisture content for House 10, located in Michigan, Climate Zone 5A. House 10 is an existing house with a newly constructed addition featuring energy-efficient walls. All sensors were installed in the addition. The house has an air leakage rate of 3.04 ACH as tested after completion of the addition—this level of air tightness meets the criteria for homes in the study. The following observations can be made:

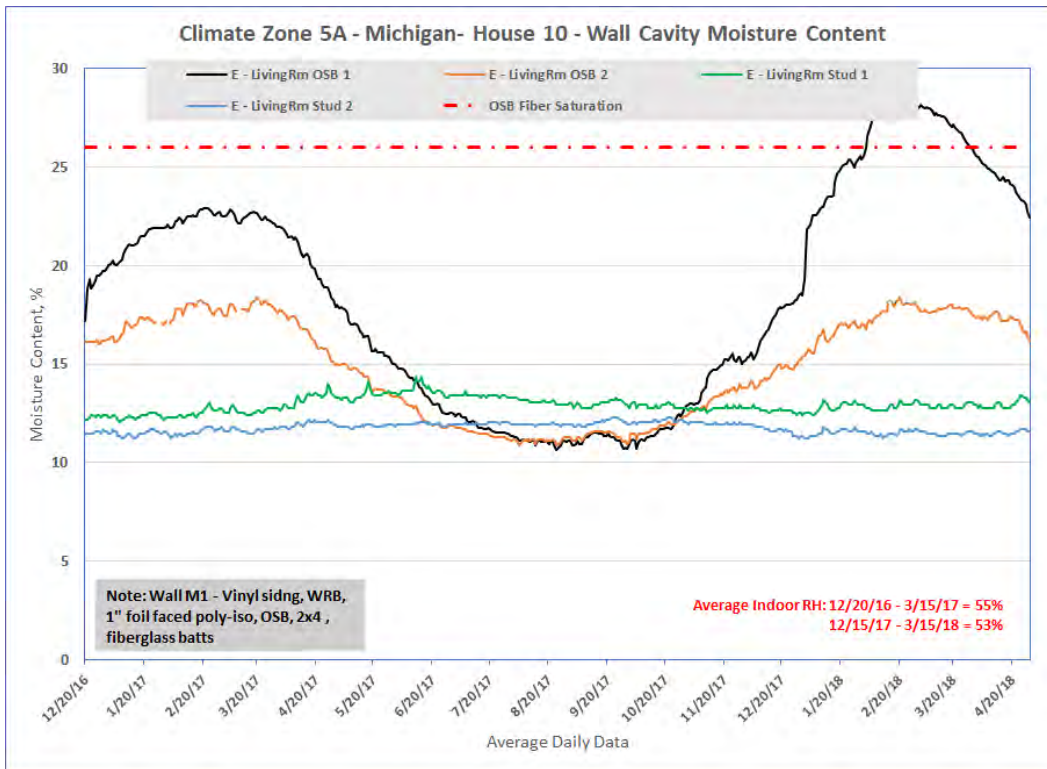
Figure A15. OSB sheathing and stud moisture content for Climate Zone 5A, Michigan (5), House 10 (Wall M1)

- A section of the wall constructed without polyethylene (Figure A15, Wall M1) showed a dramatically different performance, with moisture content levels ~~about 10 points higher compared to wall sections with polyethylene~~reaching the fiber saturation point. These results suggest that even walls with an exterior insulation R-value exceeding the code minimum (R-6.5 installed vs. R-5 code minimum) can be sensitive to high levels of indoor RH; The impact of the outdoor temperature was also evident; however, note that even without the polyethylene the OSB moisture content had not reached the fiber saturation point in the first heating season (minimum temperature 18.8°F) but remained at or near fiber saturation for an extended period of time during the second heating season (minimum temperature -2.2°F). Wall M1 showed onset of drying beginning of April early spring both years.

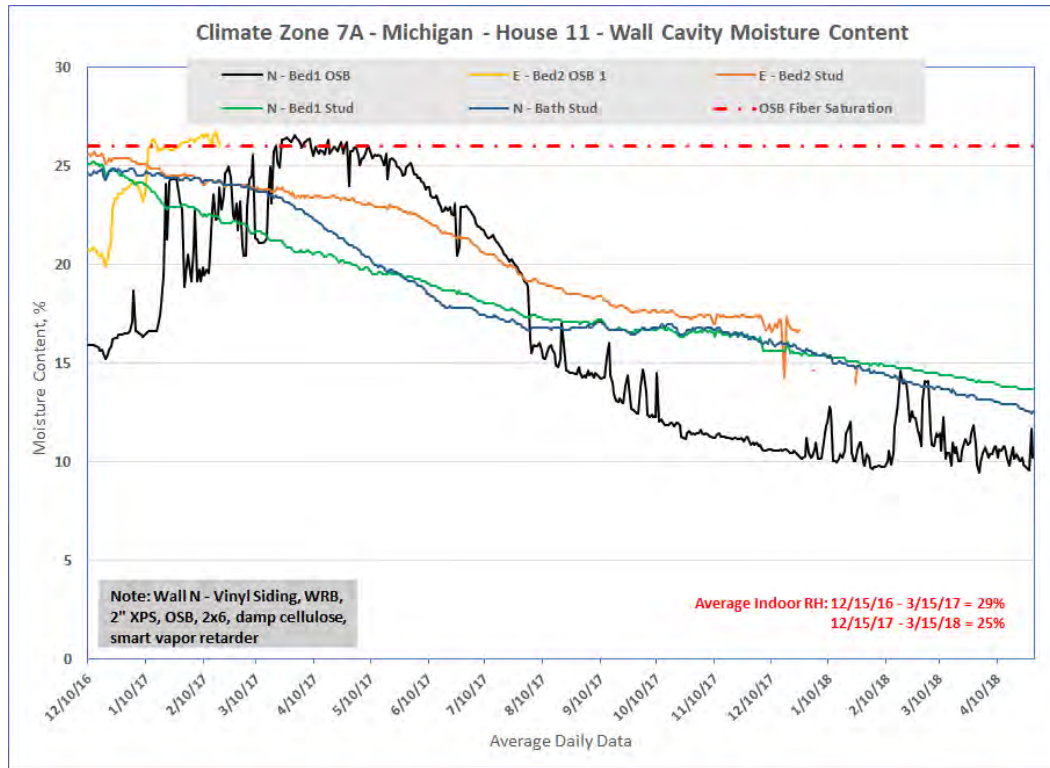
Figure A16. OSB sheathing and stud moisture content for Climate Zone 7A, Michigan (6), House 11

Figure A16 shows the summary results for the daily OSB sheathing and stud moisture content for Wall N in House 11 in Michigan, Climate Zone 7A. The wall featured a smart (i.e., variable) interior vapor retarder. The following observations can be made:

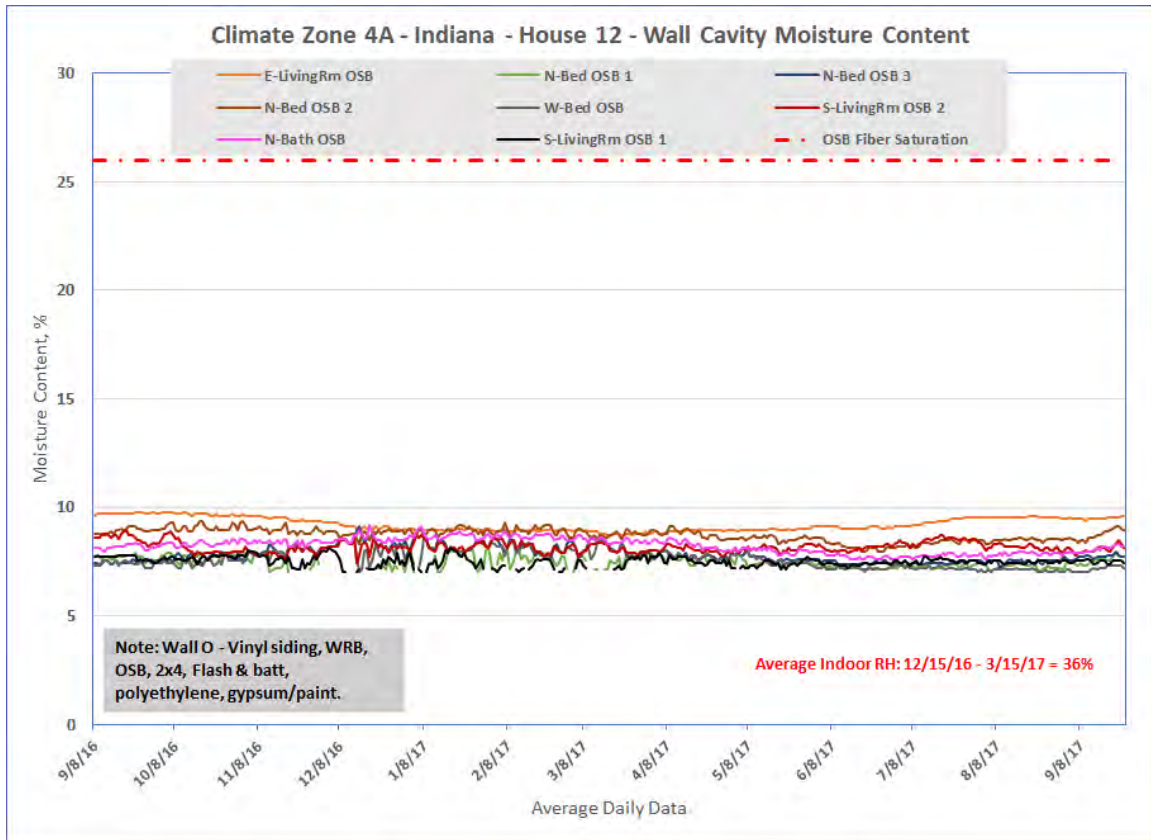
Figure A17. OSB sheathing moisture content for Climate Zone 4A, Indiana, House 12

Figure A17 shows the summary results for the daily OSB sheathing moisture content for House 12, located in Indiana, Climate Zone 4A. The following observations can be made:

- Polyethylene vapor retarder (Class I) is very effective at controlling interior vapor drive. The OSB moisture content remained stable and low (less than 10%) throughout the entire monitoring period. This observation is consistent with other studies and other houses in this study. (Note that walls with reservoir claddings are subject to solar drive; during the summer, this adds to moisture loads in walls with Class I vapor retarders.)
- The primary drying path for this wall system is expected to be to the outside.
- Performance of this wall assembly during athe cooling season ~~should be monitored to evaluate~~did not indicate the any potential for moisture buildup in the cavity ~~because of cooler indoor temperatures.~~

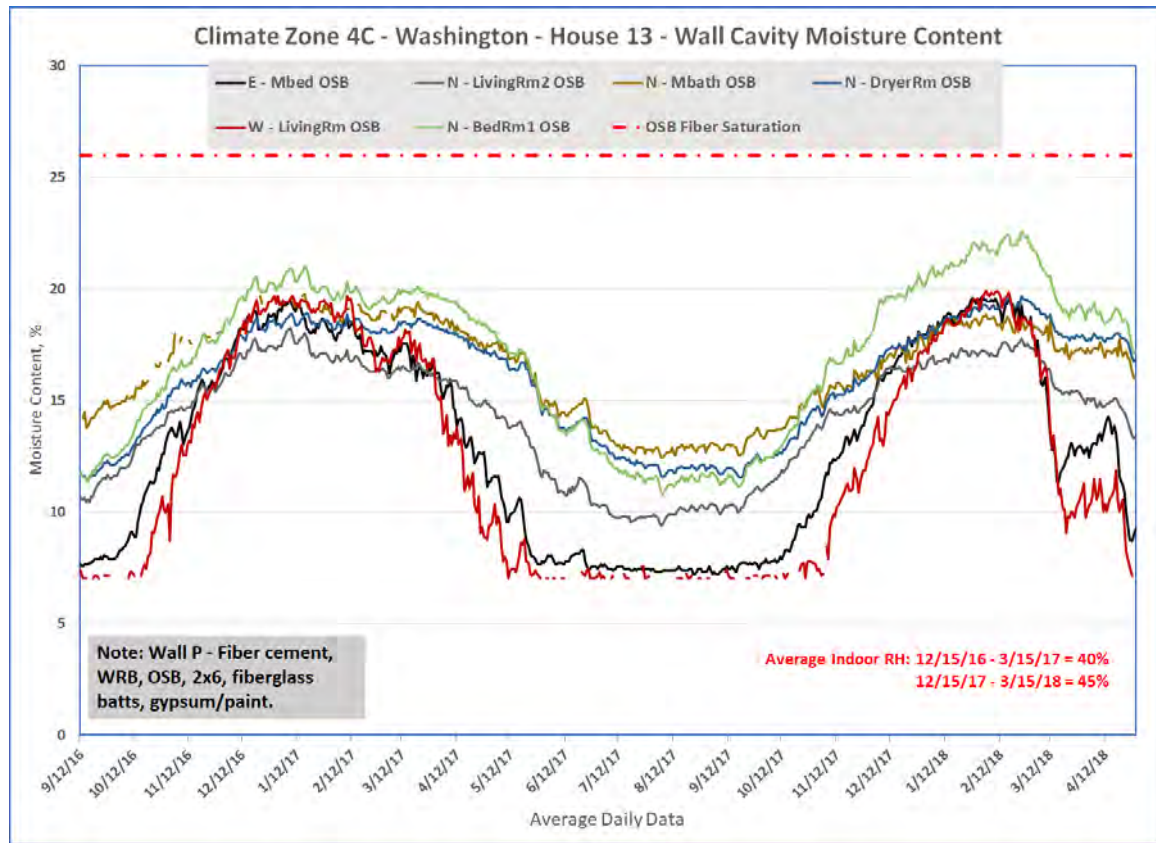
Figure A18. OSB sheathing moisture content for Climate Zone 4C, Washington, House 13

Figure A18 shows the summary results for the OSB sheathing daily moisture content for House 13, located in Washington, Climate Zone 4C. Note that because a non-vented cladding was used, the IRC requires a Class I or Class II vapor retarder (was not used in this house) in Climate Zone 4C. The following observations can be made:

- The interior RH levels during the winter seasons were 40% on average 40-45%. This was somewhat less not far from than the results of the previous monitoring study, which showed RH levels exceeding 60%. This is one of the few sites where the second winter outdoor temperatures were a few degrees higher than the first winter (minimum temperature 25.9°F in 2016-2017 vs 29.6°F in 2017-2018).
- If a wall system with reduced seasonal fluctuations was desired, the use of a Class II interior vapor retarder (e.g., Kraft paper, membranes) should be considered. Installing cladding in a vented manner can provide another mechanism for moisture dissipation to the outdoors.

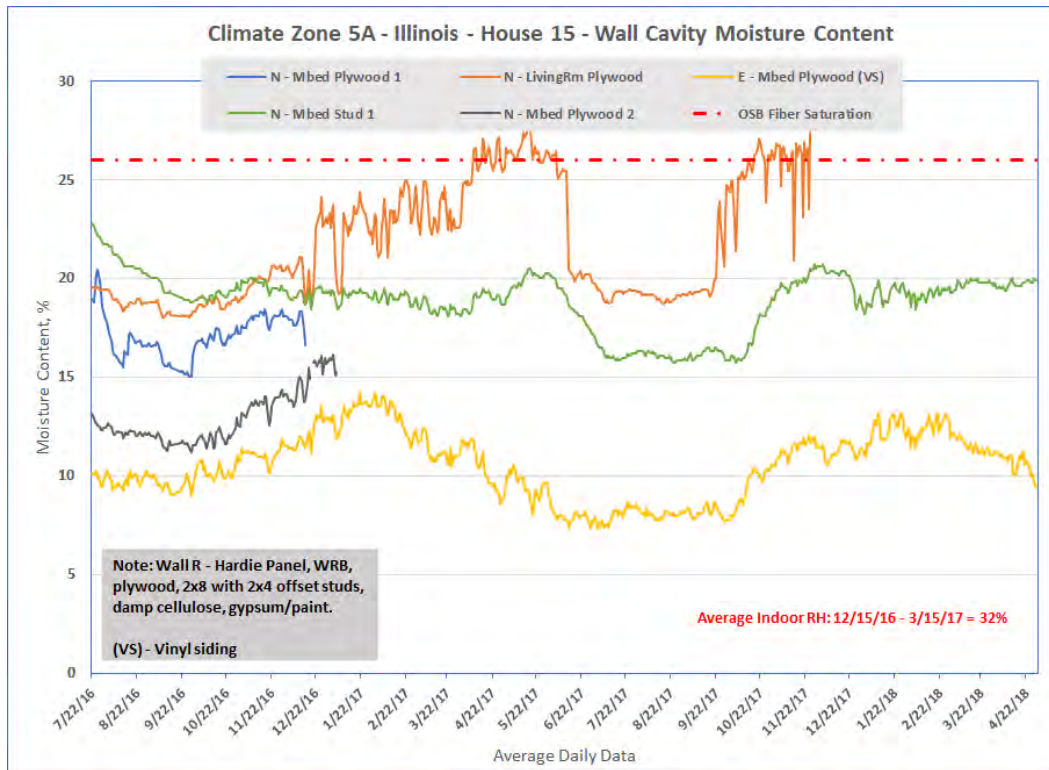
Figure A20. Plywood sheathing and stud moisture content for Climate Zone 5A, Illinois (1), House 15

Figure A20 shows the summary results for the plywood daily moisture content for House 15, located in Illinois, Climate Zone 5A. The following observations can be made:

- Another factor that contributed to the observed rise of moisture content during the heating season was low winter temperatures at this site (as low as 1°F in the first heating season and -9°F in the second heating season).

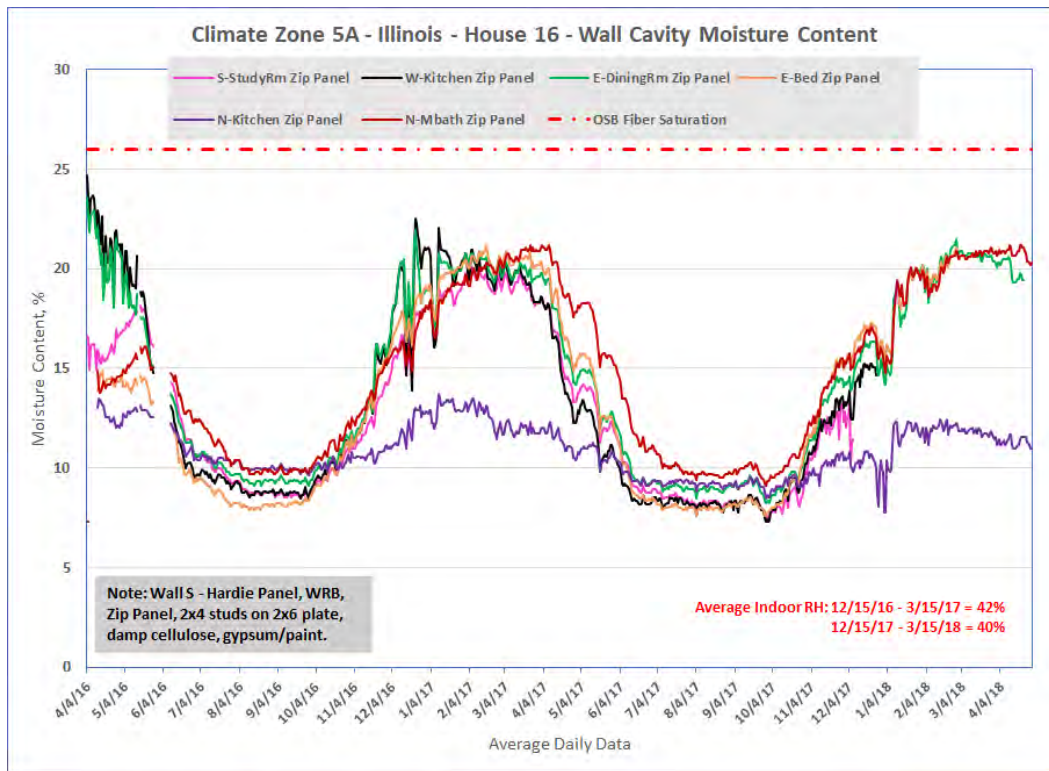
Figure A21. ZIP sheathing moisture content for Climate Zone 5A, Illinois (2), House 16

Figure A21 shows the summary results for the ZIP sheathing daily moisture content for House 16, located in Illinois, Climate Zone 5A. The following observations can be made:

- If a wall system with reduced seasonal fluctuations is desired, use of Class II interior vapor retarders or the addition of exterior insulation should be considered.
