Addendum to the May 2018 Report “Moisture Performance of High-R Wall Systems” by Home Innovation Research Labs

September 2018

Purpose

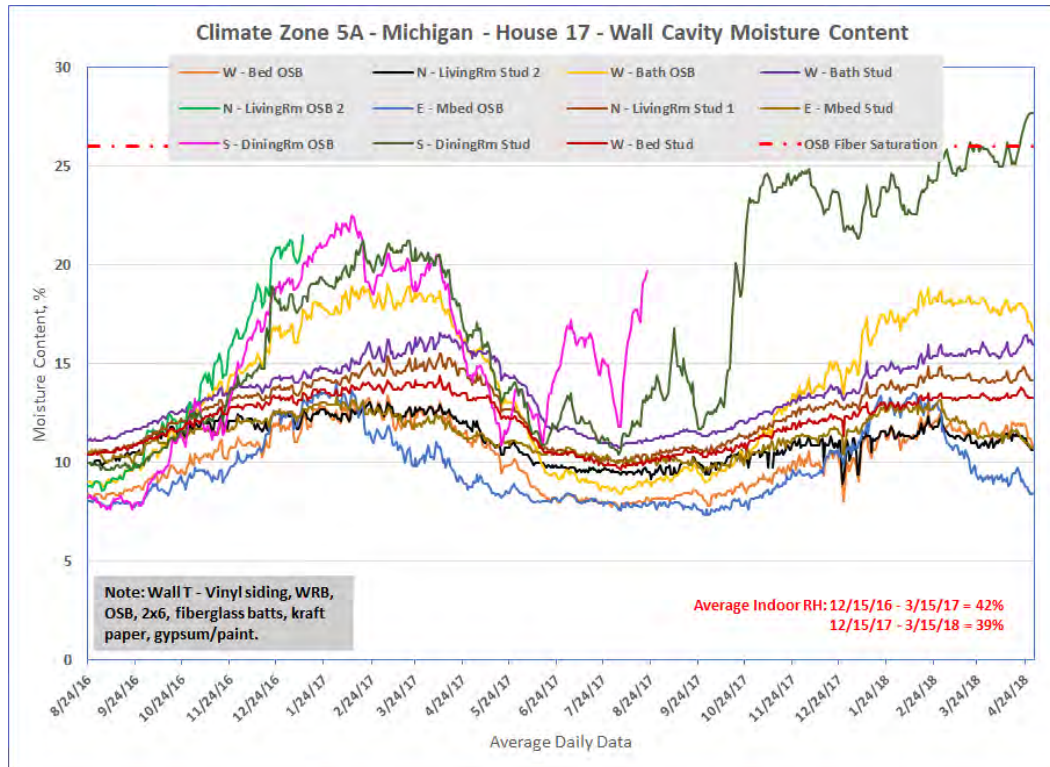
Figure A22. OSB and stud moisture content for Climate Zone 5A, Michigan (8), House 17

Figure A22 shows the summary results for the OSB sheathing and stud daily moisture content for House 17, located in Michigan, Climate Zone 5A. The following observations can be made:

- A definitive drying trend was observed in April, with moisture content rapidly dropping to levels at or near 15%. The drying path for this wall can occur to the inside and to the outside.

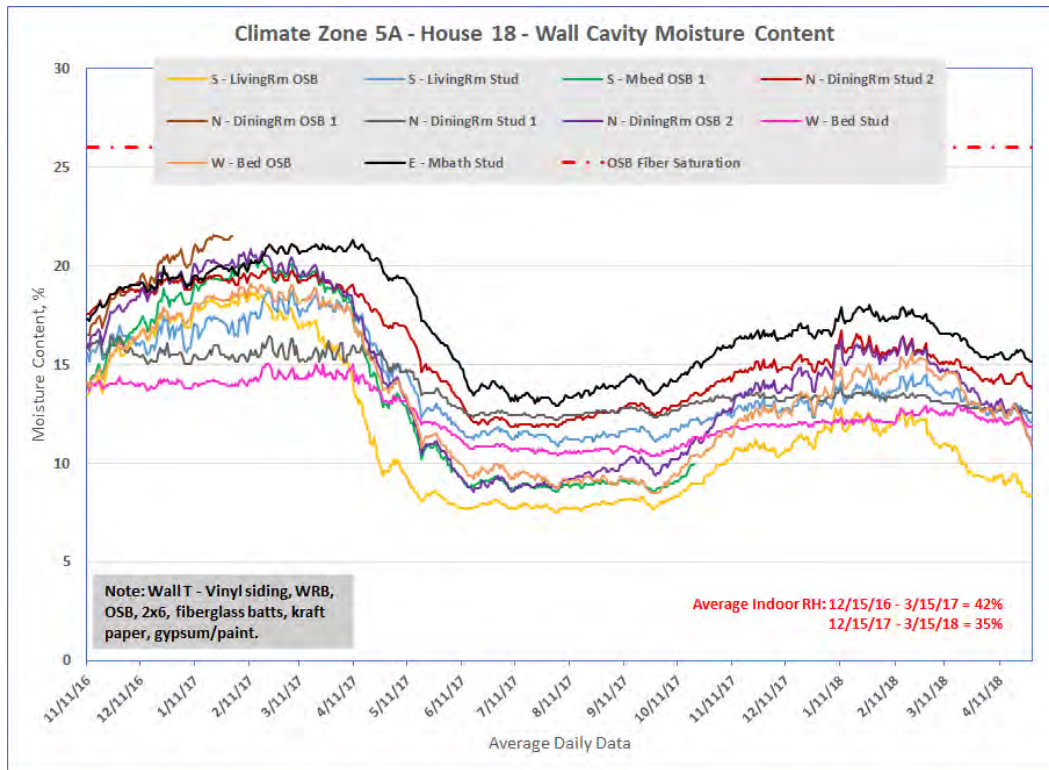
Figure A23. OSB and stud moisture content for Climate Zone 5A, Michigan (9), House 18

- House 18 is similar to House 17 in construction, and performance is also similar with exception of those three sensors in House 17 that showed amplified seasonal trends. The observations made for House 17 apply to House 18. The difference is that the monitoring period for House 18 began two and one-half months after House 17. In House 18, the upward amplitude during the second winter is about 4-6% lower compared to the first winter, which is likely due to the lower interior relative humidity levels.

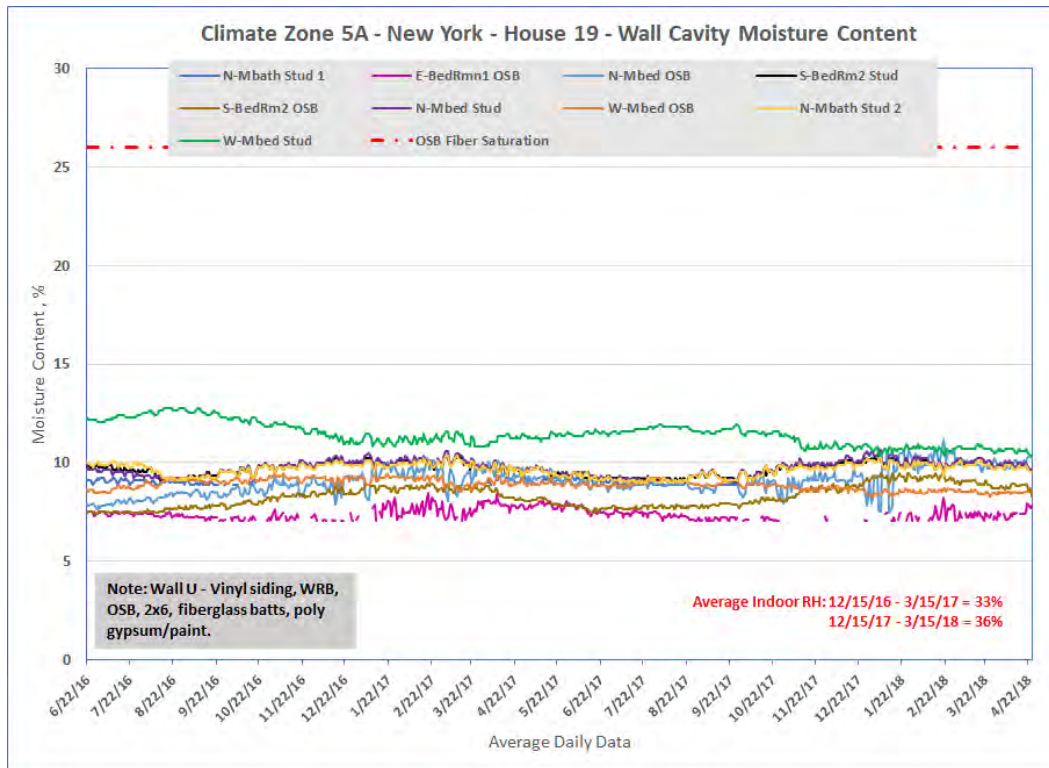
Figure A24. OSB and stud moisture content for Climate Zone 5A, New York (2), House 19

- The drying path for this wall for any incidental moisture was to the outside. The house wrap used for this house was rated at 8 perms. Although a more vapor-open house wrap may be recommended for this wall to increase its drying capacity, the observed performance did not indicate a need for a change based on the current conditions. Note that if a reservoir cladding is used, a low-perm house wrap would have helped control solar vapor drive.

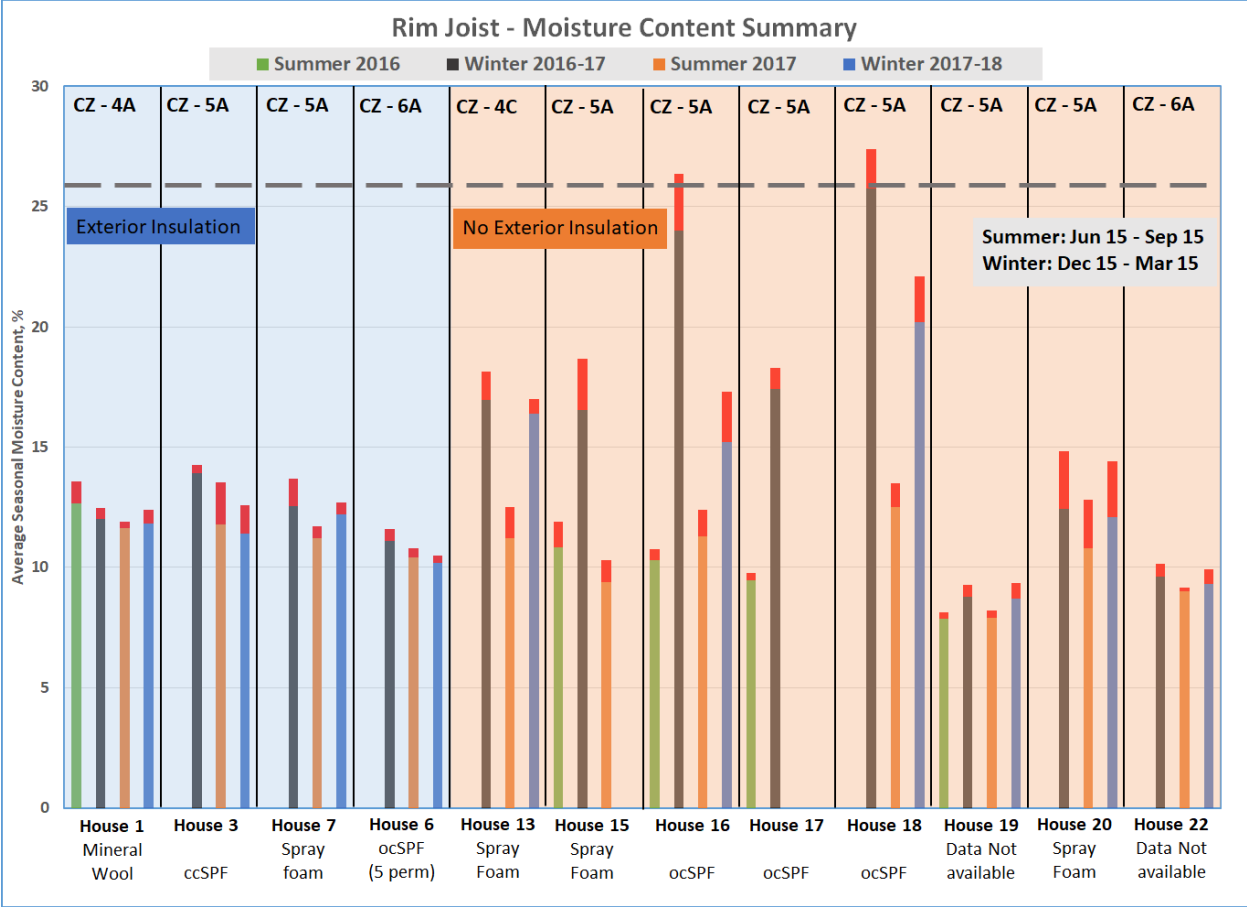
Figure A30. Summary: seasonal peak and averages moisture content of rim joists

- Walls with exterior insulation remained at low moisture levels and did not show significant seasonal fluctuations. For Climate Zone 4A (House 1), the rim area was vapor open in both directions. For climate zones 5A and 6A (~~H~~Houses 3, 6, 7), foam products were installed on both faces of the rim joist. For all walls with exterior insulation, the moisture content was less than 15% and did not exhibit significant seasonal fluctuations.
- For houses without exterior insulation, rim joists with open-cell spray foam showed larger seasonal fluctuations; however, these were not necessarily to the levels approaching the fiber saturation point and most houses showed lower moisture content levels during the second heating season even though the outdoor temperatures were lower. Those houses that did not show seasonal fluctuations (Houses 19 and 22) likely used closed-cell spray foam.
