Performance of Windows in Walls With Continuous Insulation

March 2023

Partnership for Home Innovation
Home Innovation Research Labs
400 Prince George's Blvd.
Upper Marlboro, MD 20774

John Peavey and Nay Shah. 2023. Performance of Windows in Walls With Continuous Insulation. Upper Marlboro, MD. DOE/GO-102023-5719. www.nrel.gov/docs/fy23osti/82494

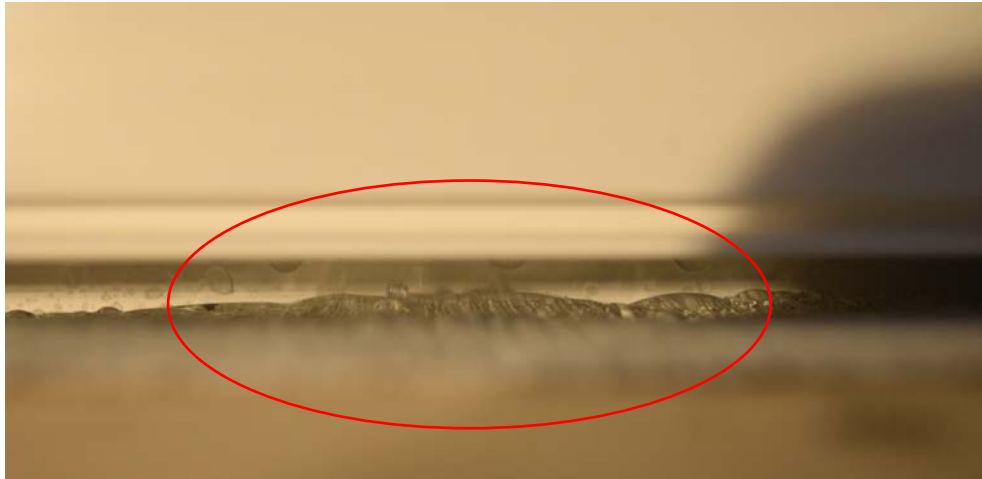
Figure 12. Slight Water Pooling at the Sill

All specimens except for Wall 15 performed similarly in the water penetration resistance test. For these 14 specimens, the water bubbled when the pressure reached 3.76 psf or 5.43 psf during the step portions of the water test. In some specimens, slight pooling was observed at the sill region, however the water never overflowed from the sill to the interior face of the framing around the window. The water usually drained once the pressure dropped to 0 psf. For the cyclic portion of the water test, the water bubbled or slightly pooled at the sill when the pressure reached 5.43 psf. The water promptly receded as the pressure dropped back to zero. These observations were consistent for walls with and without CI. See Figure 12 and Figure 13 for detailed images of the observations.

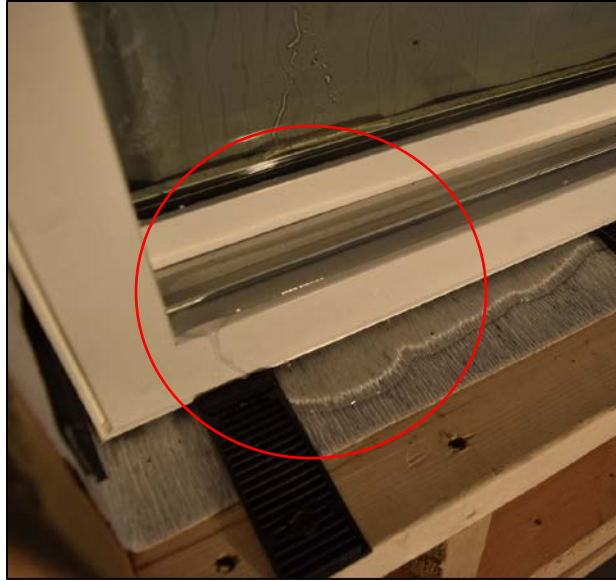
Figure 14. Water Pooling and Overflowing During the Water Test

For Wall 15, with the large slider window, there was a significant amount of water penetration at both the step and cyclic portion of the testing. The manufacturer provided a new window in case there was a factory defect, however the results were the same. See Figure 14 on the water leakage and pooling. The water pooled and overflowed from the slider rail region of the window assembly.

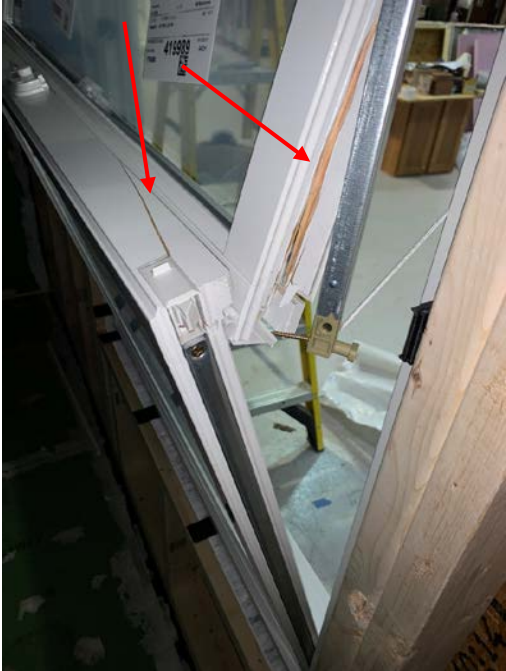
Figure 15. Window Sash Damage

For Wall 9, the window experienced a structural failure when it was loaded to 24 psf in the positive direction. The window buckled at approximately 23 psf. The window sash had cracks and the sash was displaced from the window frame. Based on the 14 other walls tested, this failure is most likely unrelated to the foam sheathing. It could have been defect/damage caused during production or shipping.

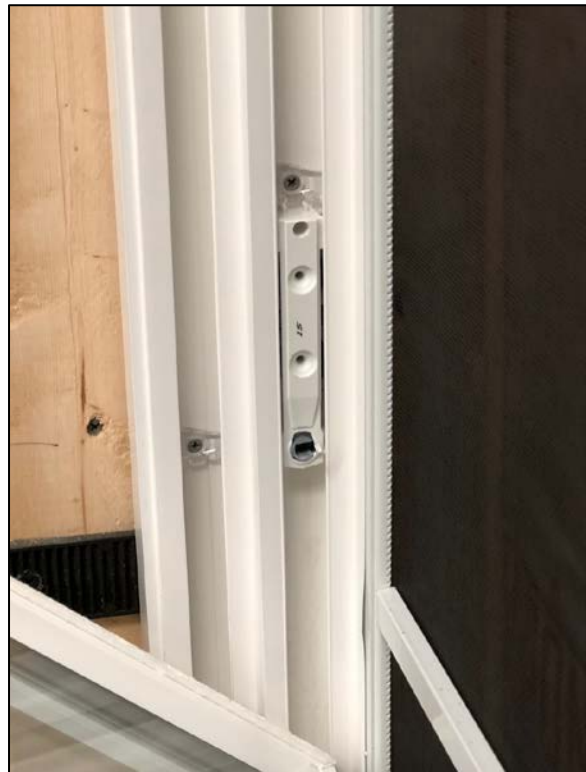
Figure 17. Window Sash Popped Out from Counterbalance Mechanism

However, there was a consistent operability failure for the double-hung windows that were installed directly on CI. During the negative pressure protocol portion of the structural test, where the foam was being pulled on, the sash of the window disengaged from the window's counterbalance mechanism. This disengagement caused the top sash of the window to slide down. Wall 8 (1 in. PIR) was slightly different as the bottom sash of the window disengaged from the counterbalance mechanism.

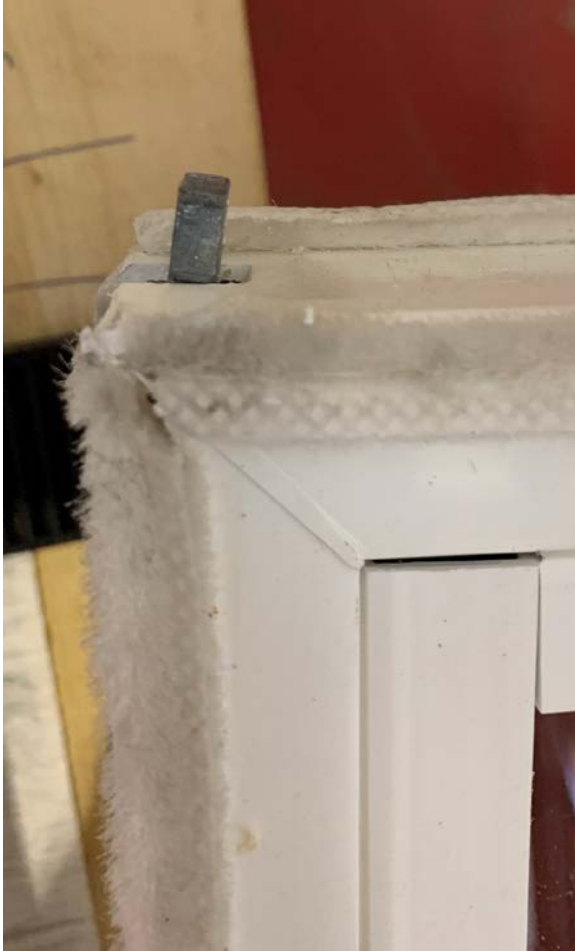
Figure 18. Sash Hook Slightly Bent

For the mulled double-hung windows (Wall 13 and Wall 14), the sash hook was slightly bent (see Figure 17), and it disengaged from the counterbalance mechanism. For Wall 14 (heavy window with 2 in. XPS), the counterbalance mechanism was disengaged in the mullion region as well.

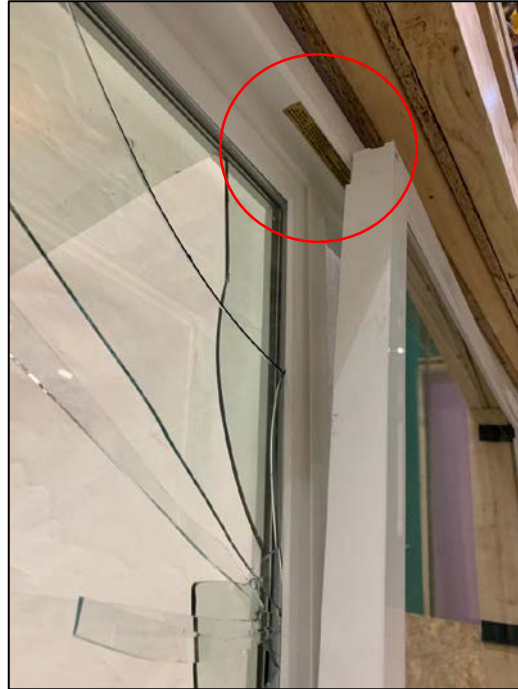
Figure 20. Window Sash Popping Out of Frame

For Wall 15 (large slider window installed over 2 in. XPS), the window experienced significant structural failure. The failure was observed at approximately 32.5 psf. See Figure 19 for photos of the structural damage. The slider window has two sashes – one stationary and one sliding. The glass broke from the stationary sash due to bending. The glass in the sliding sash did not break, but the sash popped out of the frame. During the final structural test, there was visible bending of the mullion (see Figure 19). This was the only slider window tested for this project.

For all the slider windows, the deflection at the center of the window was more significant and noticeable than the for the other types of windows. This deflection may be caused by the lack of support for the center sashes of the slider windows. Potential solutions, which would require additional testing, may include fastener spacing reduction, different types of fasteners, masonry window clips, construction adhesive, foam sealant, stronger window flange material, or straps.

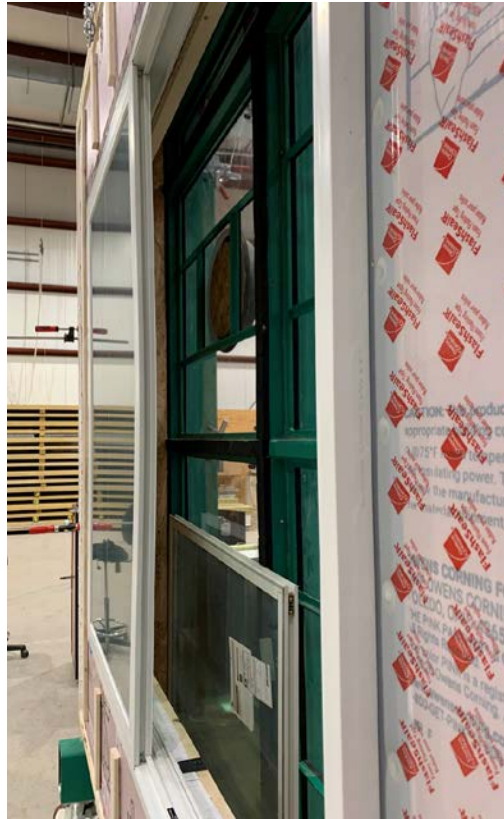
Figure 21. Window Being Pulled Off Its Sash

For the Andersen slider (ID 03) window, the sliding window unhinged from its sash and its locking mechanism during the positive pressure test. See Figure 20 for window damage. The window bowed-in significantly when the pressure was applied. The failure occurred around 60 psf as it was approaching the 75 psf (1.5 DP).
