Draft Technical Report: Winchester/Camberley Homes NCTH

Short Term Testing
Mixed Humid Climate

D. Mallay, J. Wiehagen, A. Wood

December 2011

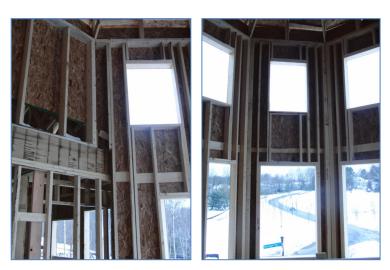
Figure 8. Complex Thermal Air Boundary (1 of 3)

To achieve very low infiltration rates given the frame walls and complex thermal boundary, it was essential to identify critical areas for air sealing. The air sealing design was considered complex to air seal primarily due to the third floor and turret as detailed in Figure 8, Figure 9, and Figure 10. The third floor had front and rear knee wall attics, partially sloped ceilings, and a separate attic above the flat ceiling. The top of the turret and the third floor were separated by the front attic. Additionally, the stairs to the third floor, the HVAC chase, a knee wall framed cavity, a gable knee wall for a second floor bedroom with a cathedral ceiling, and two closets with lower ceilings, were all adjacent to the same attic. This complex design created the need for the installation and sealing of numerous air barriers including the blocking of floor joists below third floor knee walls.

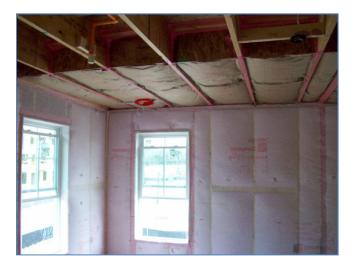
Figure 13. Wall & Attic Insulation

After air sealing, wall cavities (above grade) were netted and blown using R-24 dense-pack fiberglass insulation. The triangular voids between the wall panels of the octagonal turret were filled using spray foam insulation from a can, as these walls had been installed with a ¾" gap between panels. Basement walls were insulated using R-13 fiberglass batts. Attic insulation, including the sloped ceilings of the third floor, was increased to R-49. This was accomplished using fiberglass batt insulation in some sloped ceiling locations and blown fiberglass insulation in other locations. Attic insulation in a few locations was installed before drywall using netting because access to these attic areas would be very limited after drywall installation. Windows were double hung, vinyl, and improved to low-e, U-0.31, SHGC-0.28. The installed insulation and fenestration is detailed in Figure 13.

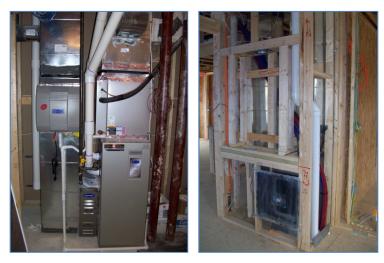
Figure 14. Furnace and First Floor Return Grille at Central Chase

High efficiency equipment was specified: a 16 SEER cooling system and a 92.5% AFUE natural gas furnace. The furnace shown in Figure 14 was direct vent (two-pipe and using outdoor air for combustion) with a two-stage gas valve and ECM air drive. The furnace was selected based on the cooling air flow requirements; in high-heat mode the furnace output was much higher than the design load, however in low-heat mode, the output matched much more closely to the calculated load. The programmable thermostat with integral humidistat had the capability of running the furnace in dehumidification mode (reduced blower speed) to improve moisture control during the cooling season. Electronic zone dampers were specified to ensure occupant comfort in this four level house design. Load calculations, equipment selection, and duct design

The centrally located duct chase shown in Figure 14 served all four levels. A simplified return duct system, consisting of one central return per level, was installed in the chase. Bedroom transfer grilles, baffled to minimize light and noise, provided a return air pathway. The return duct was intentionally sized in accordance with ACCA Manual D Air Velocity for Noise Control recommendations and acoustically lined in order to ensure quiet operation, an important consideration with the furnace installed in the basement directly below the first floor return grille.

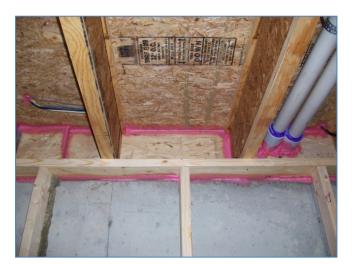
Figure 22. Air Sealing at Basement Rim Area

Sealant was not consistently applied to the faces of the bottom plates of exterior walls (bottom plates were sealed at the floor deck) or faces of rough framing around windows and doors, in accordance with the ADA, because the contractor and did not consider this necessary. Sealant was applied in the gap between the rough framing and the windows and doors, however these gaps may have been more effectively sealed using low expansion spray foam insulation instead. Sealant applied to the interior faces of the bottom cords of second and third floor roof trusses, while not detrimental, was not considered, by the Research Center, necessary. The sill plate at the foundation wall was difficult to reach and inspect because the basement wall framing had already been installed, therefore the sill plate was sealed from the exterior.

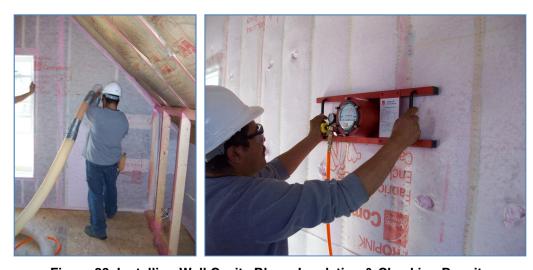
Figure 23. Installing Wall Cavity Blown Insulation & Checking Density

To insulate the wall cavities, netting was stapled to the faces of all wall framing. Next, the loose fiberglass insulation was blown into each cavity, using a hose from the truck outdoors, through one slit in the netting (see Figure 23). Wall cavity density was measured as the work progressed to ensure the target insulation levels were achieved (see figure 13). For attic insulation, netting was installed at the ceiling plane where fiberglass batts had not already been installed, and then loose fiberglass was blown into these areas. All wall and ceiling insulation was complete before drywall installation.
