ENERGY PERFORMANCE REMODELING

Case Study:

Habitat for Humanity Montgomery County (HFH-MC) Montgomery County, MD

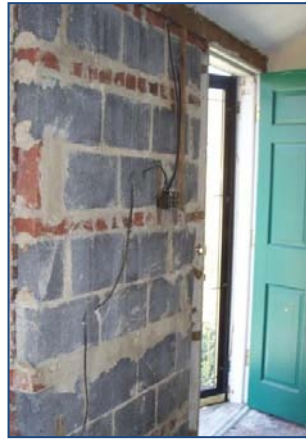
1) remove drywall

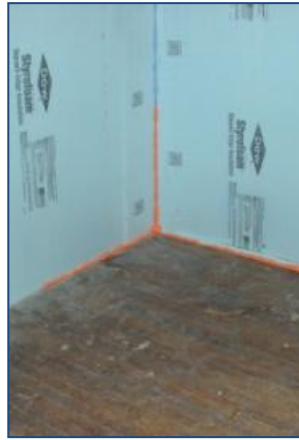
2) install rigid foam & air-seal

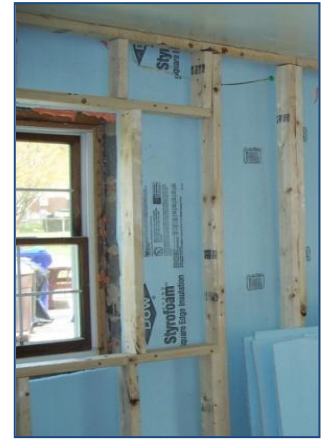
3) construct 2x4 wall

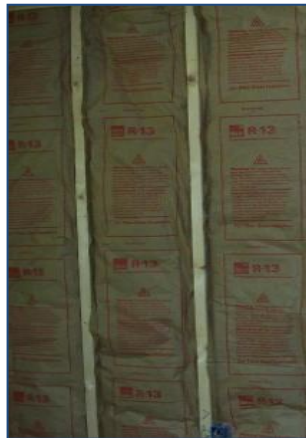
4) insulate 2x4 wall

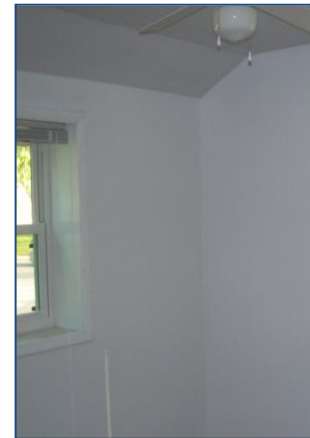
5) finish interior walls
