Initial Study of the Moisture Performance of OSB-Sheathed Walls in Homes in Climate Zones 4 and 5

Interim Report

6/30/2010

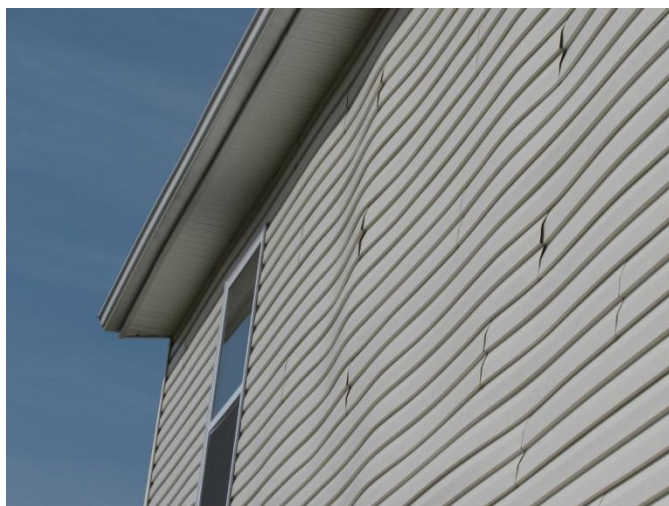
Interviews were conducted with several builders that experienced this condition. The problem manifested itself as “wavy” vinyl siding (Figures 1-4). The repairs typically involve removal of the siding and replacing of buckled OSB panels. Evidence of the panels having elevated moisture levels was observed during the repairs, including in some cases observations of a ‘mold-like substance’ on the interior face of the panel. During repairs made in the winter months, in some cases frost was also observed on the exterior face of the panel.

Figure 1 – Wavy lap siding due to buckled OSB panels on the rear wall of a house

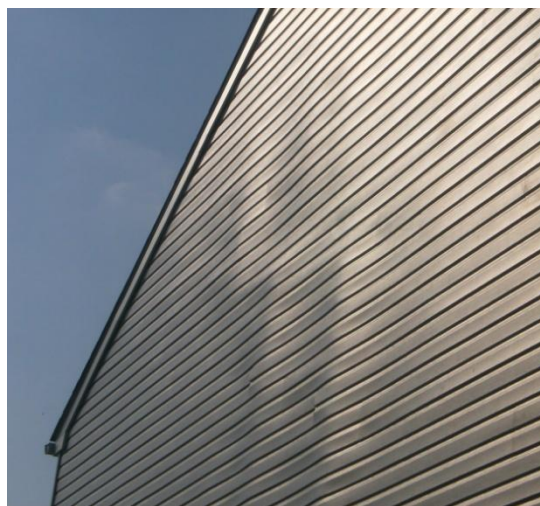
Figure 2 – Wavy siding due to buckled OSB panels on a side wall of a house

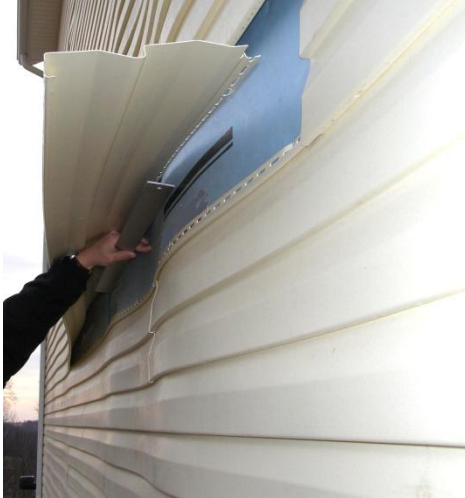
Figure 3 – Wall with buckled OSB panels (siding removed exposing water resistive barrier)

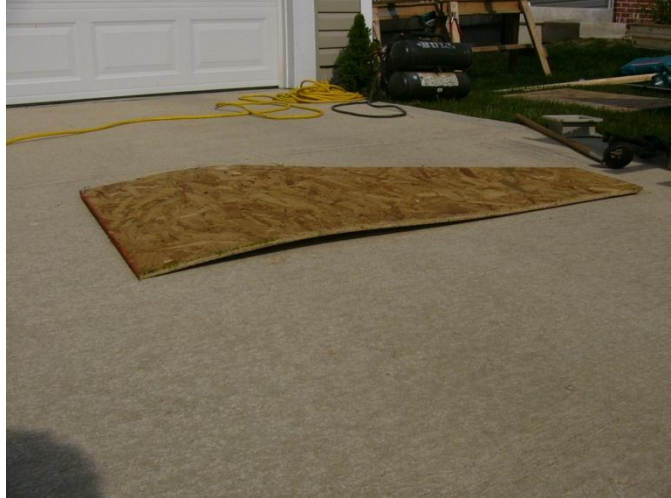
Figure 4 – Removed buckled OSB panel

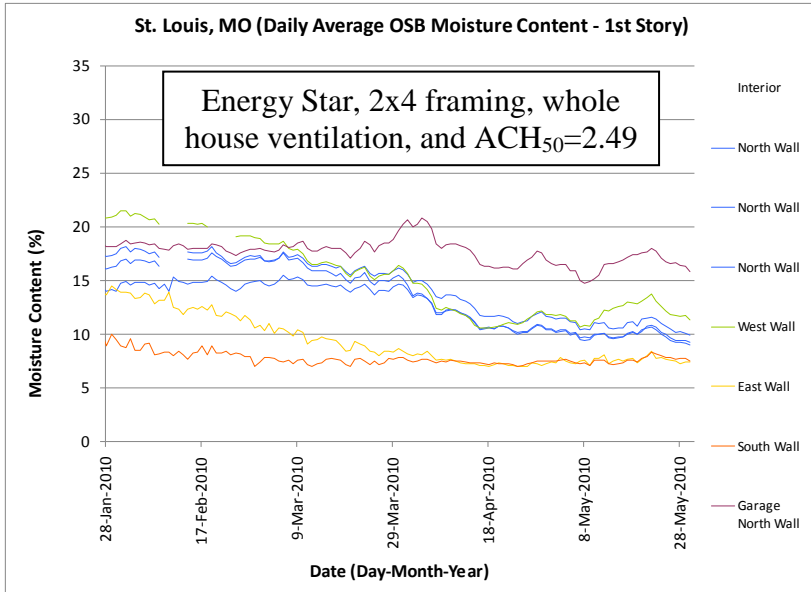
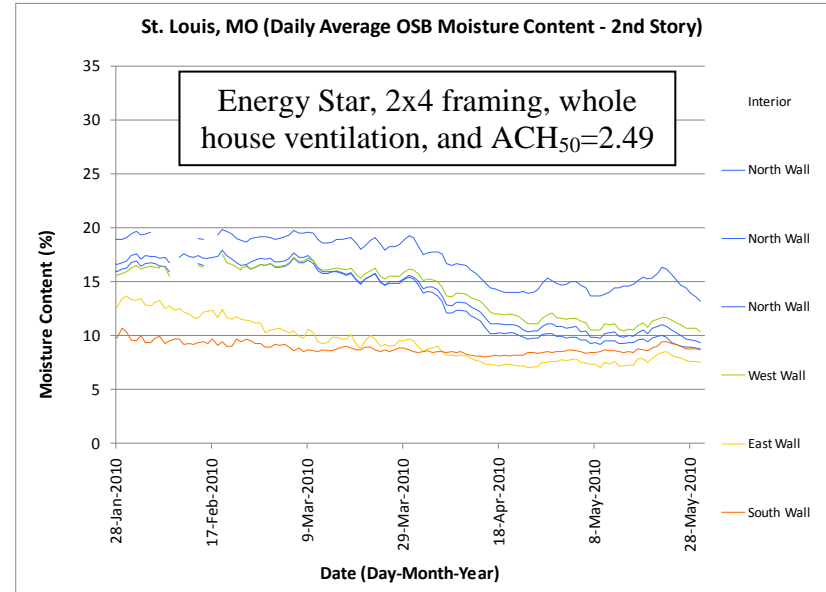
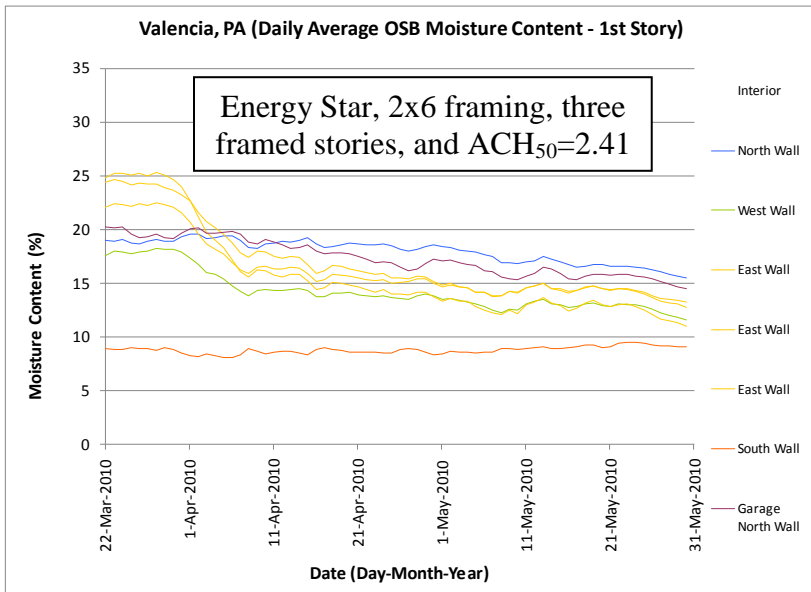
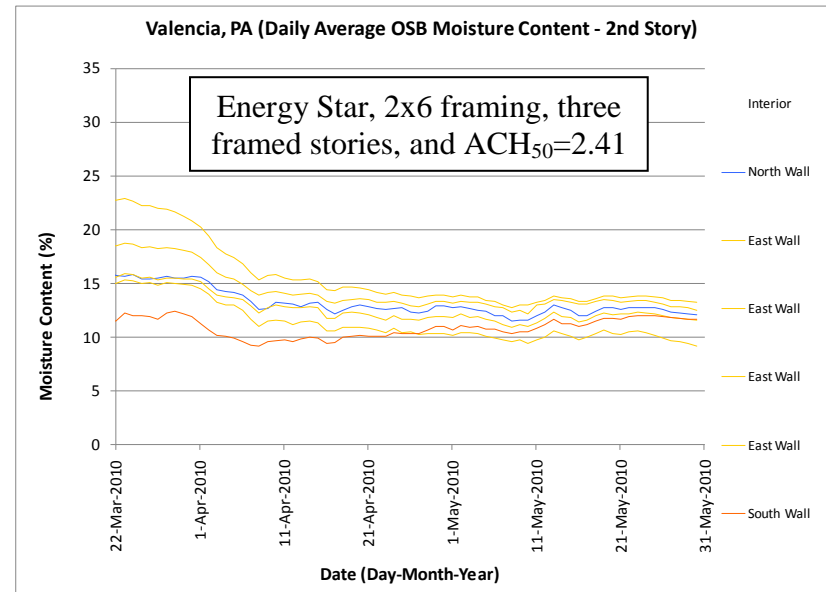
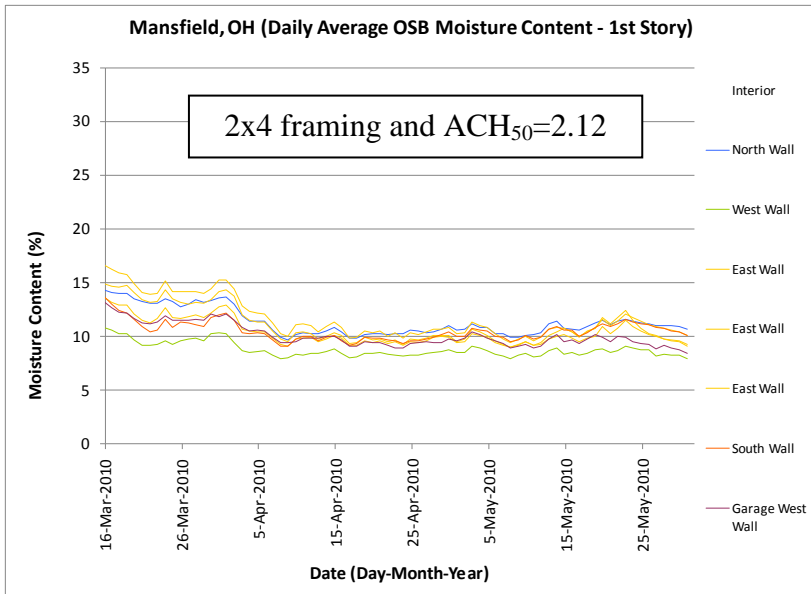
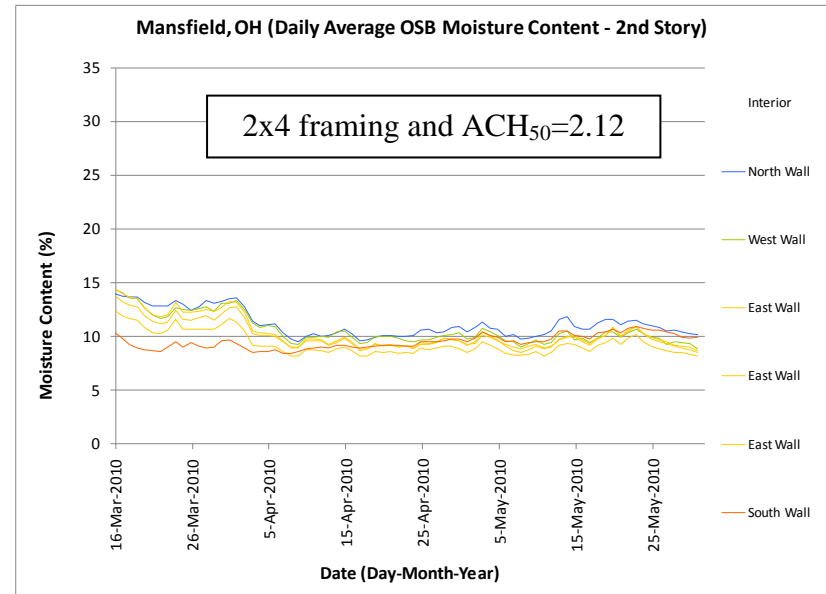
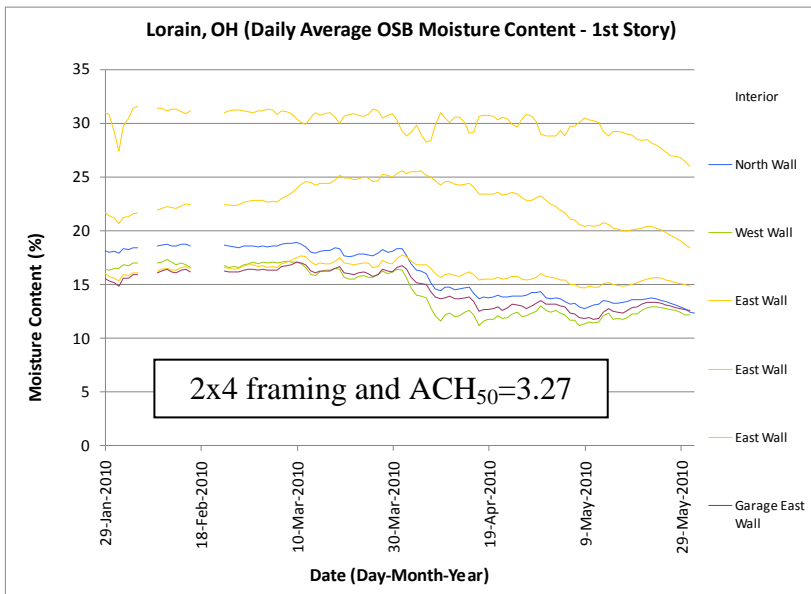
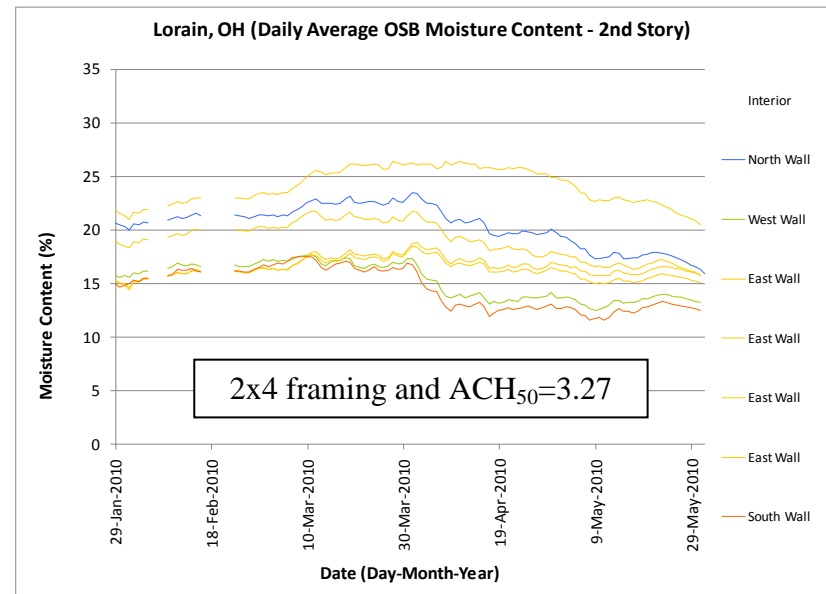
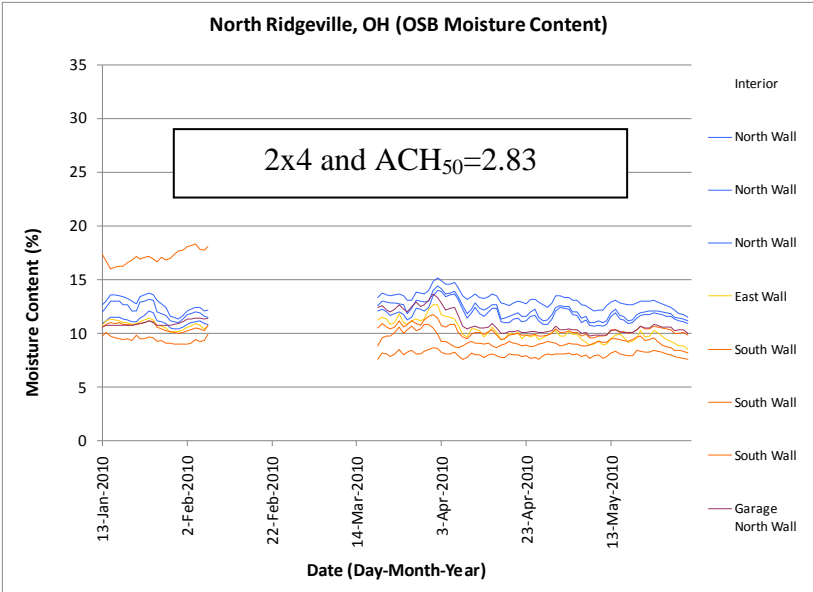
The daily average OSB moisture contents for each jobsite are provided in Figure 16 through Figure 24. In-service home interior and wall cavity measurements of temperature, relative humidity, and a comparison of dew point versus temperature are provided in Attachment 1. In-

The trends in OSB moisture contents demonstrate that during the initial stages of home occupancy moisture contents are elevated or elevating. However, as ambient temperatures increased in the spring, a decrease in moisture contents in OSB panels occurred. This ‘drying-out’ of the panels was most accentuated during the first week of April with a drop in OSB moisture content observed in each of the homes during this period.

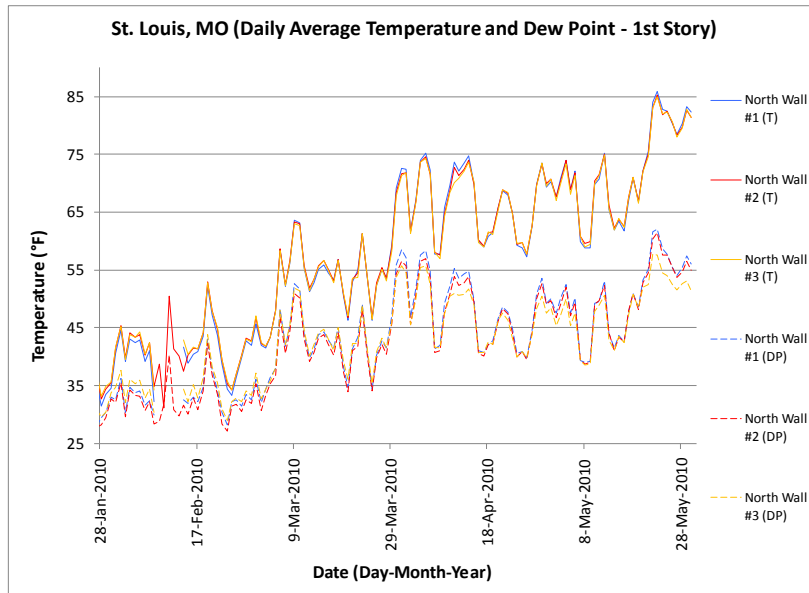
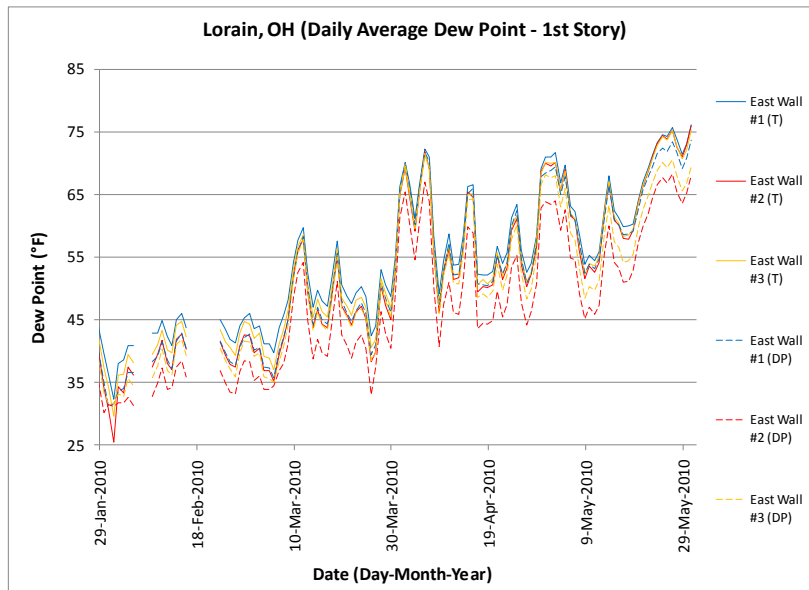
As relative humidity increases in a wall cavity, the potential for condensation of water on the interior surface of OSB panels also increases. Figure 25 and Figure 26 are comparison plots for the test wall cavity temperatures and dew point cavity temperatures for Jobsite #1 and Jobsite #5, respectively. The dew point temperatures and the cavity temperatures are converging during the winter months and diverging in the spring months in each of the two homes. Condensation potential is highest in Jobsite #5 as shown in Figure 26 where the cavity temperature is consistently approaching the cavity dew point throughout the monitoring period.

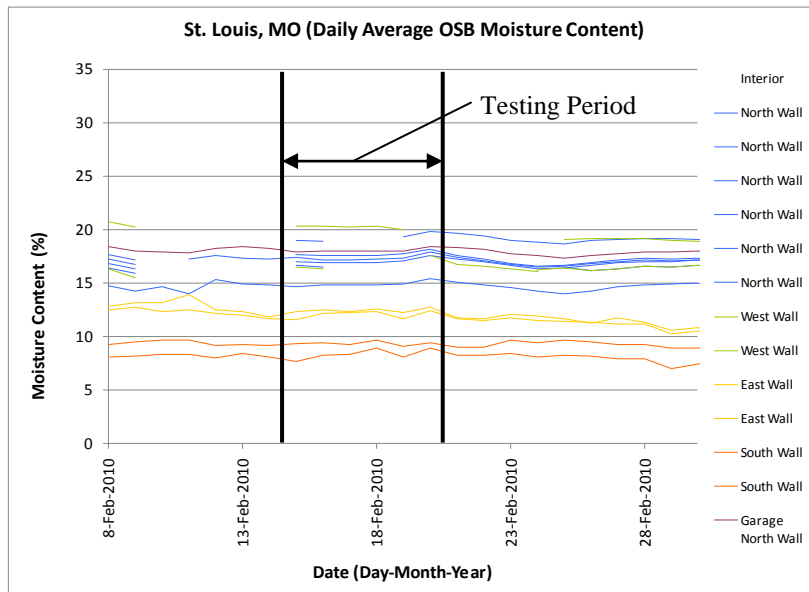
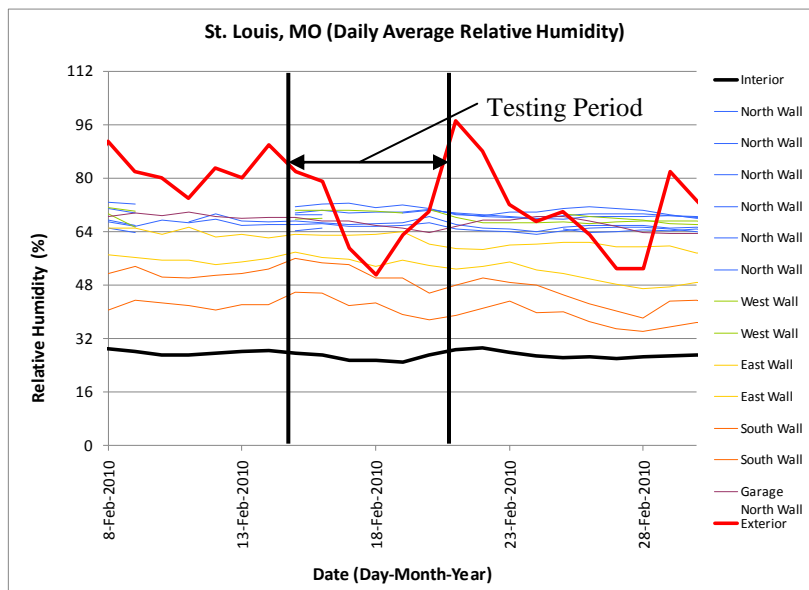
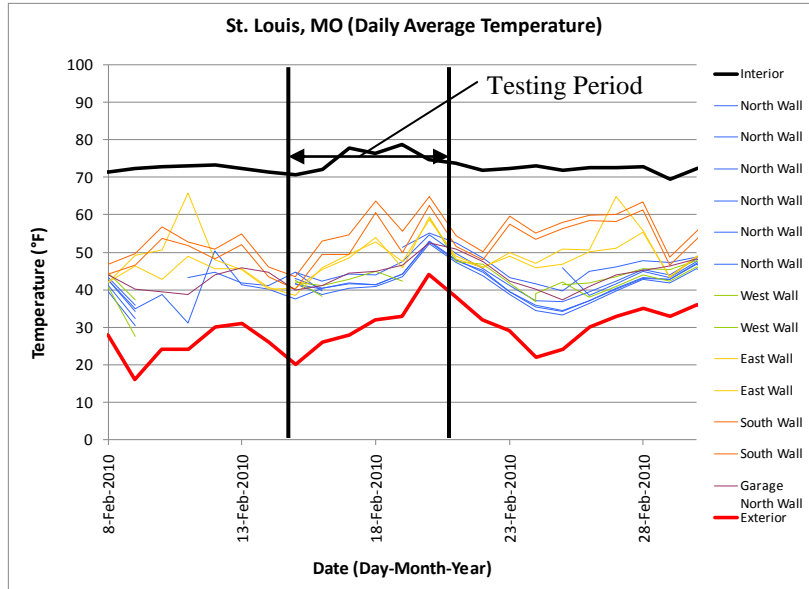
Figure 27 – Jobsite #1 continually running fan test observations

During the first week of obtaining measurements for Jobsite #1, elevated relative humidity and moisture content levels were observed. To determine the effect of interior relative humidity on OSB moisture content, the home contractor was requested to turn on bathroom fans and keep the fans running continuously for one week. No definite reductions in interior relative humidity, cavity relative humidity, or OSB moisture content were observed during the time the fans were continuously operating (Figure 27). While following the fan testing period a slight decline of moisture content and relative humidity occurred, it is observed that during this period the ambient relative humidity reduced as well (Figure 27c) and could have been the primary cause for minor reductions in OSB moisture content measurements.

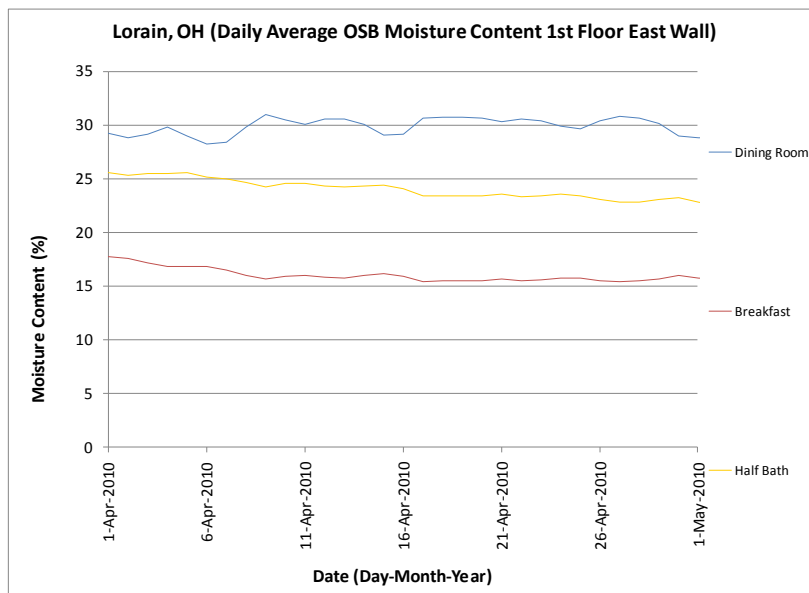
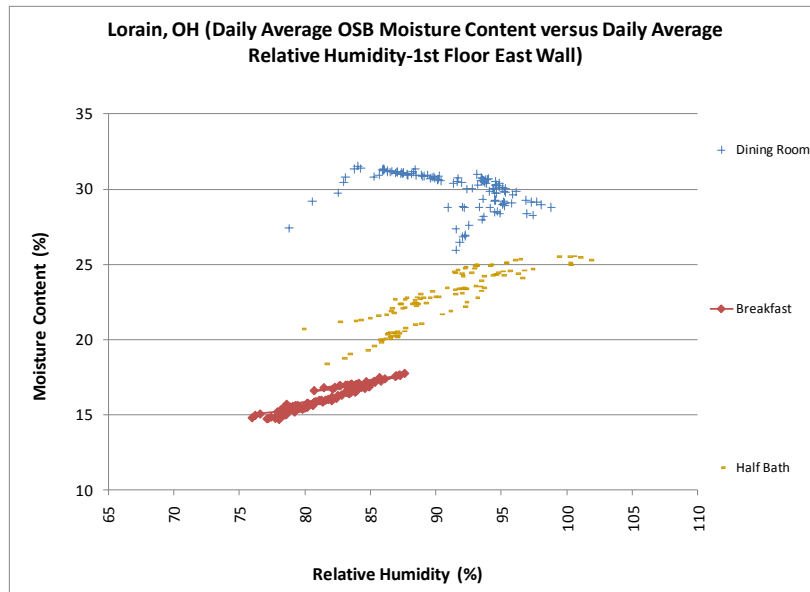
Figure 28 – Jobsite #5 1st floor east wall measurements

The sensor in the dining room of the first floor east (test) wall of the Lorain Home (Jobsite #5) measuring 30% OSB moisture content (Figure 28.a) does not follow the trends of the other sensors in the same wall. Based on Figure 28.b plots, a correlation between relative humidity in the wall cavity and OSB moisture content is observed for the sensors located in the breakfast and half bath wall sensors, whereas the sensor in the dining room does not show a correlation. Moisture content readings of the dining room sensor will continue to be monitored in order to determine the cause of apparent inconsistency.

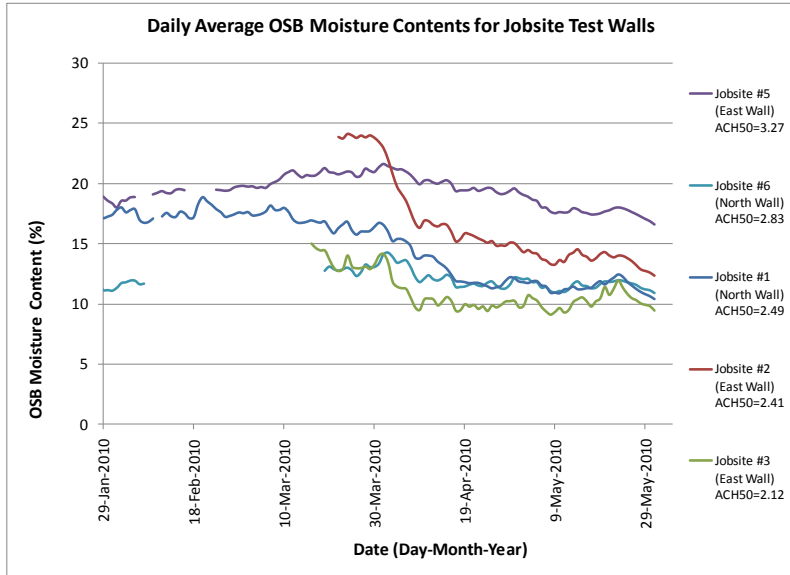
Figure 29 – Jobsite test wall daily average OSB moisture contents

The test wall OSB moisture contents through the month of May are provided in Figure 29 for each home. The legend of Figure 29 provides the calculated ACH₅₀ along with the jobsite location and test wall orientation. A total of three sensors are considered for each jobsite except for the Lorain, OH jobsite, where only the two sensors that follow general trends for the home are used. There is not a definitive relationship between the moisture content and ACH₅₀ (which serves as a measure of building’s tightness). While the home with the lowest ACH₅₀ has the lowest moisture content and the home with the highest ACH₅₀ has the highest moisture content, the remaining three homes do not align with the same trend. It should be noted that ACH₅₀ for each of the homes is relatively low and the range between all six homes is relatively narrow.

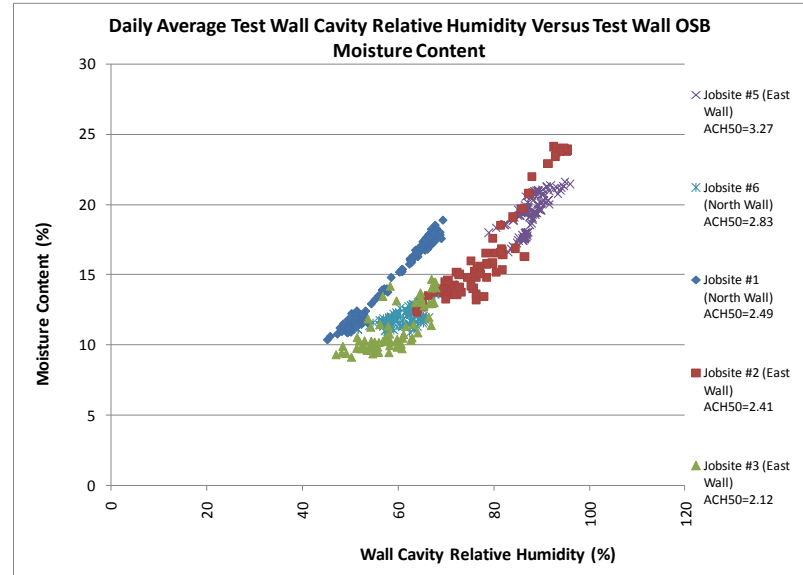
Figure 30 – Jobsite test wall relative humidity and OSB moisture content comparison

Figure 30 plots relative humidity in the wall cavity versus OSB moisture content. There is a definitive trend for all homes indicating an increase in moisture content with an increase in relative humidity. It should be noted that the trend in Jobsite #1 is several percentage points above the trend observed for the rest of the homes. Further analysis will be conducted to investigate reasons for an apparently different correlation observed in Jobsite #1.

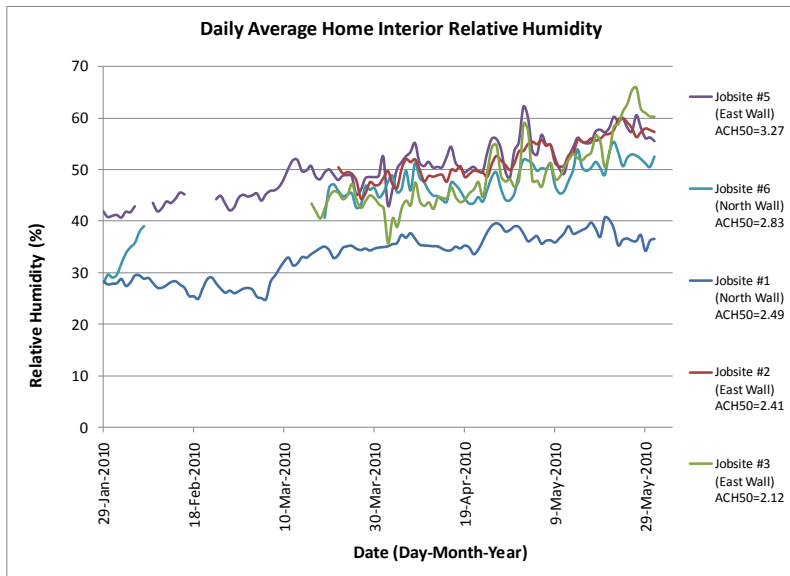
Figure 31 – Jobsite daily home interior relative humidity

Figure 31 shows relative humidity levels inside each home over the monitoring period with the legend showing the associated ACH₅₀. With one exception of Jobsite #1 (St. Louis, MO), interior relative humidity readings for all homes are clustered together indicating no distinctive trend due to the building tightness for the given range of ACH₅₀ values. The interior relative humidity in Home #1 is about 10 percent lower than interior relative humidity in the other homes throughout

the reporting period¹. This trend will be monitored throughout the summer to investigate the impact of the warmer and more humid ambient air.

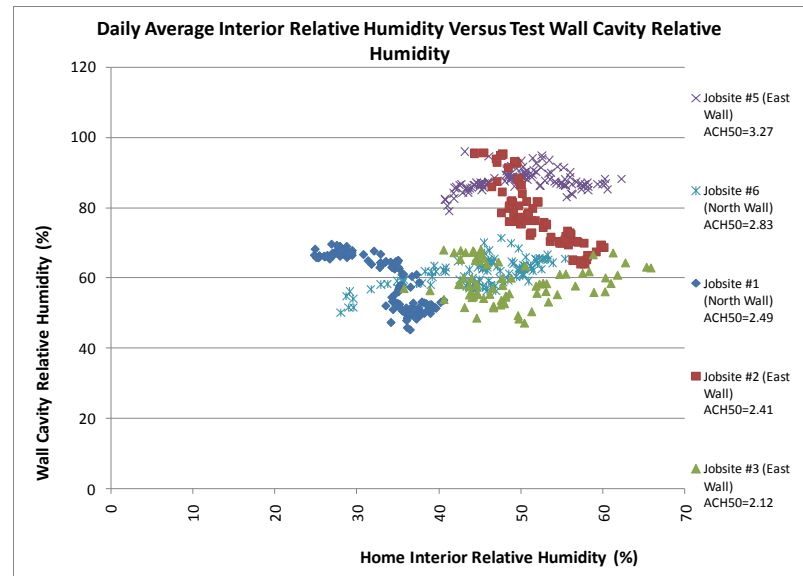
Figure 32 – Jobsite home interior and test wall relative humidity comparison

As the last point of comparison, the wall cavity relative humidity is plotted versus the home interior relative humidity. None of the homes exhibit a trend between these two variables. These results indicate that, at least over a short period following the construction process, other factors besides interior relative humidity alone influenced the conditions inside the wall cavity.
