EXTENDED PLATE & BEAM DEMONSTRATION HOME

FINAL PROJECT REPORT

January 2017

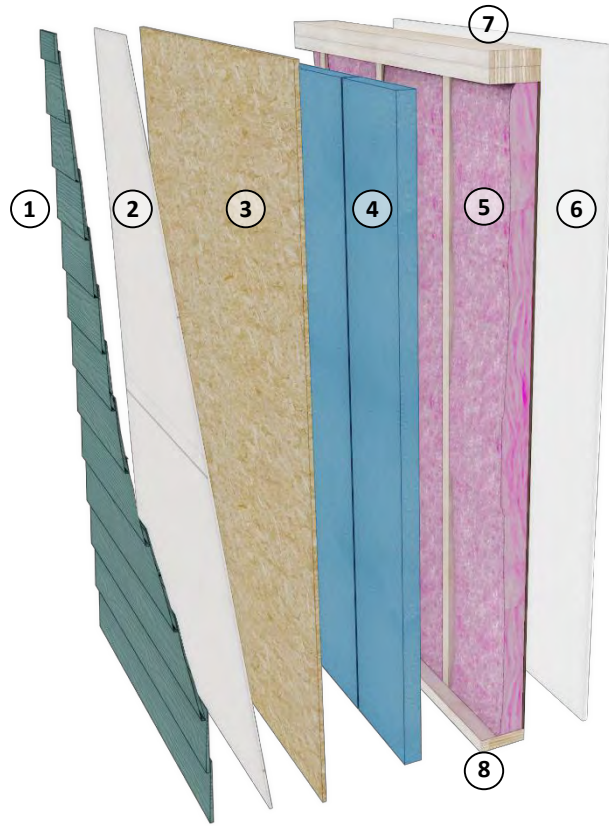
Figure 3. Materials Layering for an Extended Plate and Beam Wall

The NYSERDA demonstration home EP&B design utilized 2x4 lumber for the studs and 2x6 lumber for the bottom and second top plates, with 2-in. extruded polystyrene (XPS) rigid foam continuous insulation, OSB exterior structural sheathing, and R-15, 3- $\frac{1}{2}$ -in. thick un-faced fiberglass batts. The initial EP&B innovation specified that only the bottom and second top plate would be extended, maximizing the area for continuous FPIS. Based in part on the results of this study, the recommended configuration has now been modified to extend both top plates for improved strength and constructability. Typical materials and layering are shown in Figure 3.

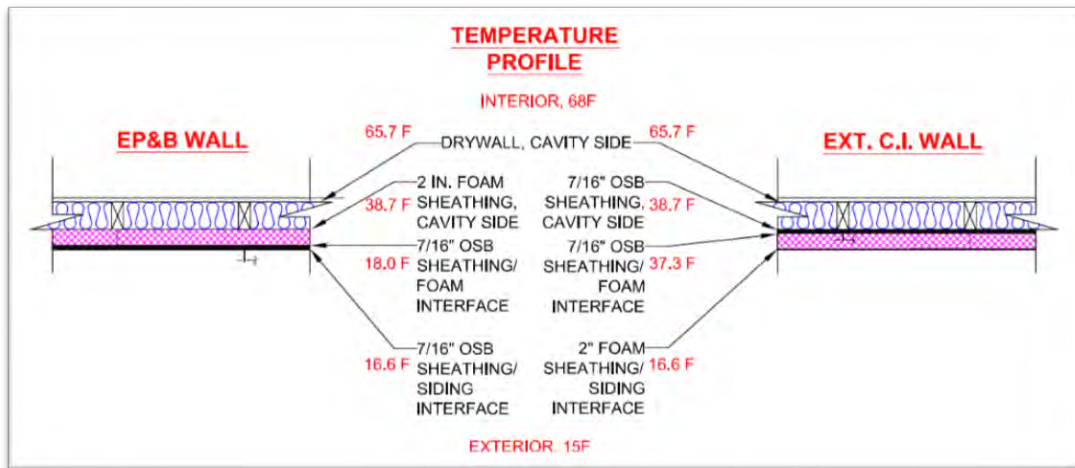
Figure 4. Temperature Profile and Drying Capability: EP&B Wall Compared to Exterior C.I. Wall

Drying capability: In the EP&B configuration, the foam sheathing installed on the interior side of the OSB provides a distinct, centrally-located vapor control plane with effective drying to the direction where the source moisture came from – exterior to the exterior and interior to the interior (Figure 4.) In an EP&B wall, outward drying of the WSP is facilitated by the use of a high-perm WRB.

non-winter seasons when the direction of the vapor drive is also to the inside. Inward drying does not occur in the winter when there is a strong vapor drive in the opposite direction.

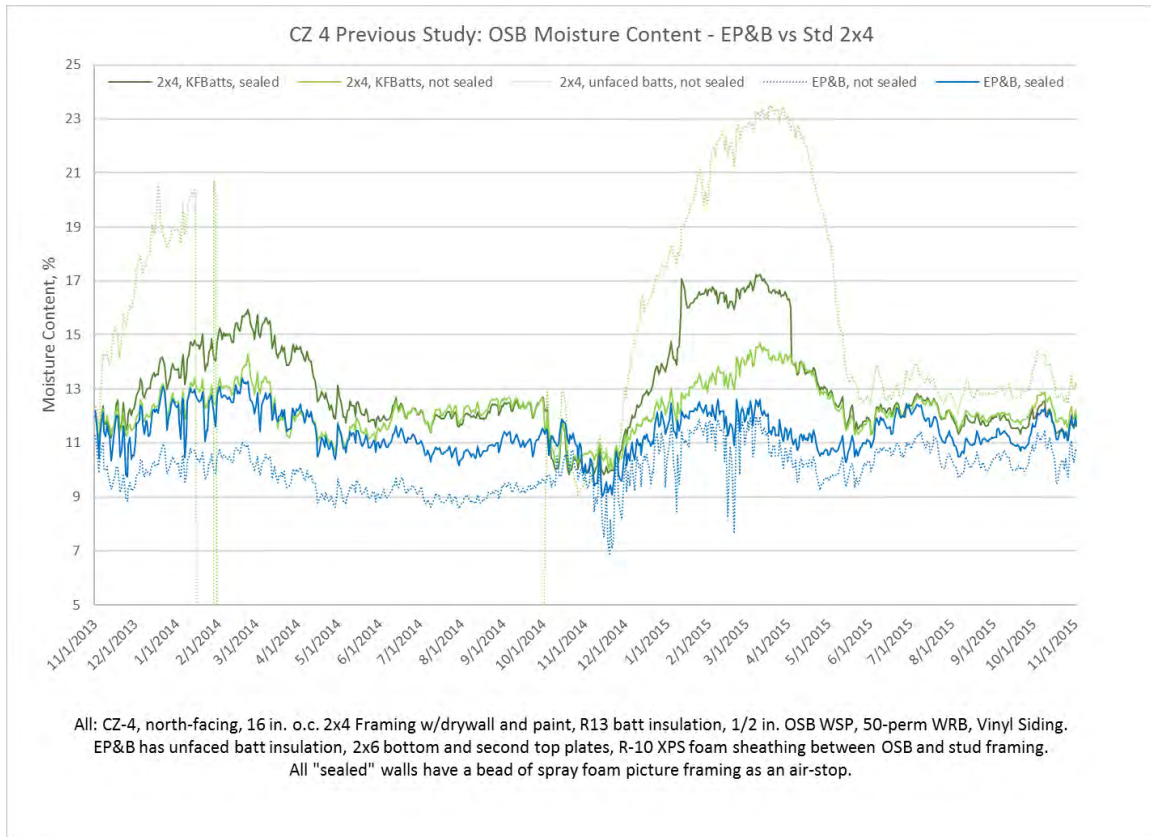
Figure 5. In a Previous Study, the EP&B Walls in CZ 4 Maintained Moisture Levels Below 14% (blue)

Increased air sealing improves thermal performance but potentially reduces drying capability. The EP&B wall with air-sealing in Figure 5 was more resilient to this effect than the kraft-faced batt wall with air-sealing. This is likely due to the location of the FPIS layer which provides a centrally-located vapor plane, allowing the OSB to dry directly to the outside, and protecting it from interior vapor drive.

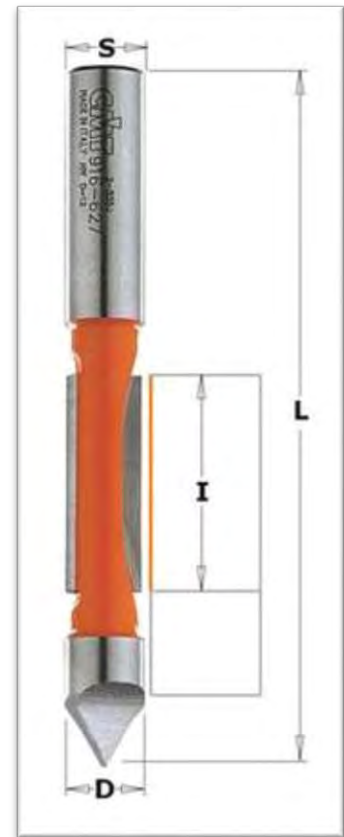
Figure 10. “Pilot Panel Bit” for Cutting OSB and Foam Together

Typically, a router bit is used when only OSB must be cut for window and door openings. These bits are too short to include the foam layer and so initially the crew cut the two layers independently. The production team was eventually able to locate a router bit that was long enough to span the combined depth of the 2-in. foam and 7/16-in. OSB. This allowed the crew to cut window and door openings at the typical location in the production line, after the foam had been installed over the studs and the OSB had been placed and fastened. Ideally, the bit would include a self-starting tip that can plunge through the OSB and foam into a known opening area, and with enough length to guide the cut along the framing of the opening the full depth of both materials – roughly 2-3/4 in. to 3 in. (Figure 10.) The tool they found had the necessary length but not the self-driving tip – a pilot hole had to be drilled separately. However, once this extra step was accounted for, the router made the cut for each window or door opening in about the same time it would have taken for the OSB without the foam. With that process solved, end-cutting of the foam panels was the step that the manager felt was least optimized. Note that FPIS was originally developed to be installed on the exterior of building walls. The typical 8-ft length spans two plates and the studs, which requires shortening to fit between top and bottom plates for the EP&B configuration.

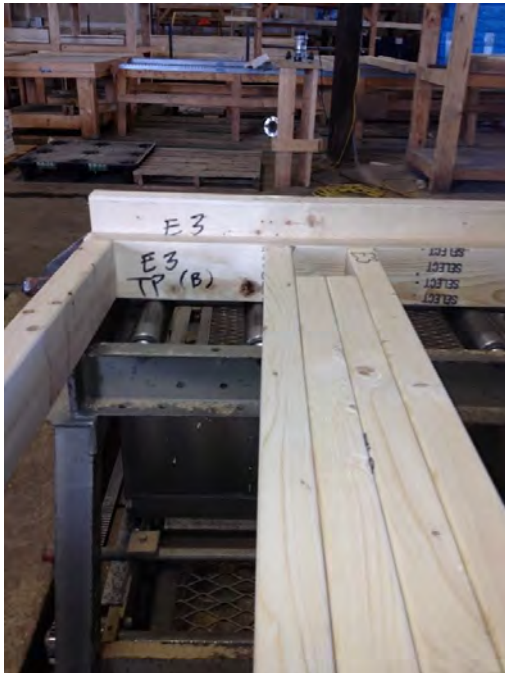
Figure 11. Studs Nailed to Bottom Plate, leaving 2-in. Gap for Foam

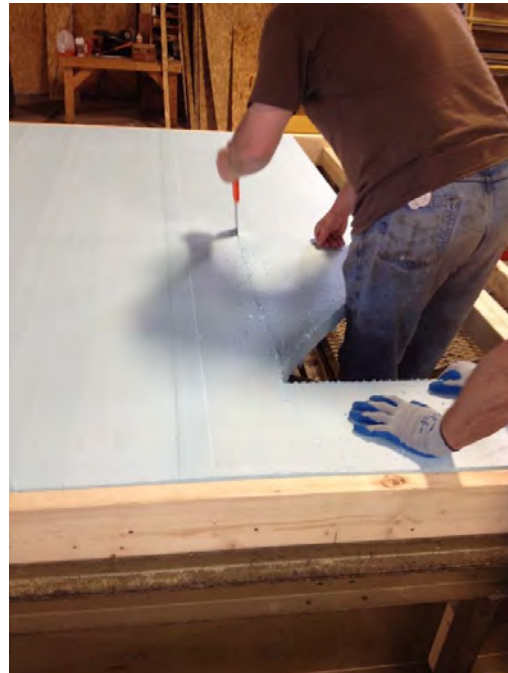
Figure 12. Using Hand Saw to Cut Foam for Windows

For window and door openings on the line, the crew initially used a hand saw for XPS and a circular saw for OSB. Since the XPS was placed on top of the framing early in the process, there was no circular saw available to use on the foam at that point in the line. The OSB was installed over the top of the foam later along the line.

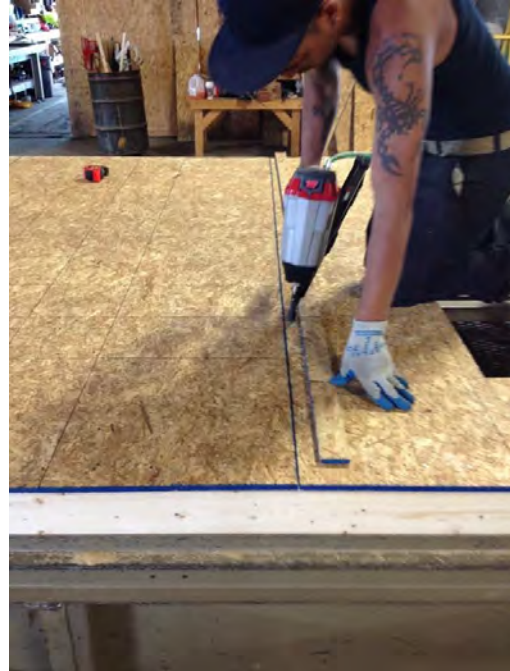
Figure 14. Using a Guide to Attach OSB to 2x4 Studs with 4-in Nails

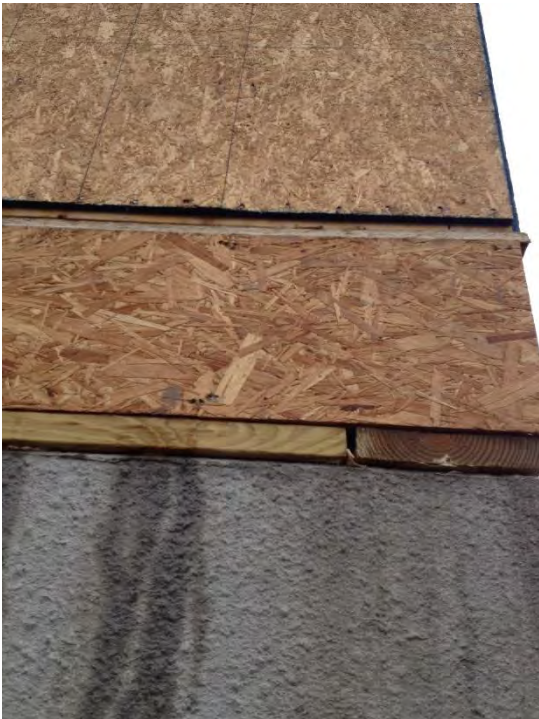
Figure 23. OSB Filler over Rim (gap was considered too small for FPIS filler)

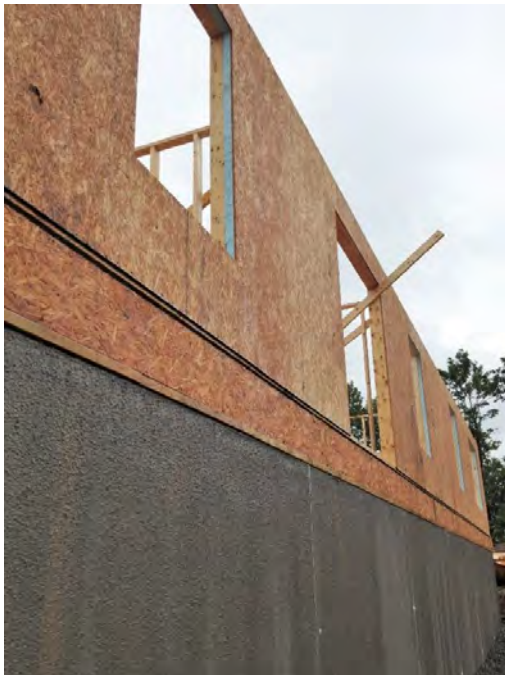
Figure 25. Test Project's Window Openings have 2x4 Framing, Door Openings Have 2x6 Framing

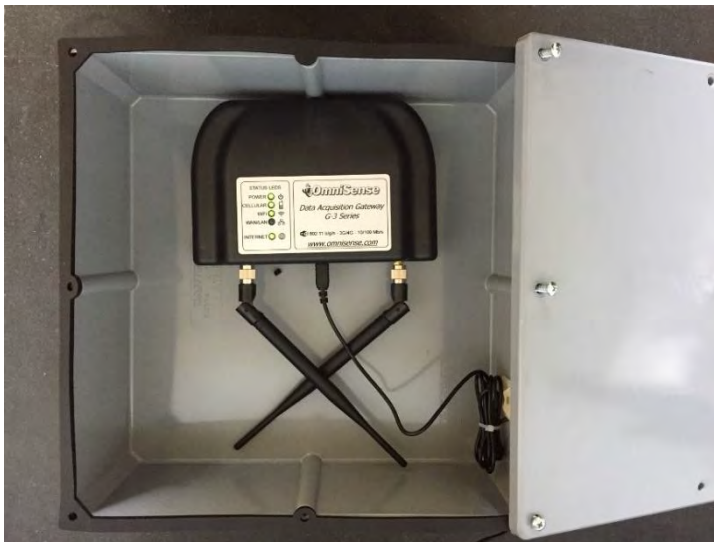
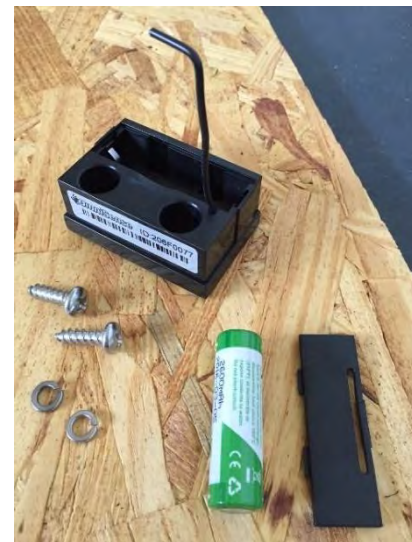
Figure 31. Omnisense Gateway Data Acquisition Unit and Omnisense T/RH%/MC% Sensor

Monitoring of the walls is accomplished using commercially available sensors and data-loggers from Omnisense. The sensor integrates a wireless transceiver, temperature sensor, humidity sensor, and pin type (resistance) moisture meter and has a battery life which can last up to 15 years. The sensors are permanently embedded into the EP&B wall structures for long term building envelope performance monitoring. A wireless data logger with built-in cellular capabilities (Gateway, also from Omnisense, installed in the garage) collects and transmits that data to the manufacturer’s web site for storage and periodic downloading for analysis. Table 6 lists the accuracy and features of the monitoring equipment used in the project. Figure 31 a and b show the sensor and data logging devices.

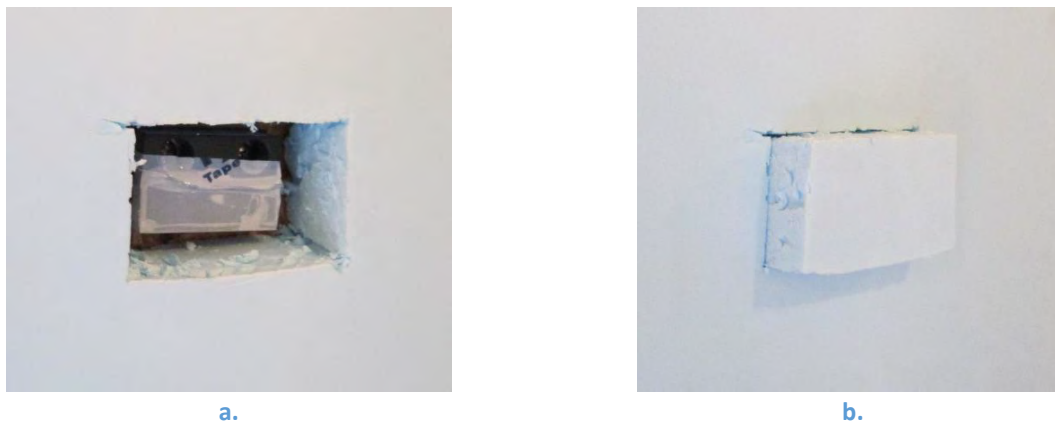
Figure 33. Typical Installation of OSB Sensors in the EP&B Wall

In an EP&B wall, the interior plane of the OSB is coincident and flush with the exterior plane of the rigid foam sheathing. To accommodate the sensor body to measure the moisture content of the OSB, small cubes of the foam layer were removed from the cavity side of the wall (Figure 33a). Once the sensor was placed and the screws inserted into the OSB (Figure 31b), the sensor cabinet was sealed with WRB tape (to avoid moisture damage to the electronic components) and the foam piece was re-inserted into the cavity (Figure 33b). This foam piece stands proud of the foam sheathing layer by approximately 1 in., due to the thickness of the sensor cabinet. The patch in the FPIS is not fully air-tight. The next intended step was to provide an air seal between the foam piece and the foam sheathing panel using either caulk or spray foam. This step was not implemented by the field representative.

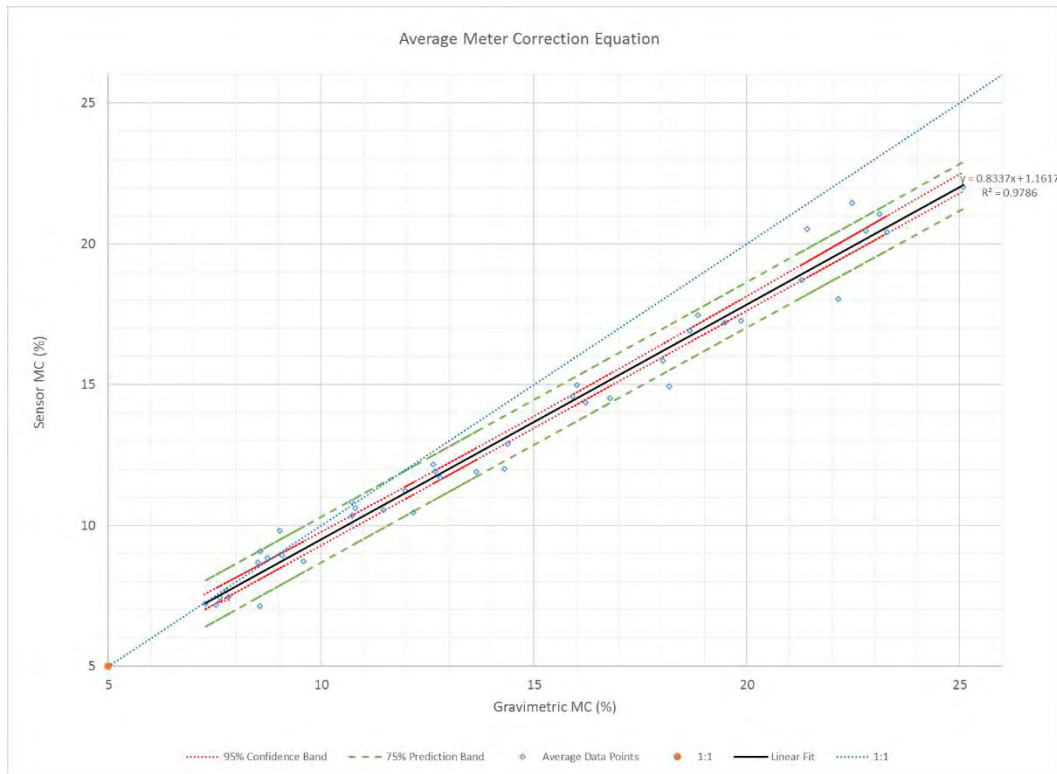
Figure 34. Curve Fit Chart for Moisture Content Sensor Calibration for All OSB Data Points

The data and fitted curve for the Home Innovation OSB moisture sensor calibration study are shown in Figure 34:

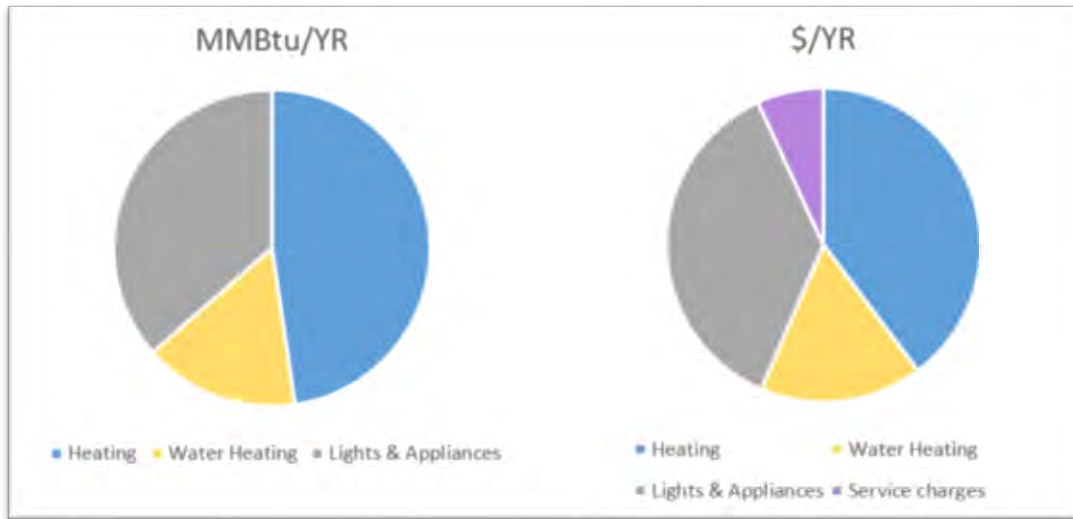
Figure 39. Proportional Annual Heat Energy Consumption and Annual Energy Cost by All End Uses

Note that in cold climates the seasonal cooling load is relatively small, less than 5%. In fact, where seasonal cooling demands are small, internal loads (people, lights, appliances) constitute a disproportionate amount of the cooling load in summer. Very tight, heavily-insulated buildings do not reject heat effectively. In this case, because the cooling load is so small, no cooling equipment was installed, and the value listed for “annual energy costs” for the category of cooling (-3\$ per year, in this case) are not a useful metric.

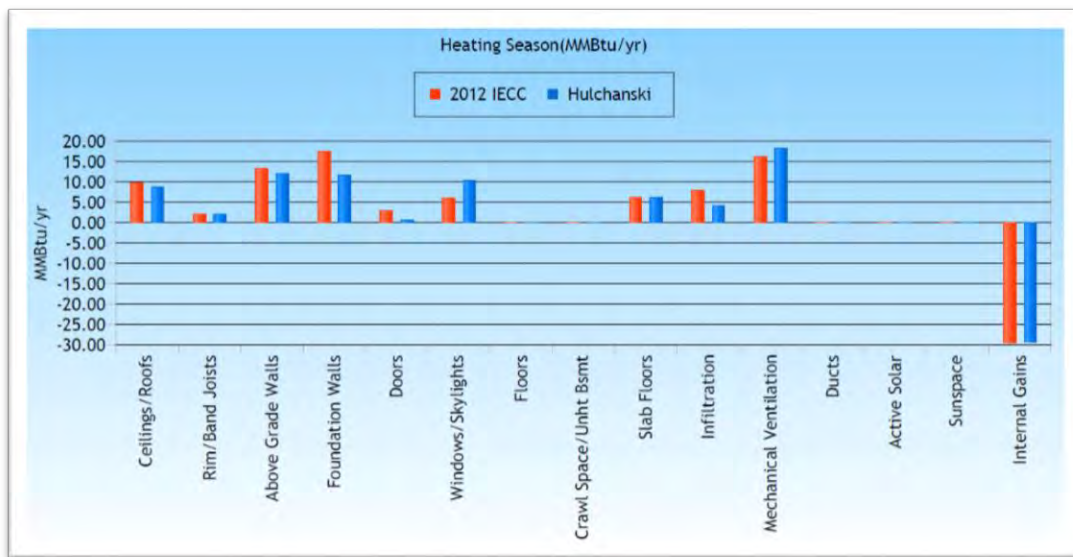
Figure 40. Comparison of Building Component Heating Energy Consumption: Ref (red) vs Test (blue)

The standard EP&B configuration used in the NYSERDA test house (2x4/2x6 with R-15+10 insulation) is a lower total installed cost (\$0.55/sf wall for either field-framed or panelized construction) compared to a CZ 6 code-minimum wall with exterior c.i. EP&B contributed, with improved windows and basement walls, to a projected whole-house energy cost saving of 6.6% - \$214 annually. The advanced-framed EP&B wall configuration (2x6/2x7.5* with R-21+10 insulation) would cost essentially the same as a CZ 6 code-minimum wall, and would increase the annual predicted whole-house savings to 8.5% in energy costs, approximately \$271 per year compared to the code-minimum configuration.

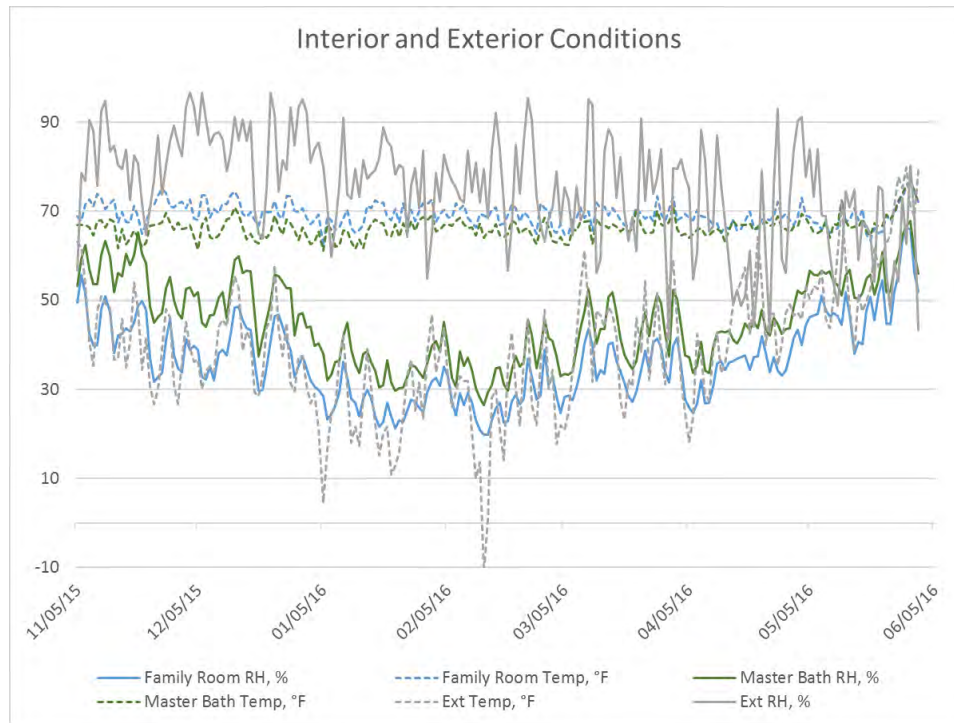
Figure 41. Test House Ambient Conditions

Data acquisition began November 5, 2015, soon after occupancy. Interior and Exterior ambient temperatures and relative humidity are within typical, expected ranges (Figure 41) for winter and spring.

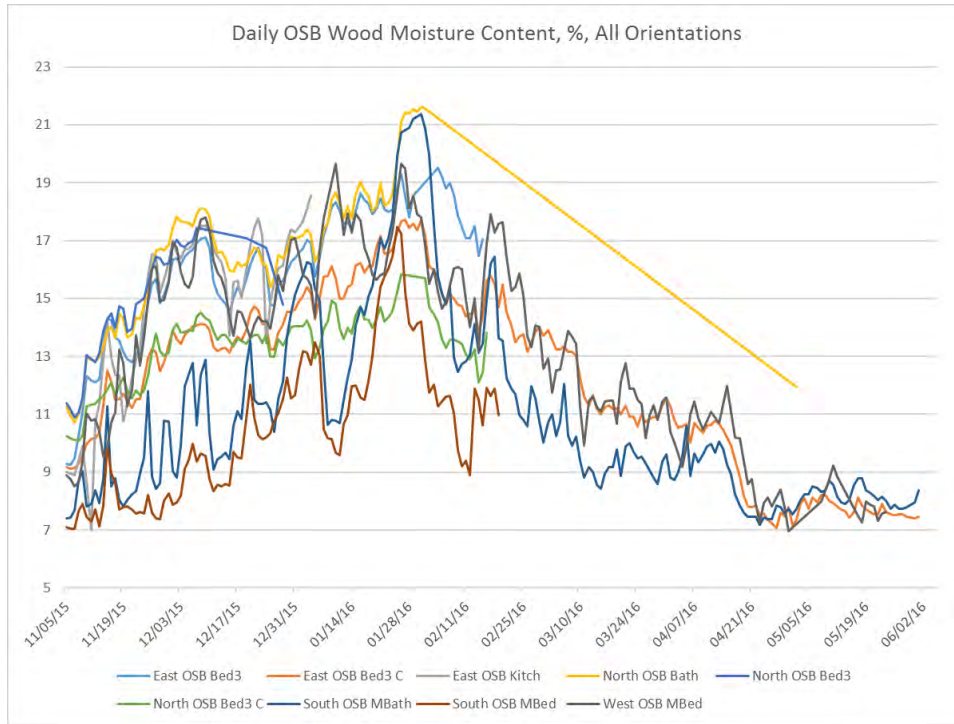
Figure 43. Daily Average OSB Wood Moisture Content, %, All Orientations

The three active sensors which continue to report MC into the spring indicate that the OSB began to dry relatively quickly: the south master bathroom, an east bedroom and a west bedroom are all reading at or below 11% MC since the second week of April (Figure 43.)

All EP&B OSB sensors in the NYSERDA test house reported daily average MC above 15% for at least one week early in the study period. Most OSB sensors recorded peak MC in the first week of February, followed by a steep drying period with occasional fluctuations (Figure 43.) These unusually high readings indicate a deviation from previous studies.

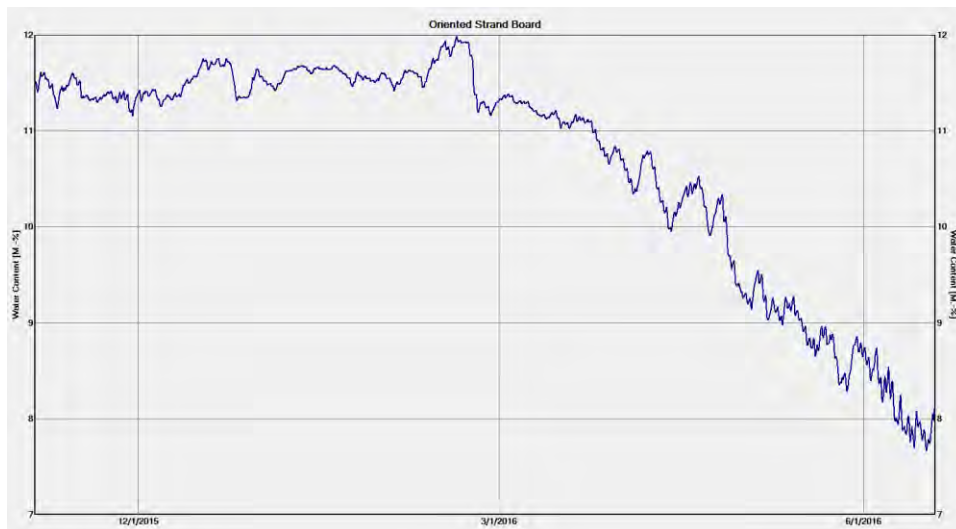
Figure 44. WUFI Simulation of the Moisture Performance of the EP&B North Wall OSB

similar conditions (Table 12) yields a similarly-shaped curve for OSB MC, except that the spikes from December through February are much shallower than the MC recorded in the NYSERDA test house (Figure 45). For the WUFI model, the MC never rises above 12%, inconsistent with the data from the sensors monitoring the OSB at the NYSERDA house. (Figure 45) The WUFI simulation results illustrated in Figure 44 for conditions matching the NYSERDA test walls shows good moisture performance. The OSB sensors in the NYSERDA test house recorded generally acceptable (though higher) moisture content by percent up until the middle of January.

Table 12 compares the configuration of the NYSERDA test house EP&B walls to the WUFI simulation inputs that generated the graph in Figure 44.

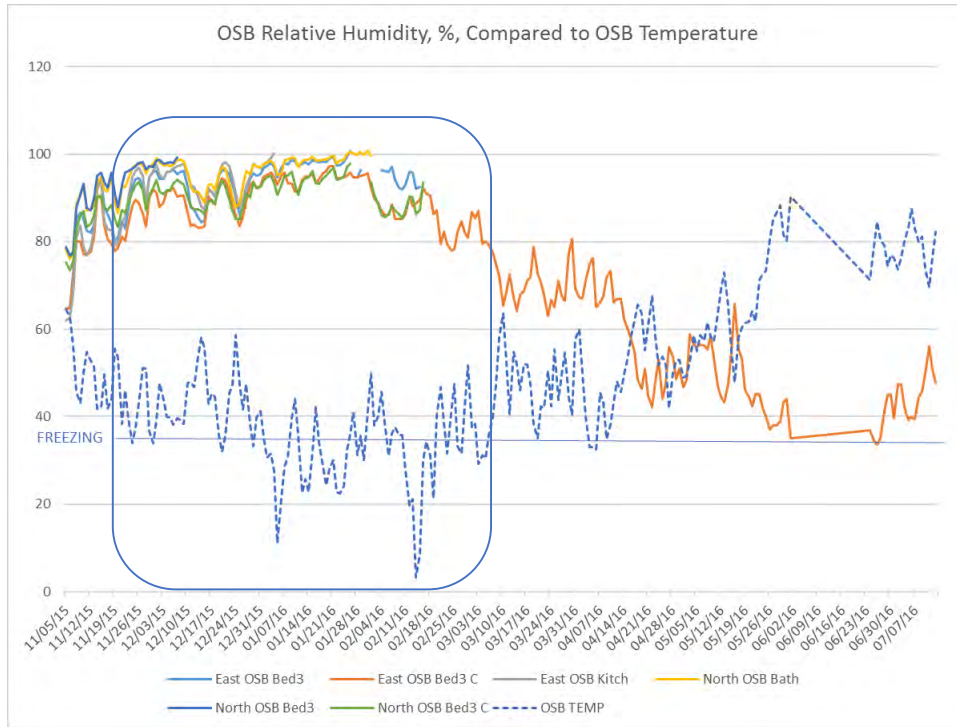
Figure 46. Sensors Malfunctioned When Ice Was Likely Present

The sensor functionality ranges are advertised as -40°F to 185°F and 0% to 100% RH. Nevertheless, the bulk of the sensors which became inactive seem to have done so during the period of highest humidity (likely presence of liquid water) and lowest temperature (below freezing) which indicates the possible formation of ice. (Figure 46)

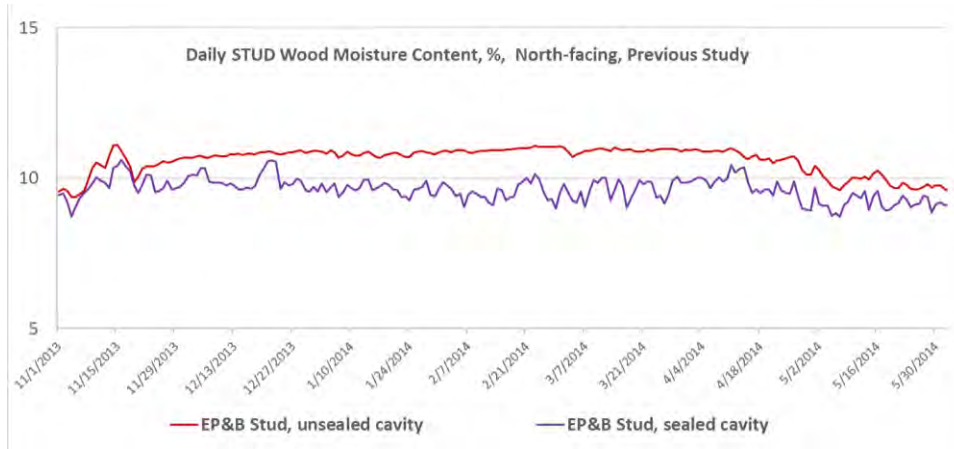
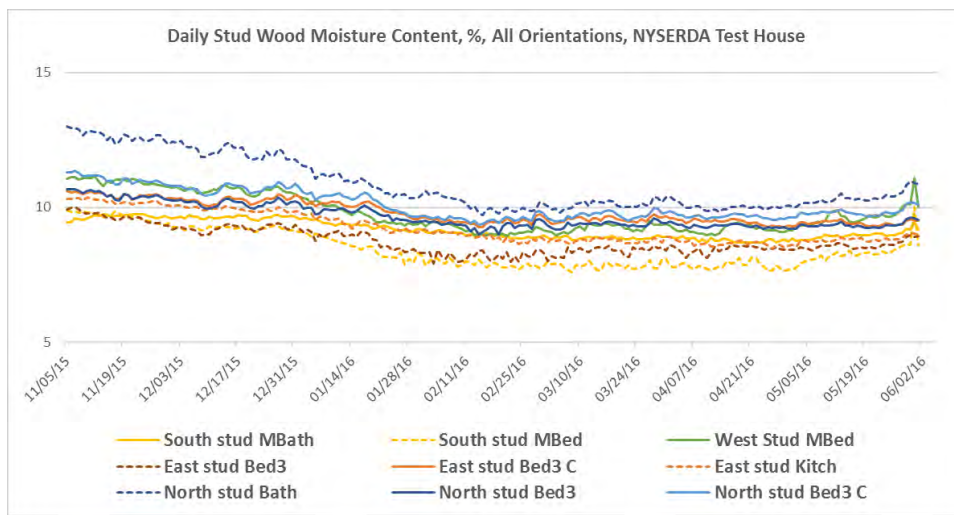
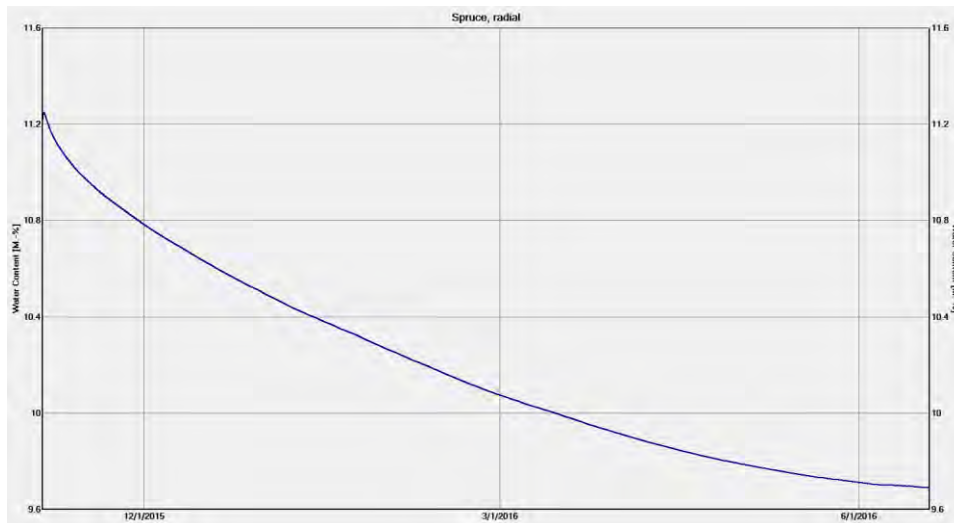
Figure 47. EP&B Wall Stud MC% for Previous Study (top), NYSEDA Test House (middle) and WUFI Moisture Simulation (bottom). All Show Good Correlation

The NYSERDA data for the stud moisture performance appears to follow the trends of previous test walls and the WUFI moisture simulation. All are well within safe MC% ranges. The installation of the stud sensors did not deviate from previous tests. (Figure 47)
