Characterization of  
Moisture Performance  
of Energy-Efficient  
Light-Frame Wood  
Wall Systems  
– Phase II

**Forest Products Laboratory  
Joint Venture Agreement  
13-JV-1111136-036**

**December 2015**

Report No. 3352.000.12292015

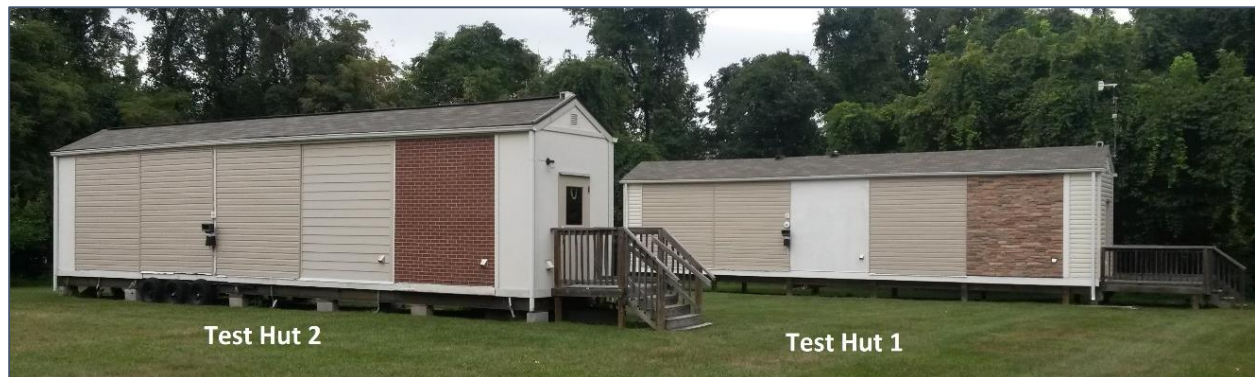
**Figure 1. South Facing Walls of Test Structures 1 (right) and 2 (left)**

The test structures were constructed on the grounds of Home Innovation Research Labs in Upper Marlboro, Md., approximately 20 miles east of Washington, D.C. The structures are a post-and-beam design, with a nominal footprint of 8'x48' (Figure 1). The hut design allowed for five pairs of 8'x9' wall test panels to be installed as exterior wall sections, with one panel of each pair having southern exposure and the other panel of the pair having northern exposure. The 8'x9' test panels were typically framed with 2x4 studs, sheathed with wood structural panels. The panels included various combinations of cladding, exterior insulation, and drainage strategies, which are described in the following section of this report. A window is located on the west end of the hut and an entrance door is located on the east end. Eight-foot on-center post spacing allows for insertion and removal of test specimens for subsequent testing. The huts' interiors were finished with ½-inch drywall and wall cavities were insulated with fiberglass batts. The perimeter of each wall panel was sealed to minimize extraneous air infiltration.

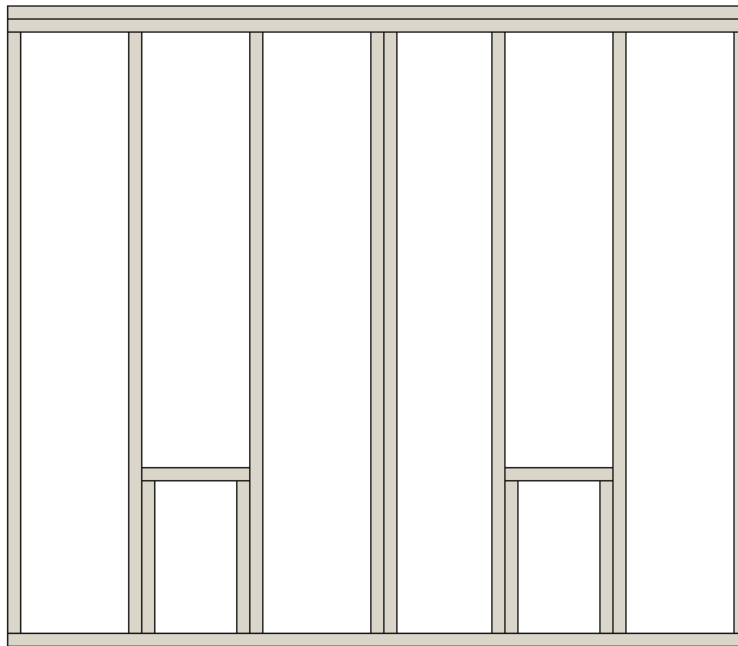
**Figure 2. Typical Construction of Two Adjacent Test Wall Specimens**

The nominal dimensions of the specimens are 9 feet tall by 4 feet wide. Walls were constructed with 2x4, 2x6, or a combination of both with studs spaced 16" o.c. The lumber was SPF grade 2. All specimens used fiberglass batt cavity insulation and several specimens also included R5 or R10 insulation exterior to the wall cavity and installed over or behind the OSB sheathing. A typical framing layout for two adjacent specimens is shown in Figure 2. The 4'x9' segments were framed in an identical manner containing three stud bays and the lower framing of a false window in the center bay. To simplify the construction, adjacent test specimens of identical thickness were constructed as a single 8'x9' wall with continuous top and bottom plates and a double center stud.

The perimeter edges between the specimens in the test huts for each of the 10 pairs of walls installed were sealed with spray foam and caulk. The vertical joints between the two abutting studs in adjacent test specimens were also sealed. All vertical seams between the OSB sheathing and the wall framing were sealed so that air movement could occur only at plates (unless sealed for a specific configuration in accordance with the test matrix).

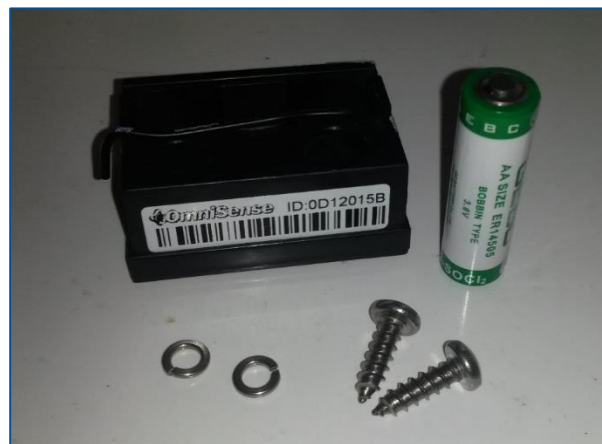
**Figure 6. Wireless Temperature, Humidity and Wood Moisture Sensor**

Each field wall sensor, as shown in Figure 6, includes two stainless steel screws that secure the device to either wood framing or sheathing and penetrate  $\frac{3}{8}$ -inch into the substrate to obtain a conductance reading related to substrate MC. The sensors are capable of measuring MC between 7 and 40 percent, temperature between -40°F and 185°F, and relative humidity from 0 to 100 percent at programmable time intervals. Sensors were gravimetrically calibrated to the SPF studs and OSB sheathing.

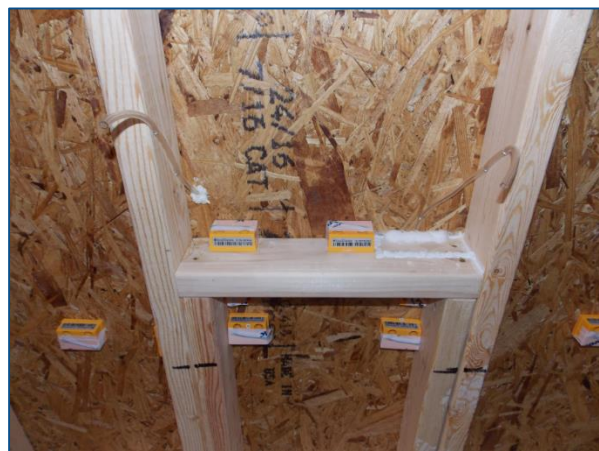
**Figure 10. Water Injection Tubes in Test Walls**

For the injections on the exterior of the OSB, a pocket made of Tyvek was sealed to the exterior face of the OSB with caulk and was filled with cotton. The cotton was used to help hold the water in the injection location and expose the OSB to moisture for a greater period of time facilitating its absorption. The top of the Tyvek pocket remained unsealed so the water was able to evaporate if not absorbed by the wall. The other injection location was on the interior face of the OSB at the intersection of the window sill plate and OSB. A notch was cut in the OSB at the injection location approximately half the thickness of the OSB. It is believed that the OSB was able to absorb more water if the surface finish was disturbed. Cotton was inserted into the slit to facilitate water absorption. A bead of caulk was installed on top of the window sill plate around the slit to ensure the water was not able to flow in any direction on the window sill plate away from the slit. A diagram of these designs can be seen in Figure 9 while Figure 10 shows the tubes.
