# RETROFIT Improvements

Making Homes Safer & More Resilient in Disaster-Prone Areas

## Flash and Seal Roof Penetrations

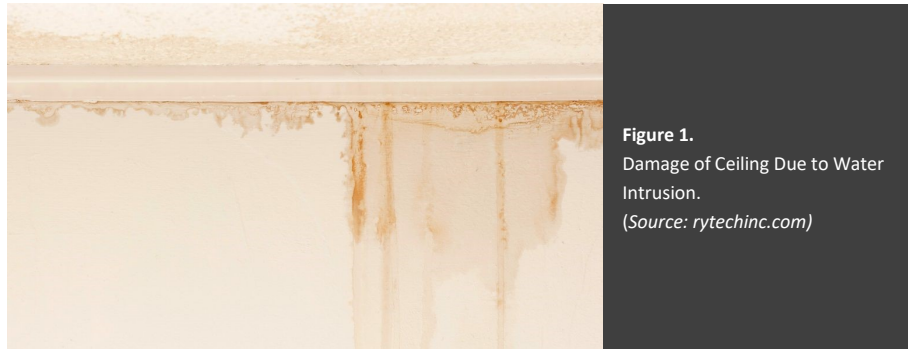
**Figure 1.**  
Damage of Ceiling Due to Water Intrusion.  
(Source: rytechinc.com)

Deteriorated or incorrectly installed flashing at roof penetrations such as plumbing vents, chimneys, and skylights can allow rainwater to enter through the roofing that can damage the roof structure and interior finishes. Visible water stains are usually the first indication water has leaked through the roof. Water will travel through the path of least resistance and may leave a stain far from where it first penetrated. Homeowners can inspect for water intrusion at roof penetrations by carefully looking for signs of leakage in the attic, water stains on the roof sheathing or even walls below, wet insulation, and deterioration of roof coverings and roof deck. The flow of water on the roof should be observed from inside if possible and outside while it's raining and afterwards.

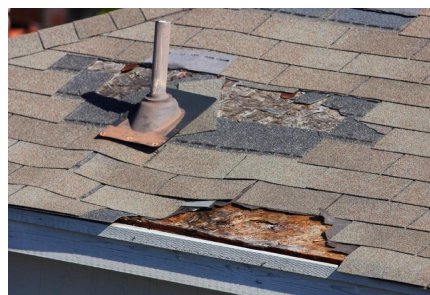
**Figure 2.** Damaged Shingles and Rotted Roof Deck. (Source: mullinsgc.com)

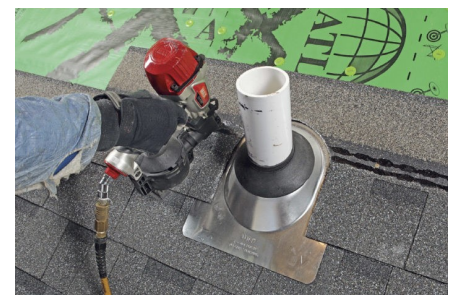
**Figure 3.** Integrating Roof Penetration Flashing with Shingle. (Source: finehomebuilding.com)

Water intrusion at roof penetrations can be prevented by proper flashing. Flashing is required at plumbing vents, masonry and metal chimneys, exhaust vent caps, dormers, and skylights. Flashing must be integrated with the roof covering (e.g., shingles) and roof underlayment and installed shingle-fashion such that the top layer of the roofing or flashing laps over the bottom layer to prevent water from draining behind the bottom layer. Roofs should be inspected periodically, and flashing repaired or replaced as needed.
