Characterization of the Moisture Performance of Energy-Efficient and Conventional Light-Frame Wood Wall Systems

Home Innovation Research Labs, Inc.
400 Prince George's Boulevard
Upper Marlboro, MD 20774

Report # 3329_11182013

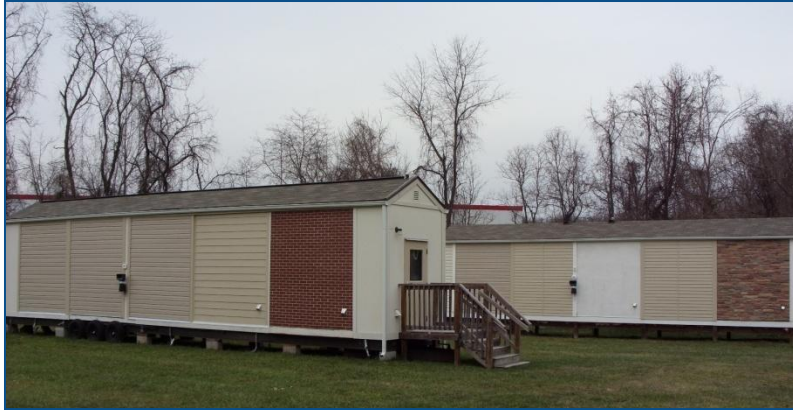
Figure 3. Test Structures Showing South-Facing Test Walls

Back building right-to-left: 2x4 w. manufactured stone cladding (#1), [privately funded system], 2x4 w. stucco (#2), 2x4 w. cedar siding (#3), 2x4 w. vinyl siding (#4)

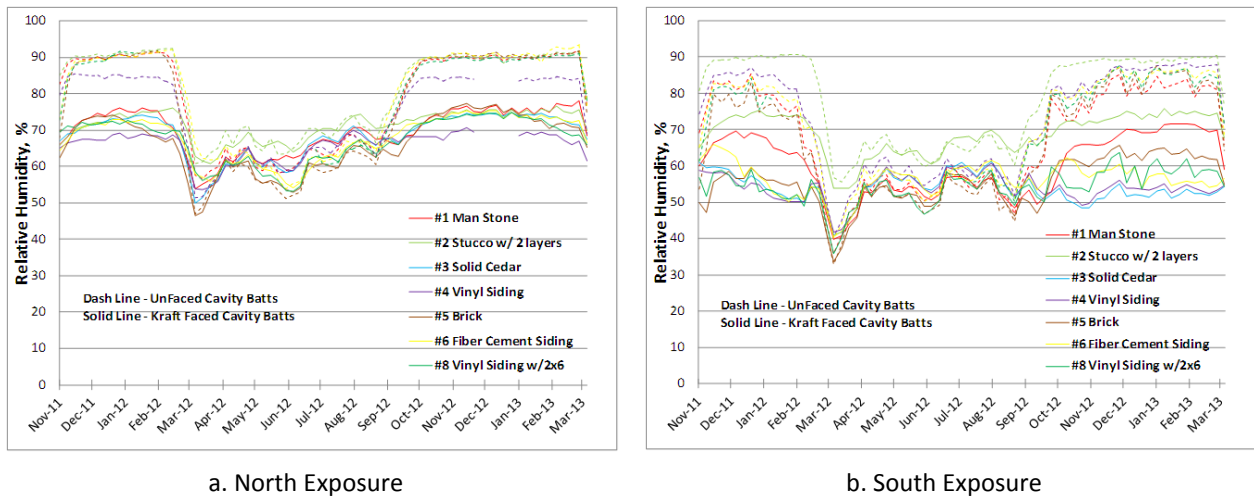
Figure 8. Cavity Relative Humidity: Kraft-Faced Batt vs. Unfaced Batts (North Exposure)

To show the underlying drivers for the OSB moisture content, Figure 8 compares cavity relative humidity for the wall sections with and without Class II vapor retarder (i.e., batts with and without Kraft-facing) for the North and South exposure. As consistent with the moisture content trends, walls without Kraft facing exhibit significantly higher cavity relative humidity. (It should be noted that because the sensors included stand-off legs, the temperature and relative humidity measurements were taken approximately 1-1/4 inch away from the interior surface of the OSB sheathing. The fiberglass batt insulation was installed over the sensor such that there was an air pocket between the sensor and the OSB sheathing.)

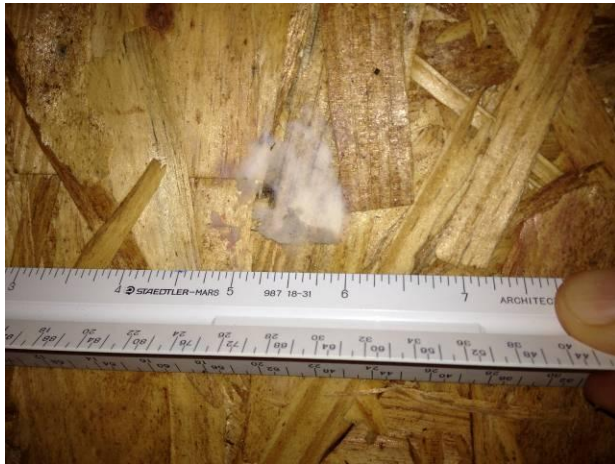
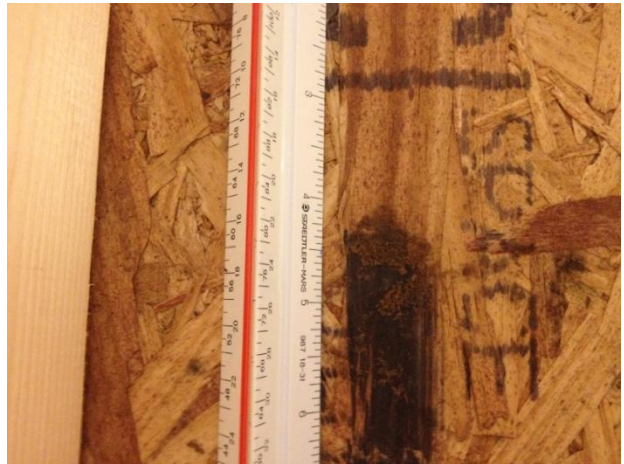
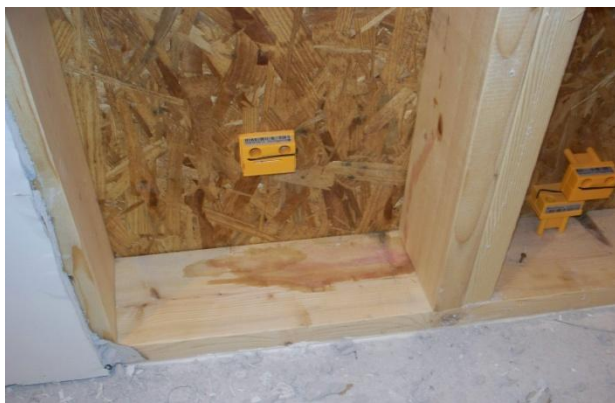
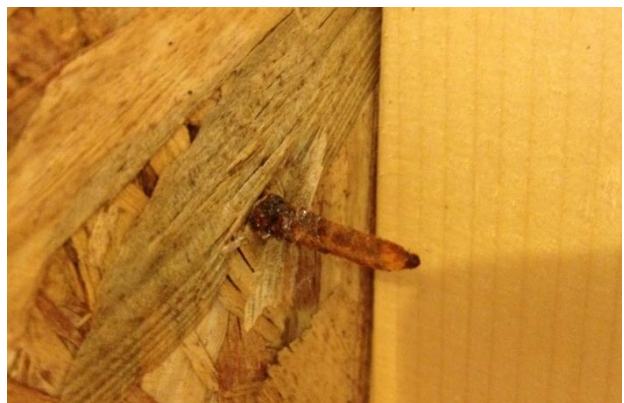
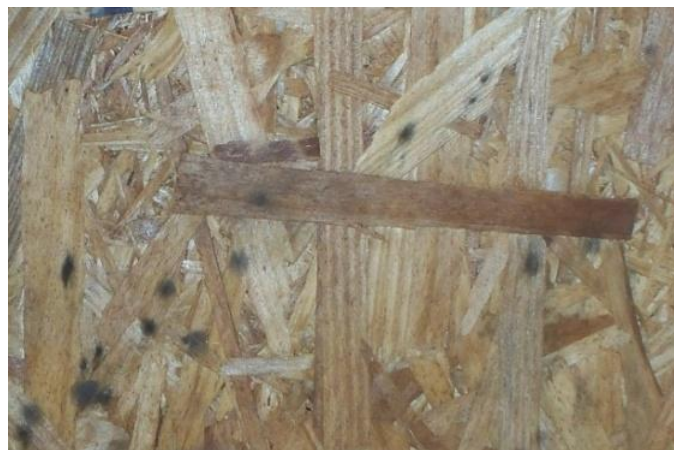
Figure 9. Moisture Damage: Mold, Corrosion, Staining

Failure of some of the moisture sensors during the 2011-2012 winter in Configuration #8b prompted inspection of the interior cavity of that wall section. The drywall and insulation were removed from the #8b wall in the summer of 2012. Inspection of the OSB and the framing members revealed water stains, mold, and rusted nails (Figure 9). The observed damage suggest water condensation, high levels of relative humidity for an extended period of time, and high levels of moisture content. Because the sensors do not detect moisture levels above the fiber saturation point, the actual moisture content in

this wall configuration is unknown. The water damage and the fact that the sensors' batteries shorted out suggest presence of liquid water and high moisture content levels. Sensors did not fail in any other walls.

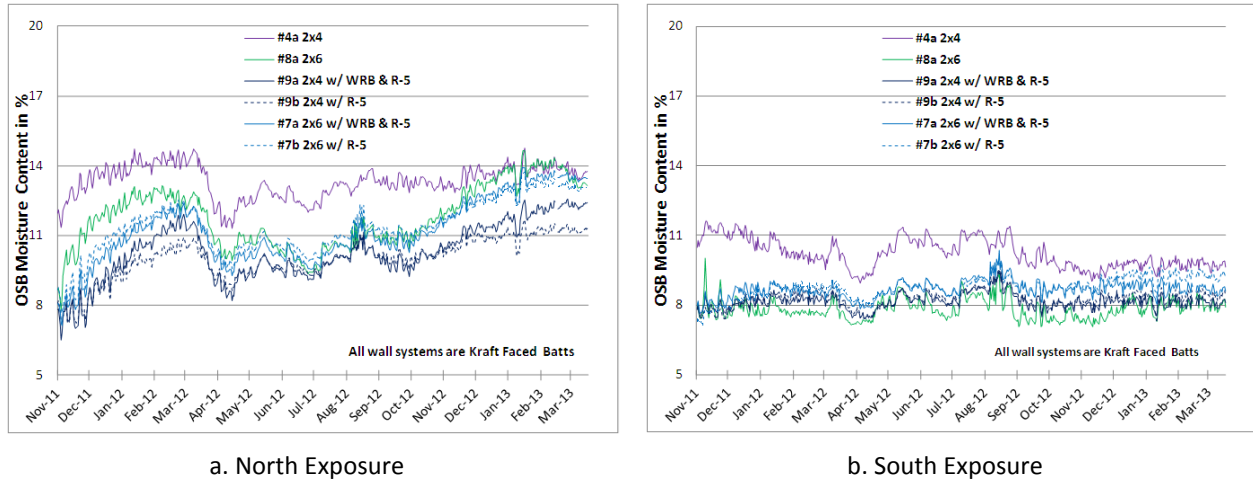
Figure 10. OSB MC for Walls with and without Exterior Rigid Foam (North Exposure)

Figure 10 shows the OSB moisture content for walls with exterior foam and without exterior foam (baseline). All walls in this comparison used Kraft facing as interior vapor retarder. To enable direct comparison, the difference between Configuration pairs #4a & #9 (2x4 studs) and #8a & #7 (2x6 studs) is the use of one-inch exterior rigid XPS foam. For the North exposure, the results indicate that the 2x4 wall with foam (#9) consistently has the lowest moisture content. However, all six walls exhibit OSB moisture content below 15% percent and the difference between the walls is typically within a 3 percent range. While Configuration #4 starts at a higher moisture content level and consistently remains at 2-3 percent higher than the other walls for nearly a year, during the second heating season the gap between the lines becomes smaller and the performance of 2x4 and 2x6 walls without foam becomes nearly identical. All six wall configurations showed a drying trend in the spring months. Interestingly, all walls showed a very similar drying rate as evidenced by the slopes of the moisture content lines. This behavior can be explained by sharp drop of relative humidity in the cavity as a result of increasing cavity temperatures in the spring. It does not mean that all that water left the wall assembly at the same rapid

For the South exposure, with exception of Configuration 4a (2x4 wall) that had a higher initial moisture content, all walls oscillate within a 1-2 percent range of each other and below 10 percent. Configuration 4a oscillates 3 percent higher on average compared to other walls during the first 12 months of the study. During the second heating season, Configuration 4a oscillated closer to the range observed for other walls.

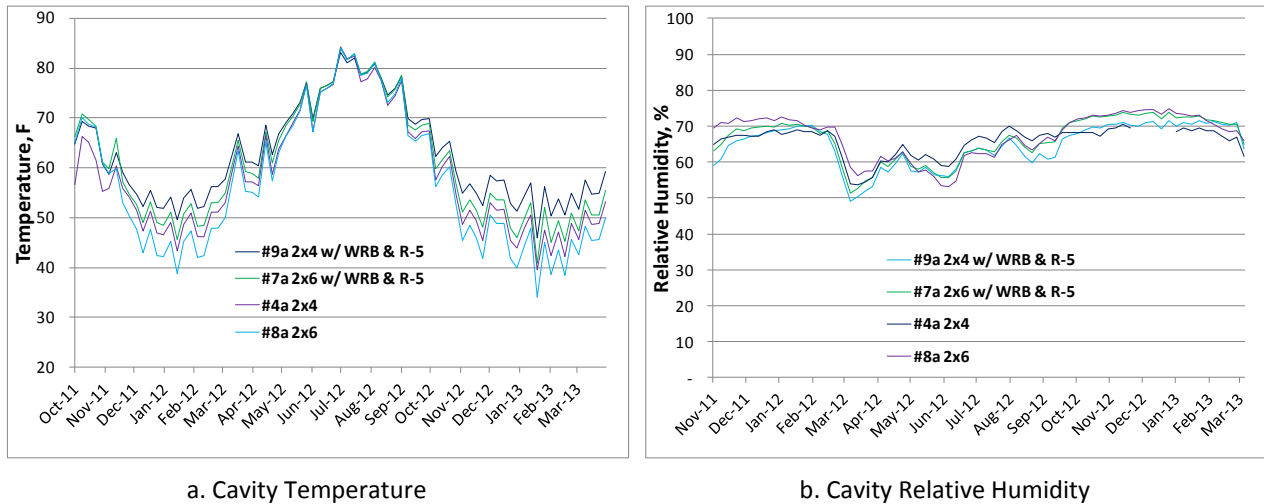
Figure 11. Cavity Temperature and Relative Humidity in Walls with and without Exterior Foam (North Exposure)

Figure 11 shows the impact of exterior foam on cavity temperature and cavity relative humidity for north exposure walls (weekly averages are shown to reduce noise due to daily fluctuations). There is a distinct separation of cavity temperature lines between all four walls in the winter months in a logical sequence from coldest to warmest:

The difference in cavity temperatures is the highest during the month of January for both heating seasons with the maximum difference of 10°F. In the observed temperature range (35-50°F) and average relative humidity range (less than 75%), the difference of 10°F can lead to a change of moisture content of 4 percent or less, consistent with the reported measurements. The difference in observed

levels of cavity relative humidity does not follow a consistent trend. These results can partially be explained by the large expected relative humidity gradient across the wall cavity and the large daily fluctuations of temperatures leading to fluctuations in relative humidity. Moisture content is a more stable moisture parameter for monitoring and drawing conclusions. The average relative humidity measurements serve a more informative function in terms of the overall range observed – showing an approximate 20 percent increase during the winter months relative to the summer months.

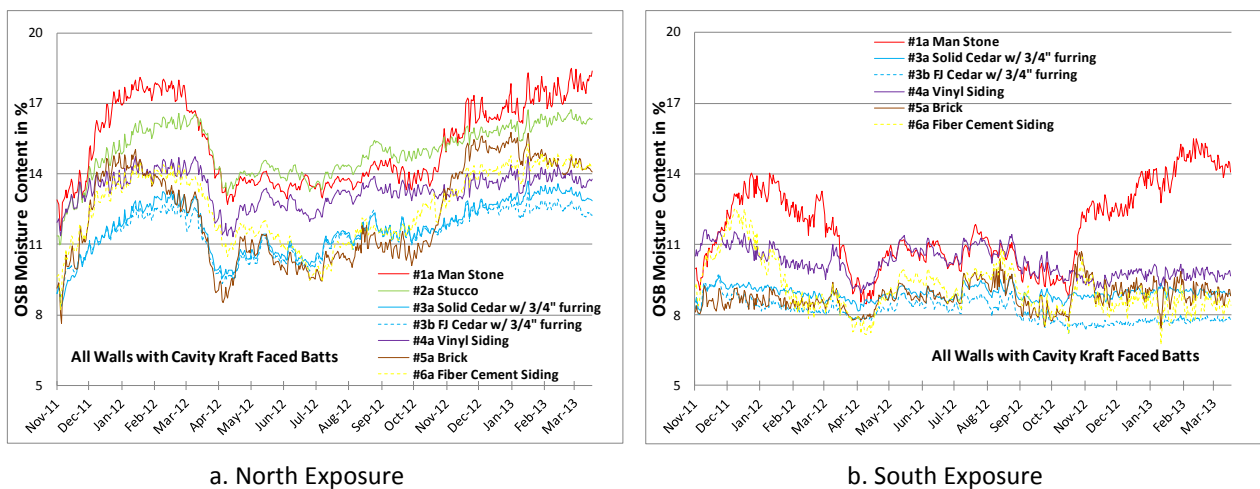
Figure 13. OSB Moisture Content – Comparison of Cedar Siding with Other Claddings

For the 2011-2013 seasons, cedar siding was added to expand the library of cladding systems monitored at the Home Innovation test huts since 2007. Figure 13 shows OSB moisture content for Configurations 3a and 3b (cedar siding over ¾-inch furring) along with five other walls for direct moisture performance comparison. All walls used 2x4 construction and fiberglass batt cavity insulation with Kraft facing. Only cladding/drainage system varied between the configurations: #1a (manufactured stone), #2a (stucco), #4a (vinyl siding), #5a (brick veneer), and #6a (fiber cement siding).

In the north exposure, the wall with cedar siding consistently had one of the lowest moisture contents trending in the 10-13 percent range and at the bottom of the overall spread between the different wall configurations throughout the 2011-2013 monitoring period. In the south exposure, the wall with cedar siding consistently trended in the 8-9 percent range over the same period clustering with other lap siding systems (vinyl and fiber cement) and brick veneer. There is no detectable difference in OSB moisture content between walls with solid and finger-jointed cedar siding.

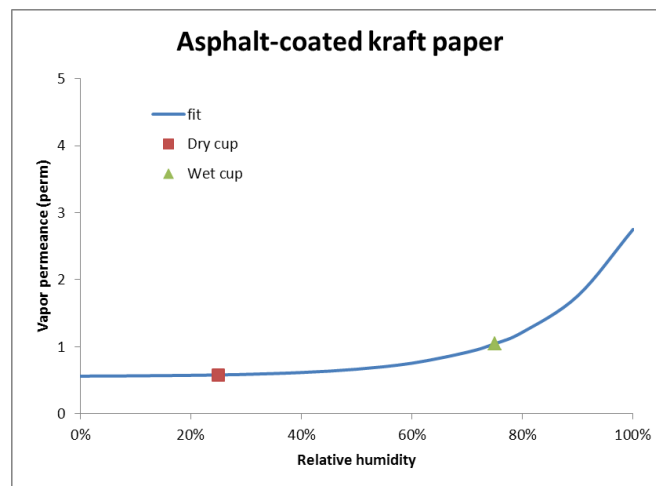
Figure A3.

Asphalt-Coated Kraft Paper. The vapor permeance curve was a user-defined function of RH based on measured dry cup and wet cup tests (see Figure A3). The trend of increasing permeance with increasing RH agrees with literature values (Glass 2013). The measured values are intermediate between those of Gatland (2005) and Burch et al. (1992).
