EVALUATION OF WOOD SOLE PLATE ANCHORAGE TO CONCRETE UNDER MONOTONIC AND CYCLIC LOADING

Prepared for
NAHB and FPL

Prepared by
NAHB Research Center
400 Prince Georges Boulevard
Upper Marlboro, MD 20774-8731

March 2010

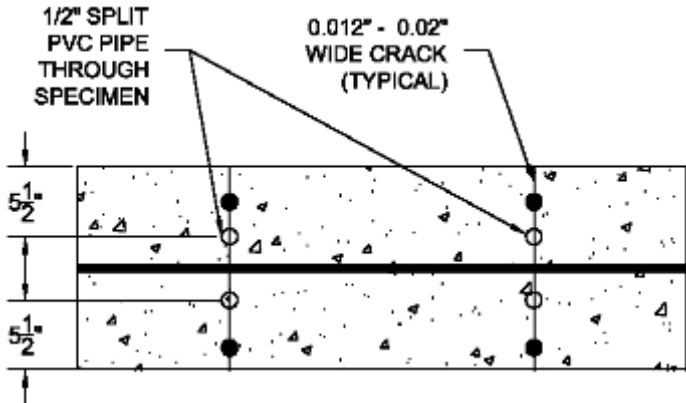
Figure 1 – Location of crack generation in test specimens

Where indicated by the test matrix (Table 1), the concrete at the anchor bolt was pre-cracked prior to testing. The crack was introduced by inserting metal splitting wedges into 1/2-inch-diameter PVC pipe inserts pre-installed into the concrete during specimen fabrication (see Figure 1). The PVC inserts were pre-split before installation in the direction of the crack and were lubricated to enable better crack control. The crack was introduced perpendicular to the direction of loading and was opened to an approximate width between 0.012 and 0.02 inches. The width of the crack was controlled by the depth of the splitting wedges driven into the PVC inserts.

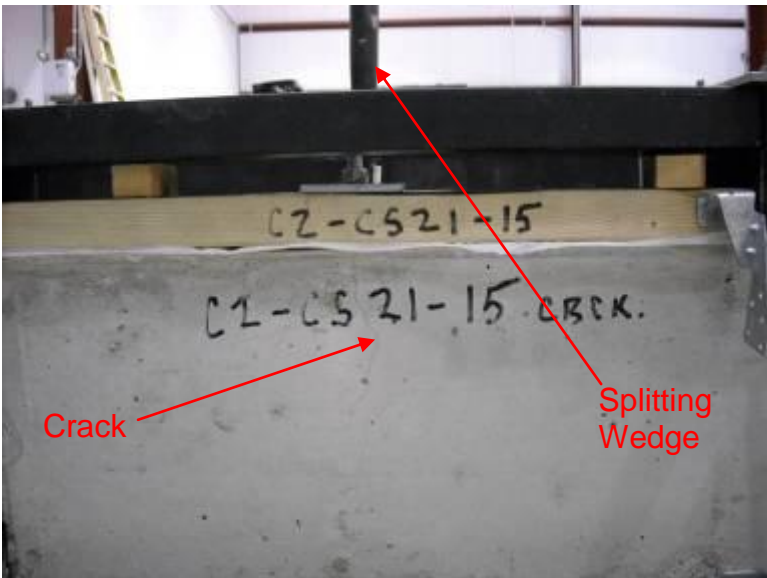
Figure 2 – Pre-cracked test specimen

This method is in accordance with the recommendations outlined by Eligehausen et al [7] to generate cracks for testing of anchors in cracked-concrete conditions. All specimens had one #4 horizontal steel reinforcing bar top and bottom with 3 inches of clear cover at the top, placed in the center of the specimens to control the crack width and keep the specimen as one unit. This amount of reinforcement is less than the amount recommended by Eligehausen, but was sufficient to control crack width for the purposes of this testing. The rebar was at least 5 inches away from the bolt and the cone failure of the concrete. A series of exploratory tests confirmed that the cone plane was sufficiently apart from the rebar. Figure 2 provides a photo of a pre-cracked specimen.

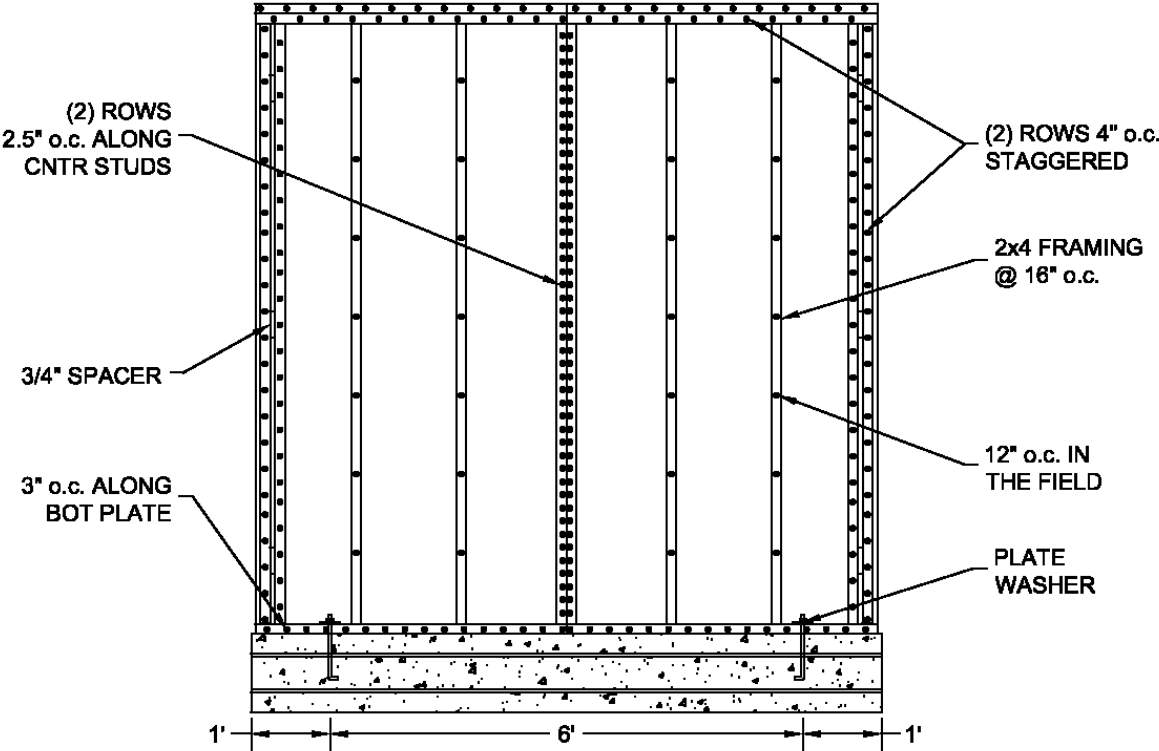
Figure 3 – Configuration 1 specimen construction

The shear wall specimens were constructed using Southern Pine #2 grade 2x4 studs spaced at 16-inches on center, sheathed on both sides with wood structural panels. Two anchor bolts were used per specimen. The nailing schedule was initially selected at 3.5 inches on center on the panel edges and 12 inches in the panel field with the design indicating adequate shear wall capacity to reach failure of the anchor bolts. The first two tests with this nailing schedule demonstrated that the capacity of the anchor bolts was narrowly balanced with the capacity of the shear wall such that the failure of concrete bolts could not be consistently achieved. Therefore, the nailing schedule was changed to a non-standard pattern shown in Figure 3 to provide a stronger and stiffer wall specimen to consistently force the failure at the anchor bolts.

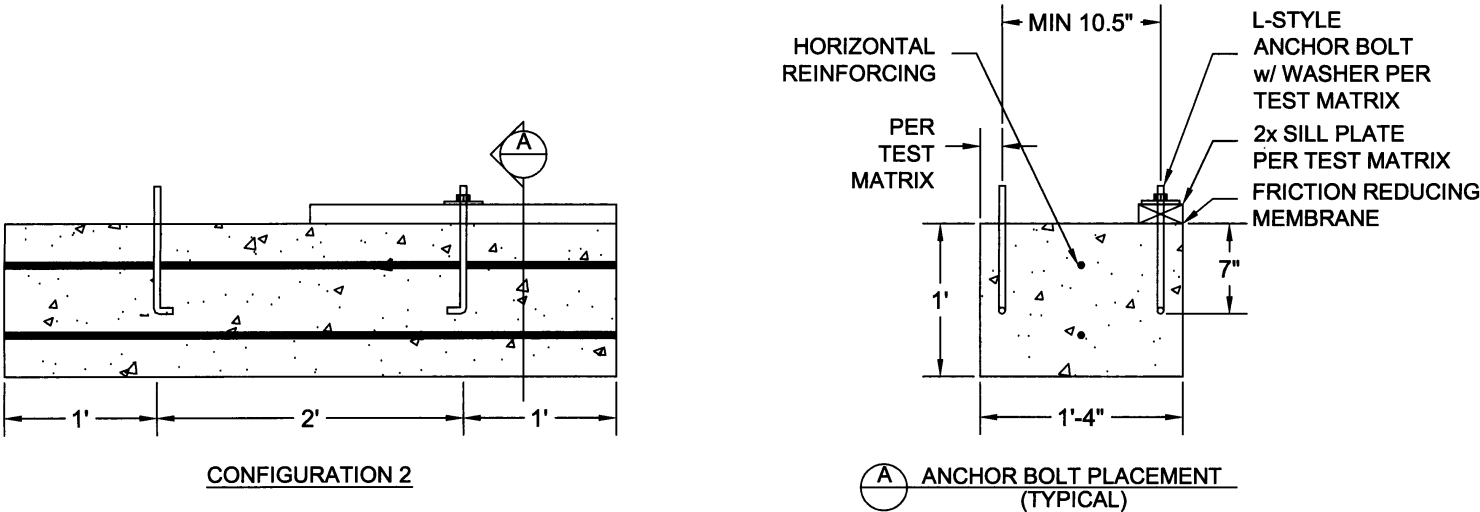
Figure 4 – Configuration 2 specimen construction

Figures 4 and 5 show the specimen construction for Configurations 2 and 3, respectively. All concrete blocks were cast with two rows of anchors along the two edges of the specimen to enable multiple tests on a single block. Bolt rows were spaced at least 10.5 inches apart to prevent interaction between the concrete at adjacent anchors. The 12-inch specimen depth allowed for the development of the full cone failure in the concrete. Configuration 2 specimens were designed to enable four individual anchor tests per concrete specimen. Configuration 3 specimens were designed to provide two group anchor tests per concrete specimen. The 12-inch distance to the end of the specimens in both configurations is typical of residential construction and in accordance with the requirements of Section R403.1.6 of the 2006 IRC.

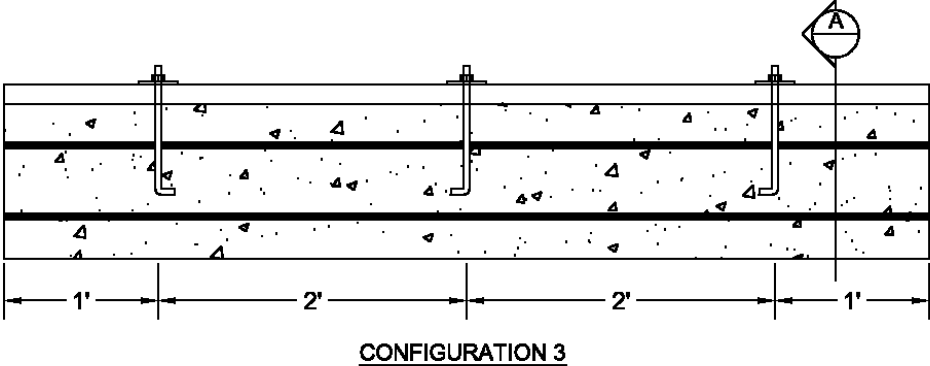
Figure 5 – Configuration 3 specimen construction

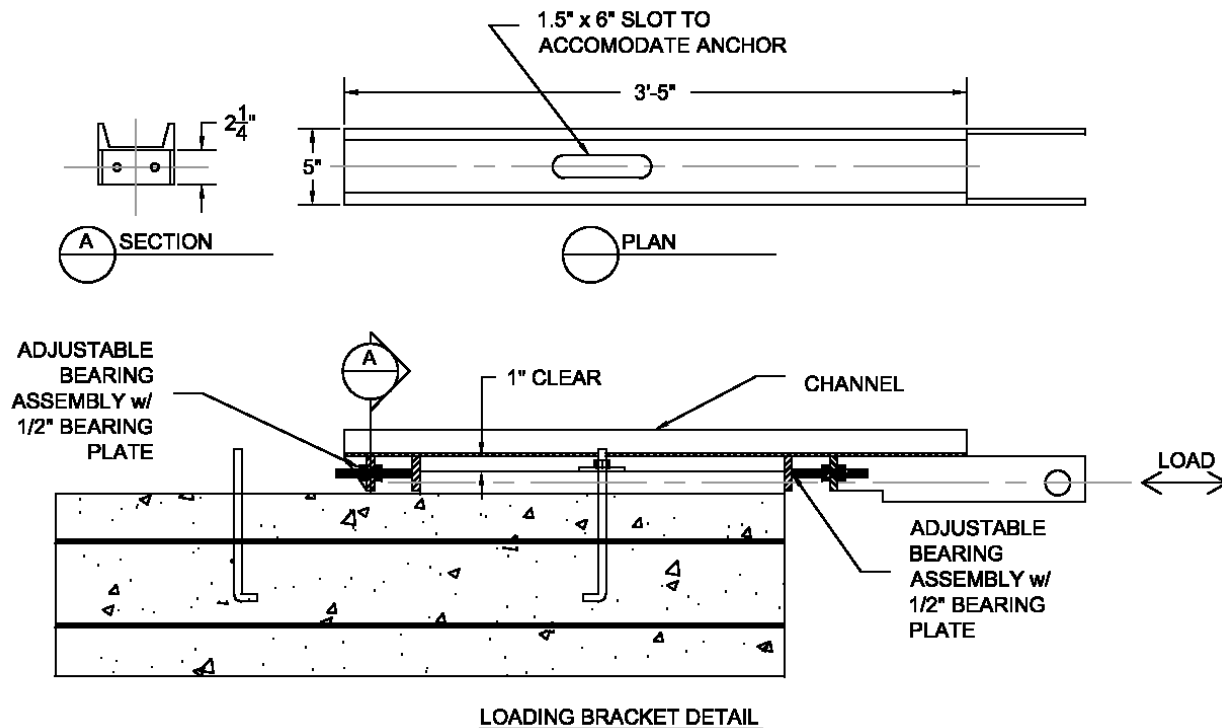
Figure 6 – Loading bracket detail

Displacements in monotonic and cyclic testing of Configurations 2 and 3 were applied to the sole plate using a steel loading bracket. Figure 6 provides a schematic of the loading bracket used for Configuration 2 tests. The bracket used in the Configuration 3 tests was identical except that it was longer and had three slots to accommodate the two additional anchors. The brackets consisted of steel channels with steel bearing tabs at each end of the sole plate that applied the load in both directions through end-grain bearing. The loading cylinder was restrained to prevent uplift of the cylinder. The concrete block was secured from lateral movement with restraint fixtures at each end located in the bottom third of the block (Figure 7). The concrete blocks were also restrained against uplift with a steel tube hold-down fixture oriented along the length of the specimen (Figure 9).

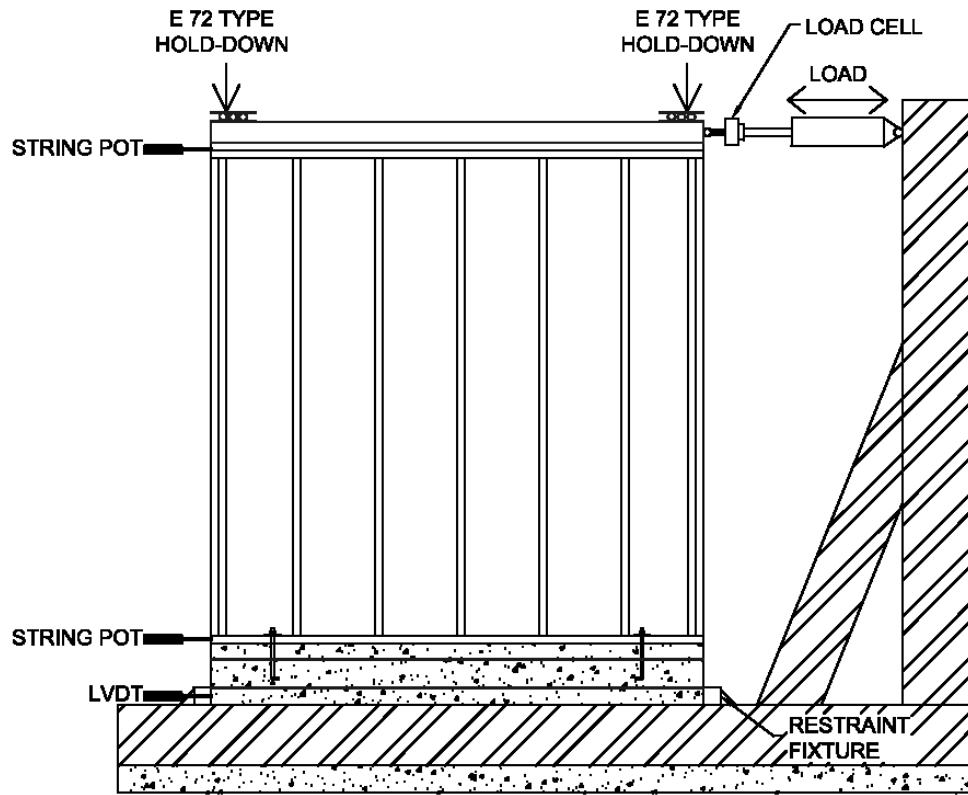
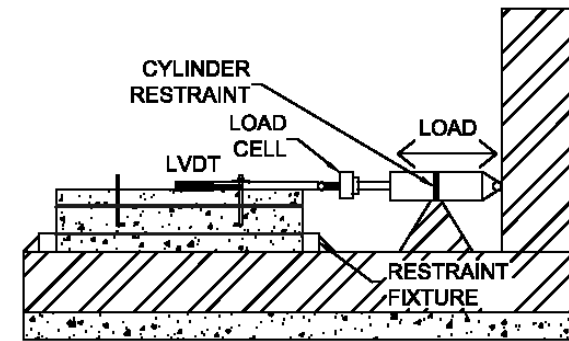
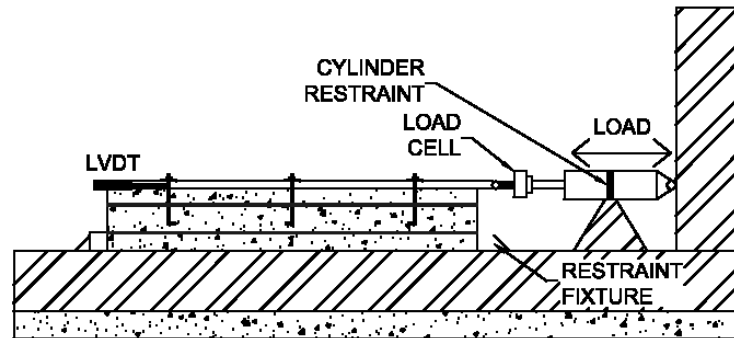
Figure 7 – Instrumentation of test set-up

Slip displacement between the sole plate and the concrete specimen was captured using a LVDT. Movement of the concrete specimen relative to the base of the racking shear apparatus was also captured. Figure 7 shows the locations of the load and deflection measurements for the various configurations and Figures 8 through 10 provide photographs of the various test set-ups.

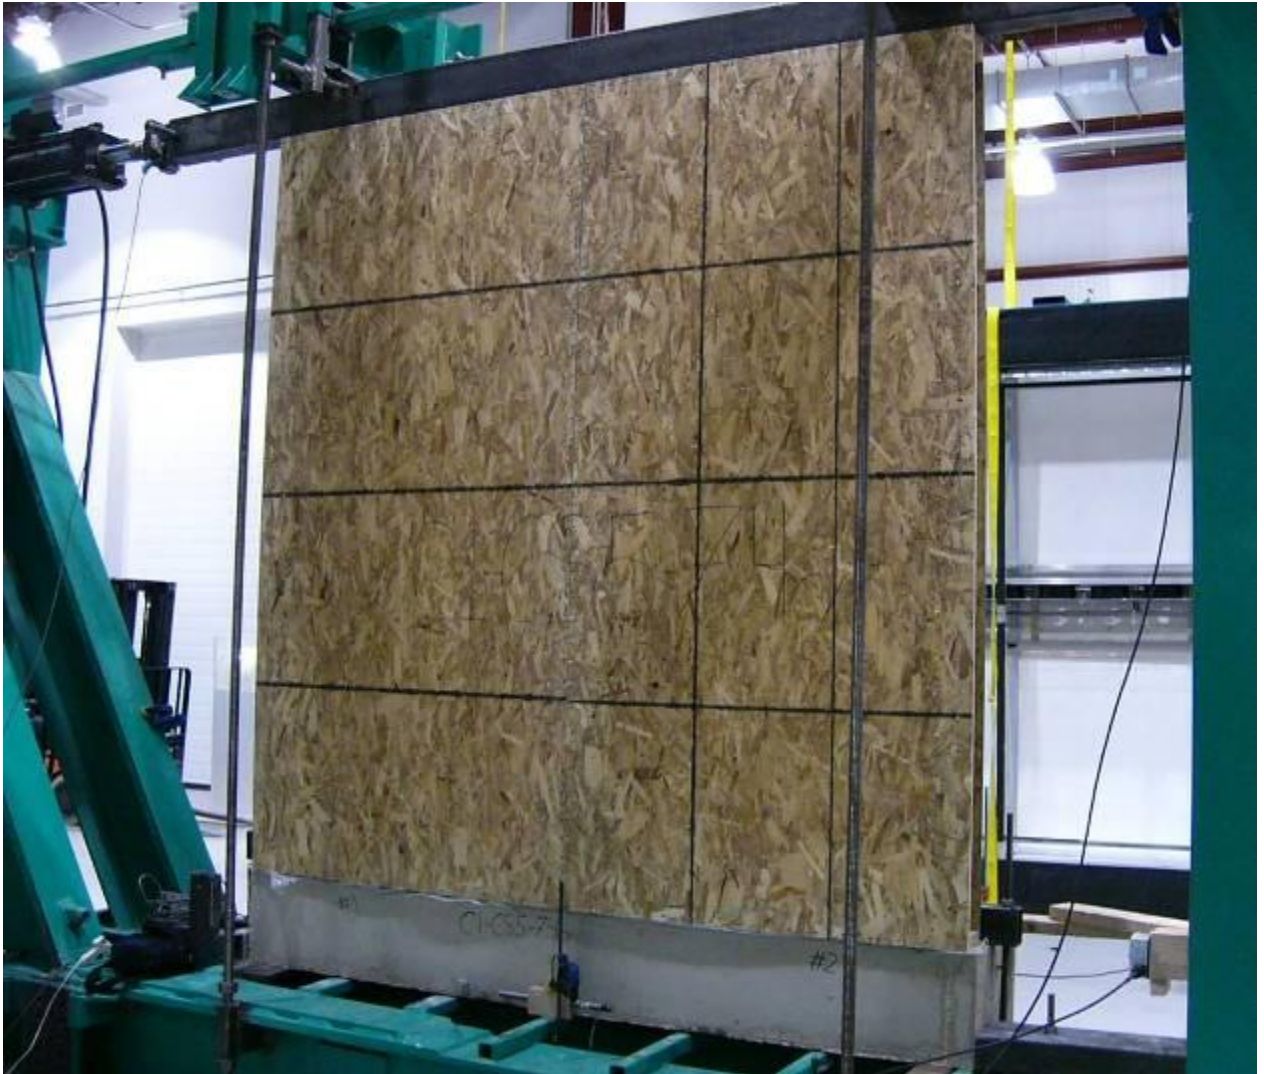
Figure 8 – Configuration 1 test set up

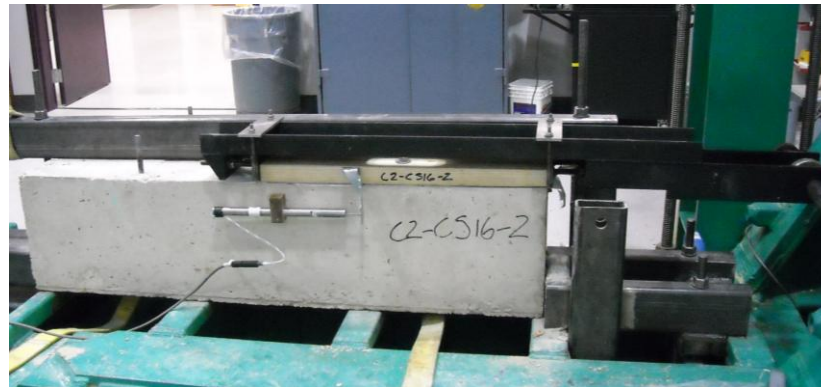
Figure 9 – Configuration 2 test set-up

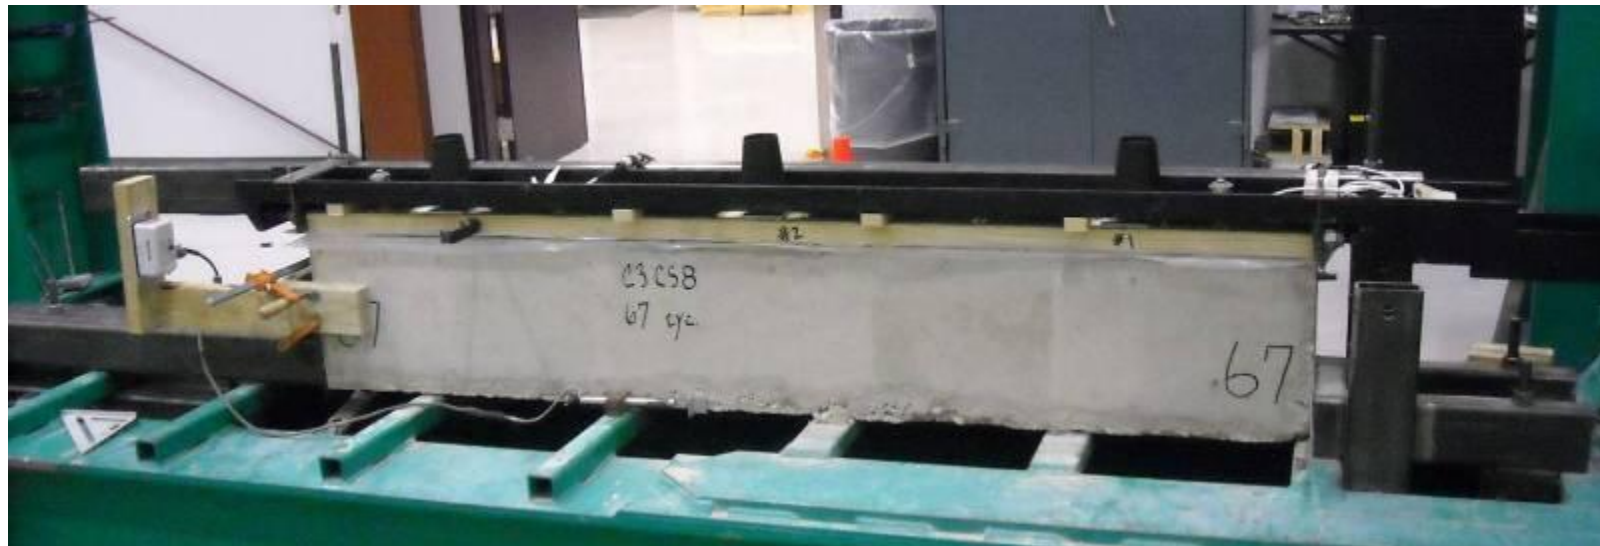
Figure 10 – Configuration 3 test set-up

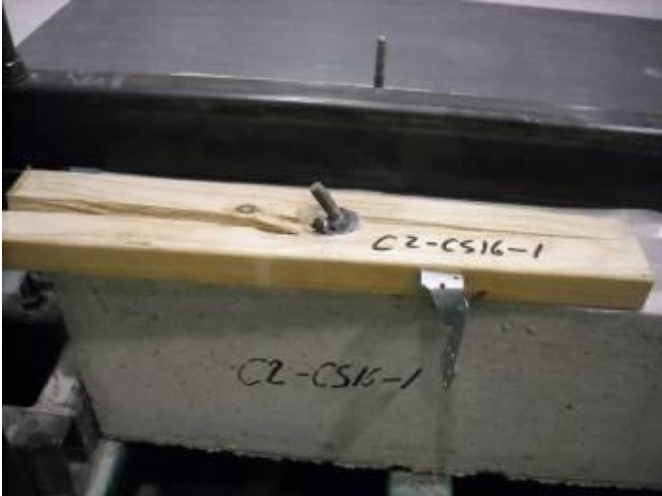
Figure 11 – Plate splitting failure in monotonic test of 2x4 plate with round cut washer (no spall)

The first four tests of Configuration 2 included specimens with a 2x4 sole plate and standard round cut washers. The primary failure mode was splitting of the wood sole plate (Figures 11 & 12). Only two of the four specimens exhibited any visible damage to the concrete and then only in the form of minor spalling at the surface (Figure 12). Based on observations of specimens after the test, the bolts typically exhibited a deformed mode shape corresponding to Yield Mode IIIs based on the NDS design nomenclature. The average peak load achieved by specimens with round cut washers was 5,128 lb.

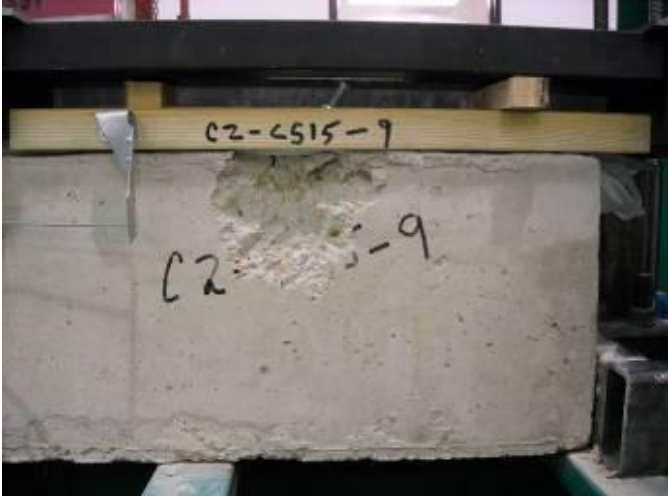
Figure 12 – Minor spalling in monotonic test of 2x4 plate with round cut washer

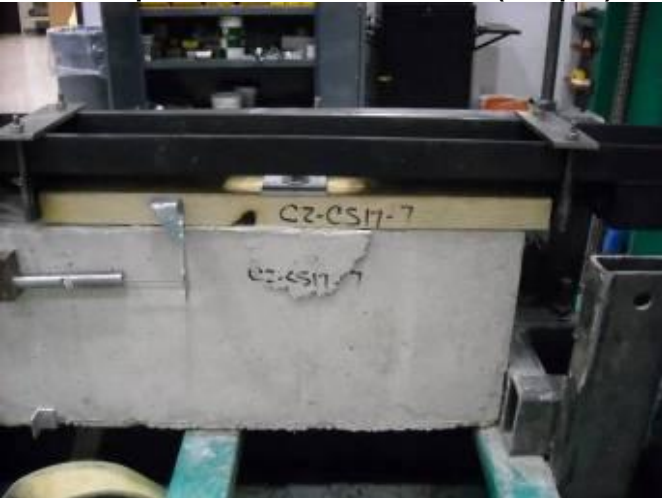
Figure 13 – Initial spall in monotonic test of 2x4 plate with plate washer

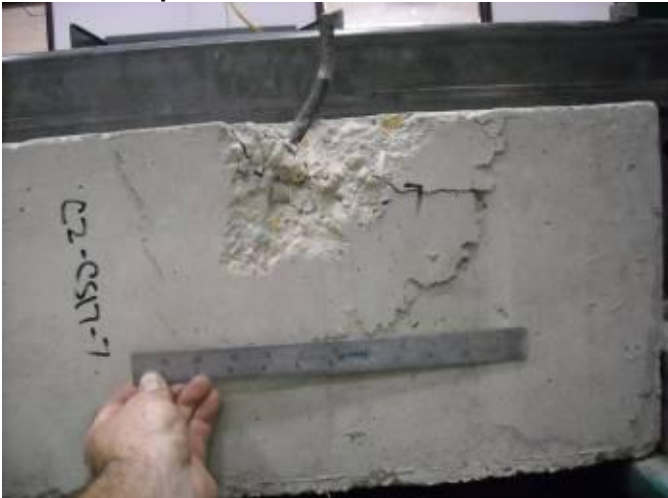
Figure 14 – Final large spall in monotonic test of 2x4 plate with plate washer

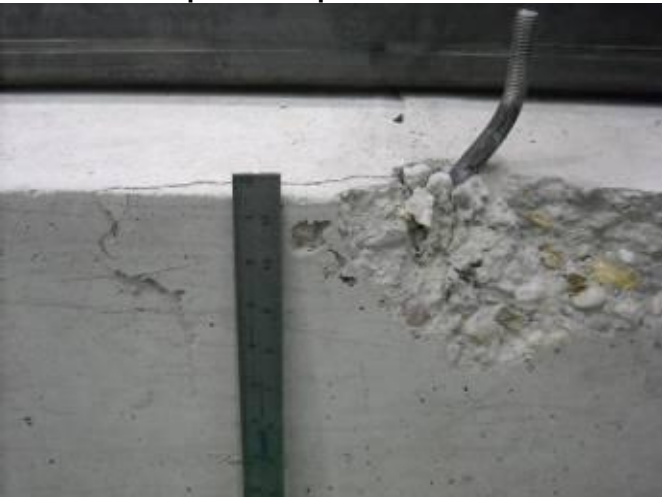
Figure 15 – Typical yield shape of steel anchor bolt in monotonic test with plate washer

Figure 15 shows the typical shape of the anchor bolt after the test (the wood plate removed to facilitate inspection of the bolt). This deformed shape corresponds with a Yield Mode IVs based on NDS nomenclature and was observed in the majority of monotonic tests with 2x4 sole plates and plate washers. Some deformation of the bolt in the direction perpendicular to the edge of the concrete was also observed (see Figure 16). This movement is indicative of the lack of out-of-plane restraint placed on the sole plate during testing.

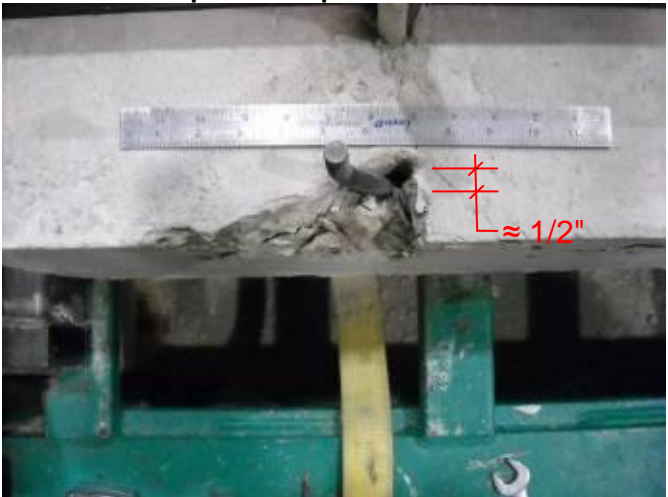
Figure 16 – Out-of-plane translation of anchor bolt

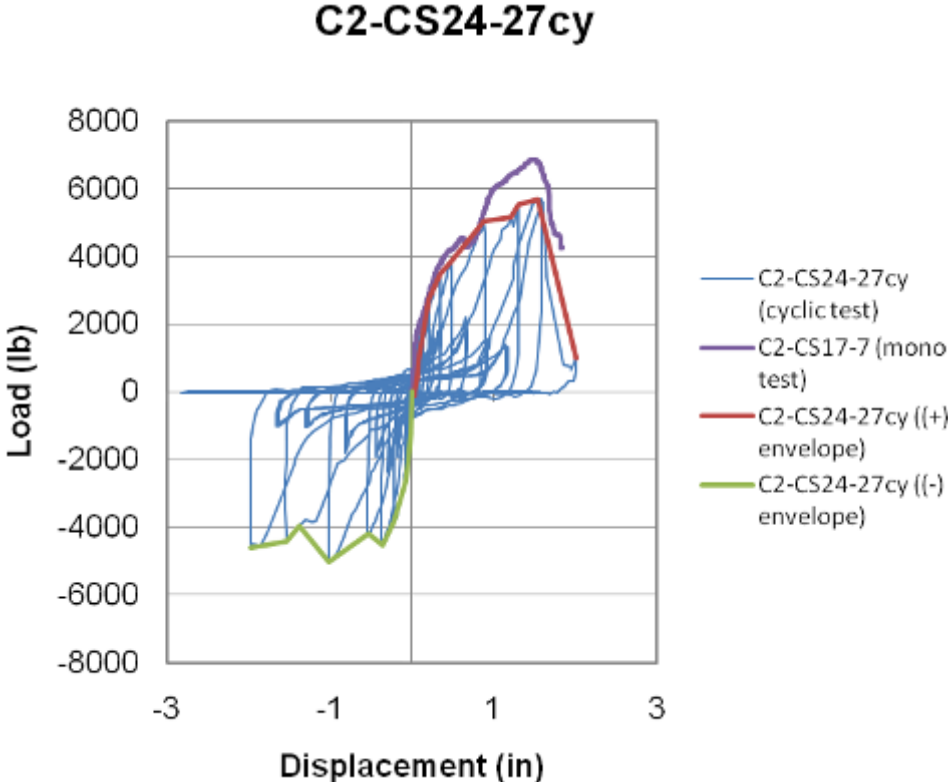
Figure 17 – Comparison of behavior of un-cracked specimens under cyclic and monotonic loading

The Configuration 2 specimens exhibited performance behavior similar to those specimens tested under monotonic loading. Figure 17 provides an example comparison between the behavior of un-cracked specimens loaded under monotonic and cyclic loading protocols. Typically, the positive envelope curves of the cyclically tested specimens matched the basic shape of the load-displacement curves from monotonic testing.

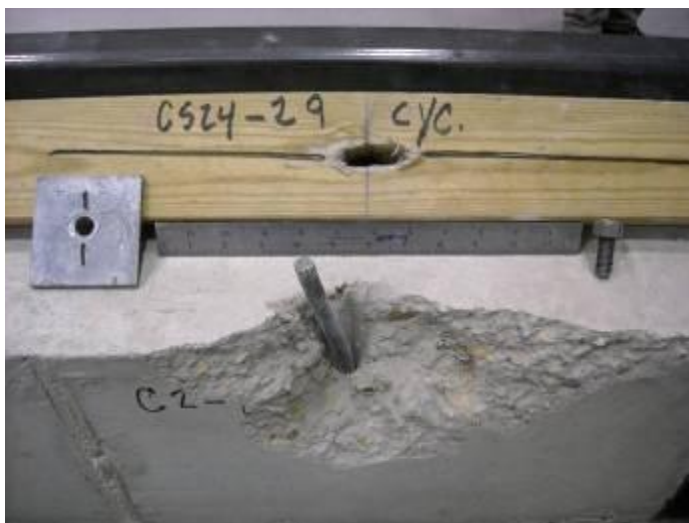
Figure 18 – Tensile failure of bolt in Configuration 2 test

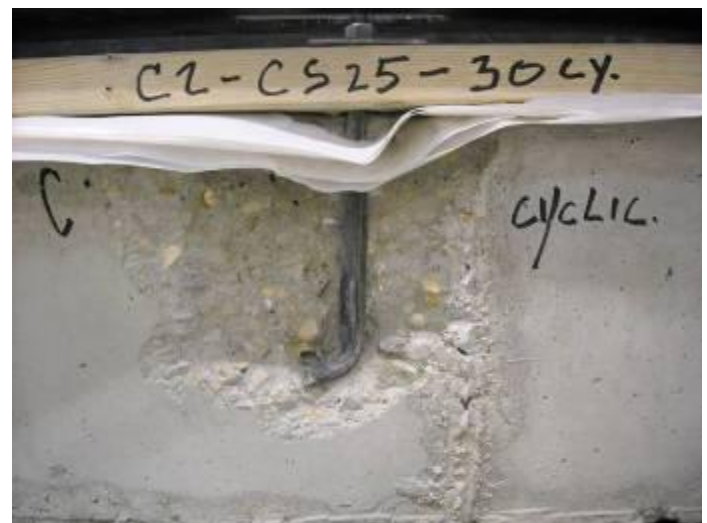
Figure 19 – Complete concrete breakout at anchor in Configuration 2 test

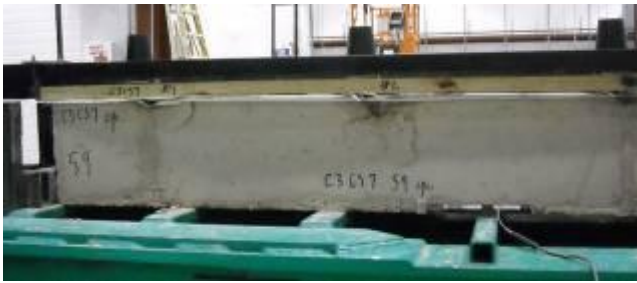
Figure 20 – Large spall at center bolt in Configuration 3 test

All of the Configuration 3 tests exhibited similar failure behavior to Configuration 2 tests. All three anchor bolts in a specimen exhibited initial spalling during the same loading cycle, followed by a continuing increase in load. Large spalling occurred next, generally at the center bolt location in both the un-cracked and cracked specimens (Figure 20). Several tests also exhibited large spalling at least one of the end bolt locations as well. Ultimate failure occurred as either tensile failure of one, two or all three bolts (Figure 21), or complete concrete break out of a single bolt (Figure 22).

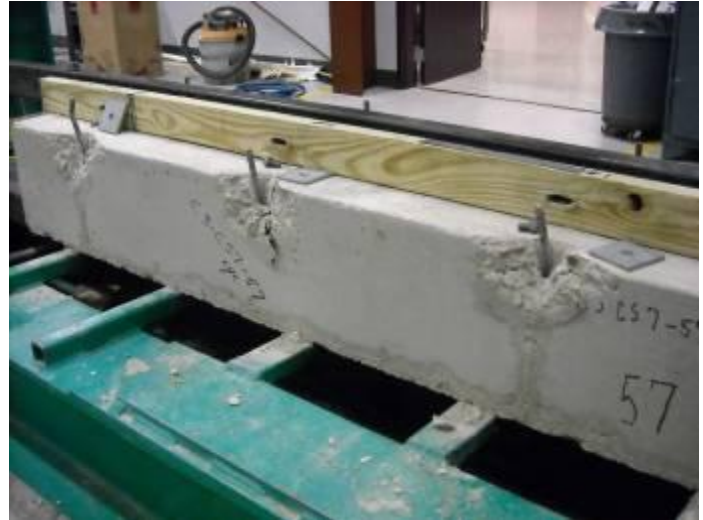
Figure 21 – Tensile failure of bolts in Configuration 3 test

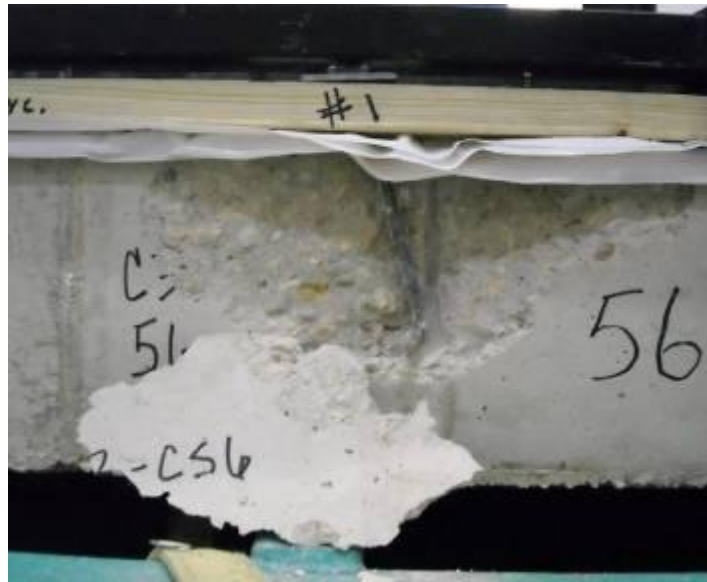
Figure 22 – Complete concrete breakout at anchor in Configuration 3 test

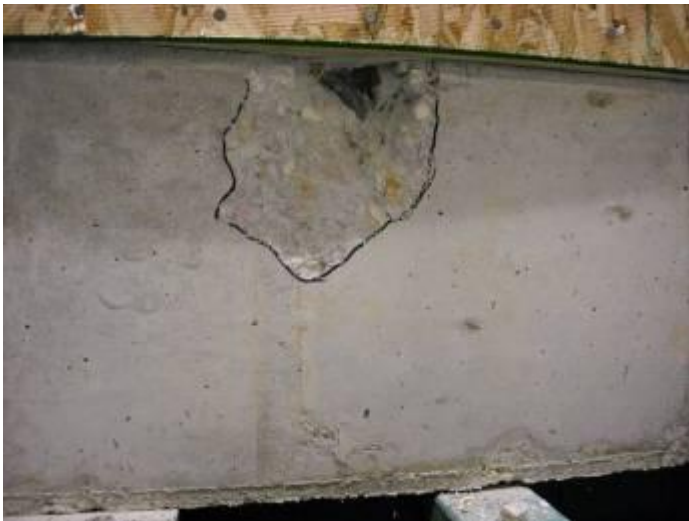
Figure 23 – Large spall in first full-scale shear wall test

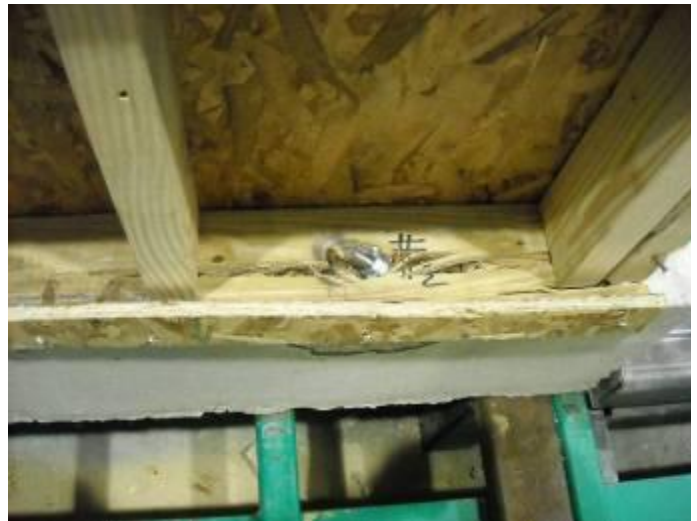
Figure 24 – Plate degradation in full-scale shear wall test with round cut washers

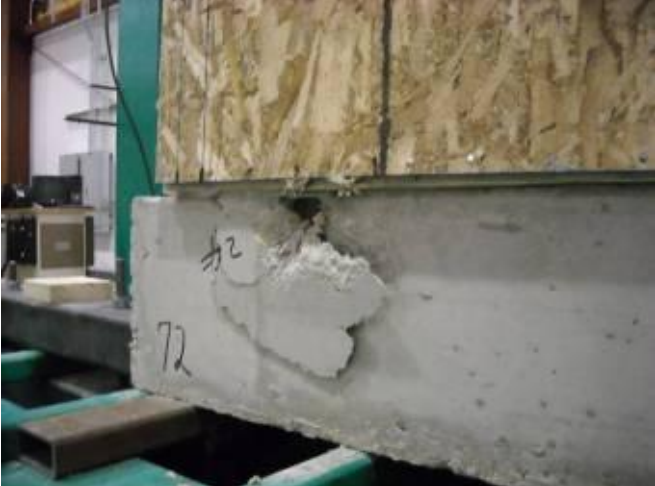
Figure 25 – Large spall in third monotonic full-scale shear wall test

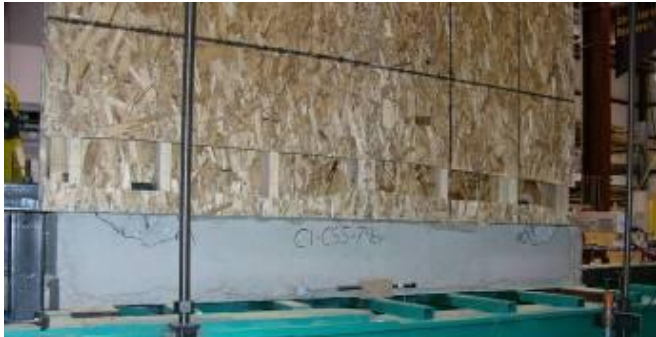
Figure 26 – Failure of full-scale shear wall specimen during cyclic testing (sheathing removed post-test to allow for inspection)

The primary failure mode was initial spalling of the concrete at both bolts, followed by tensile failure of both anchors due to the in-plane lateral displacement of the sole plate. Figure 26 shows the large concrete spall at the uplift end of the wall. The bottom plate at the uplift end also moved perpendicular to the face of the concrete approximately 1/2-inch. No perpendicular movement occurred at the compression end of the wall.

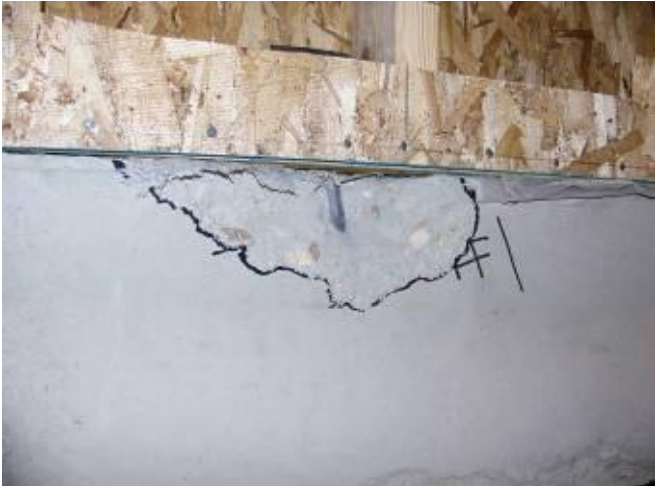
Figure 27 – Large spall in full-scale shear wall specimen during cyclic testing (sheathing removed post-test to allow for inspection)

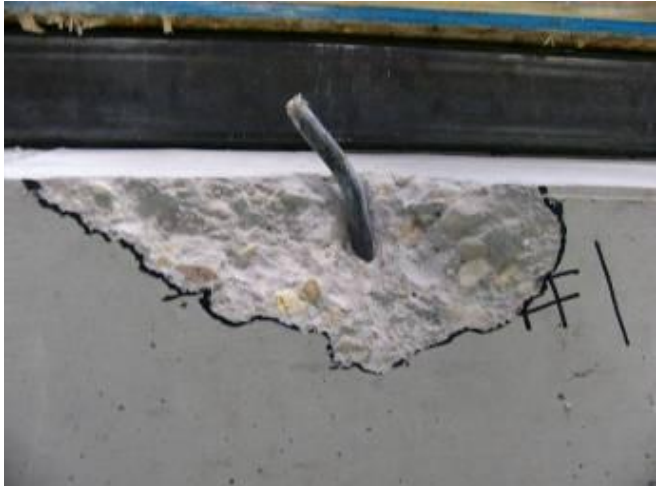
Figure 28 – Bolt yielding in full-scale shear wall specimen during cyclic testing

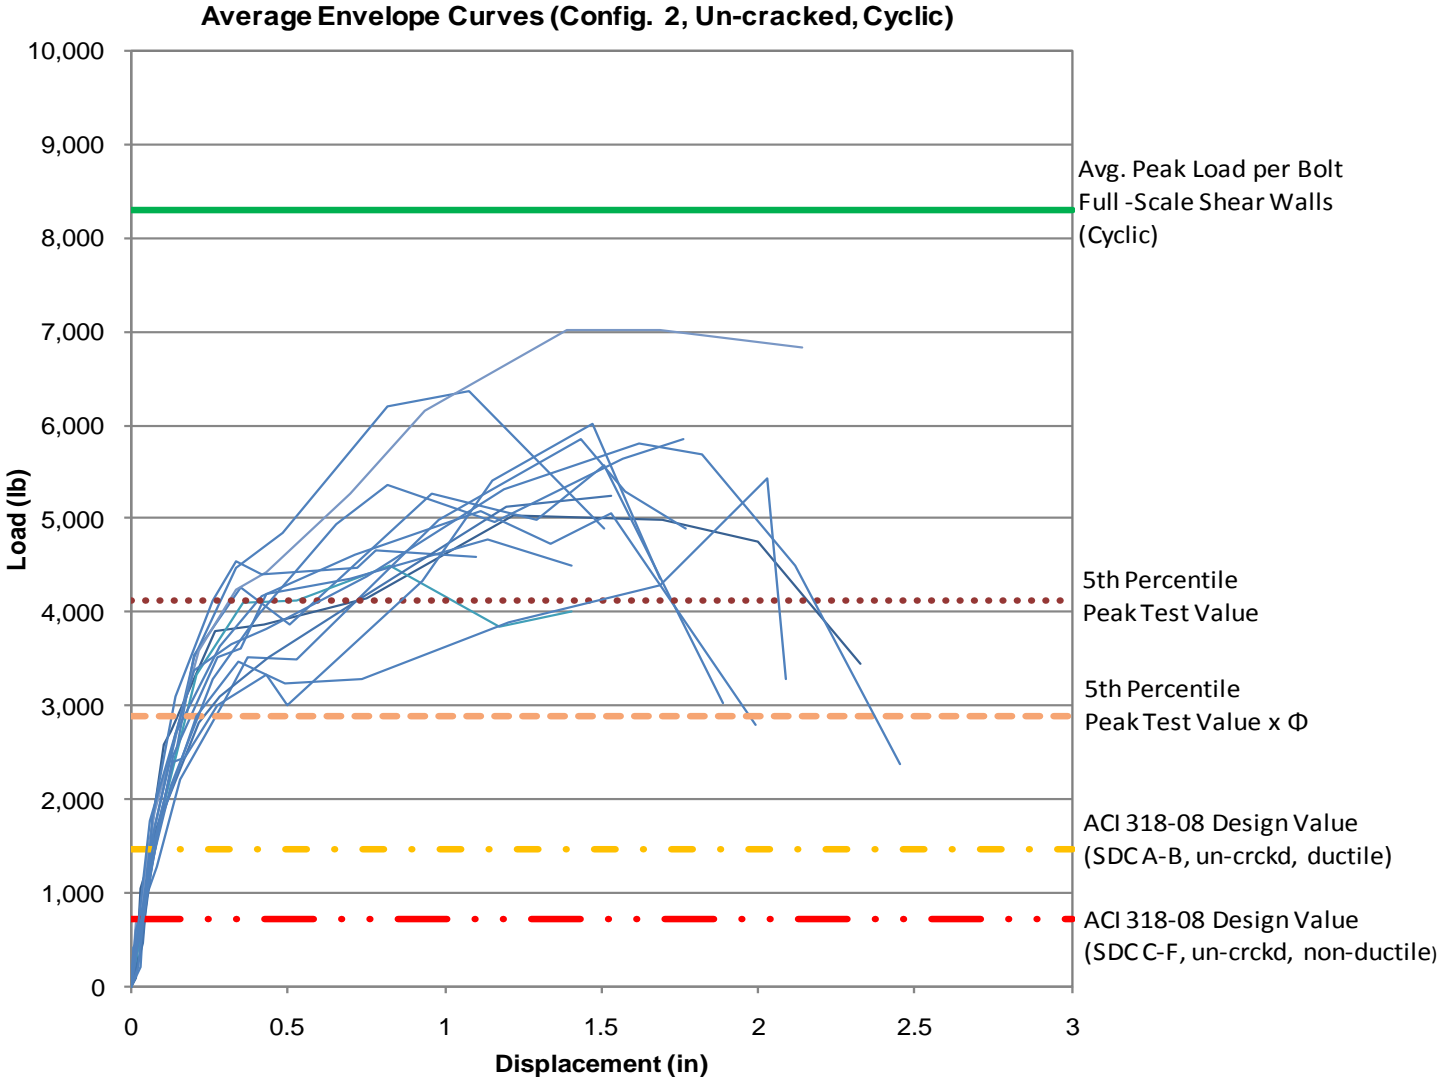
Figure 29 – Comparison of ACI 318-08 design values to un-cracked cyclic test results

Figures 29 and 30 provide a comparison of ACI 318-08 design values with and without penalties for cracked concrete and ductile performance to average envelope curves from single anchor cyclic tests of un-cracked and cracked concrete, respectively. Figures 31 and 32 provide a comparison of NDS-2005 design values to average envelope curves from single anchor cyclic tests of uncracked and cracked concrete, respectively. The average peak load of the full-scale shear walls on a per bolt basis is also given for comparison. This per bolt performance was calculated by dividing the peak load resisted in the wall by the number of anchors and includes some contribution from friction effects due to overturning at the compression toe of the wall. (These friction effects due to overturning will also be present in actual construction.)

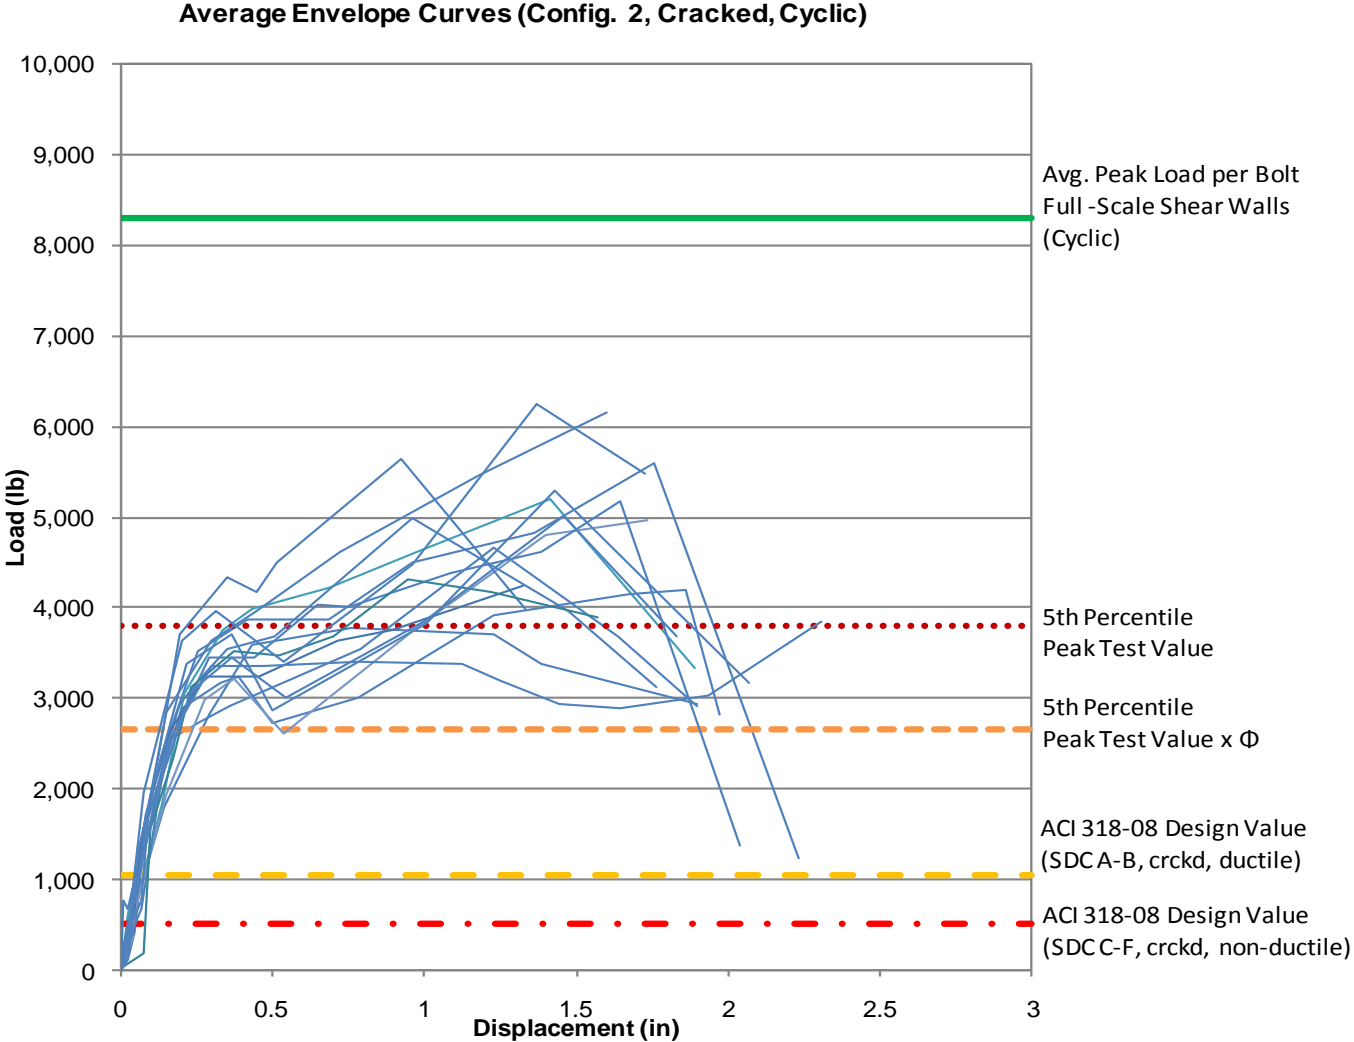
Figure 30 – Comparison of ACI 318-08 design values to cracked cyclic test results

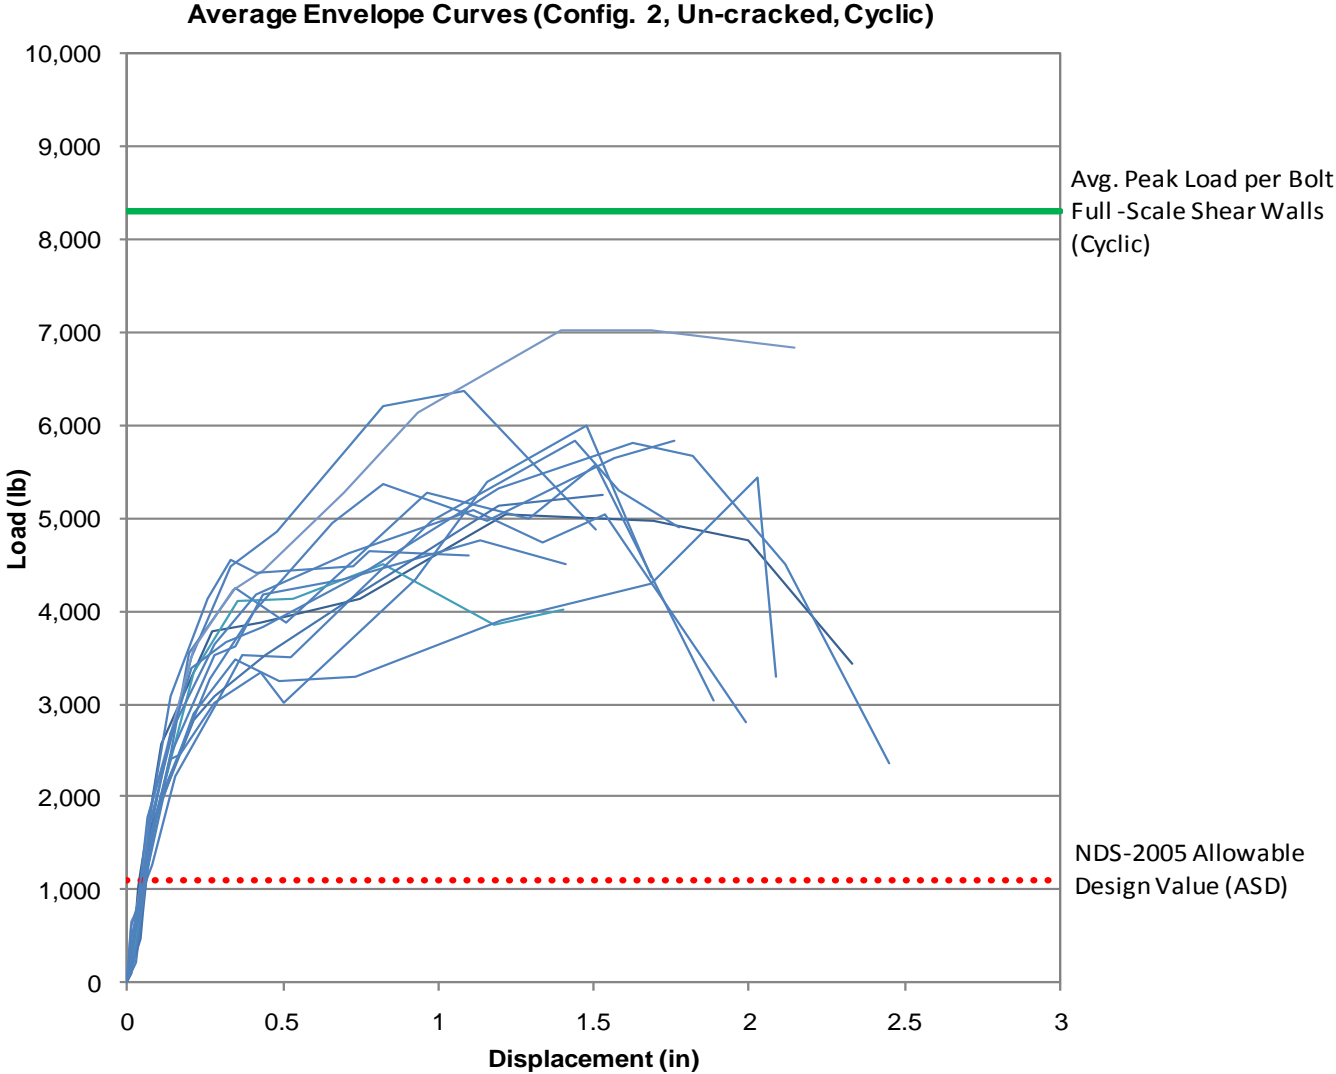
Figure 31 – Comparison of NDS-2005 allowable design values to un-cracked cyclic test results

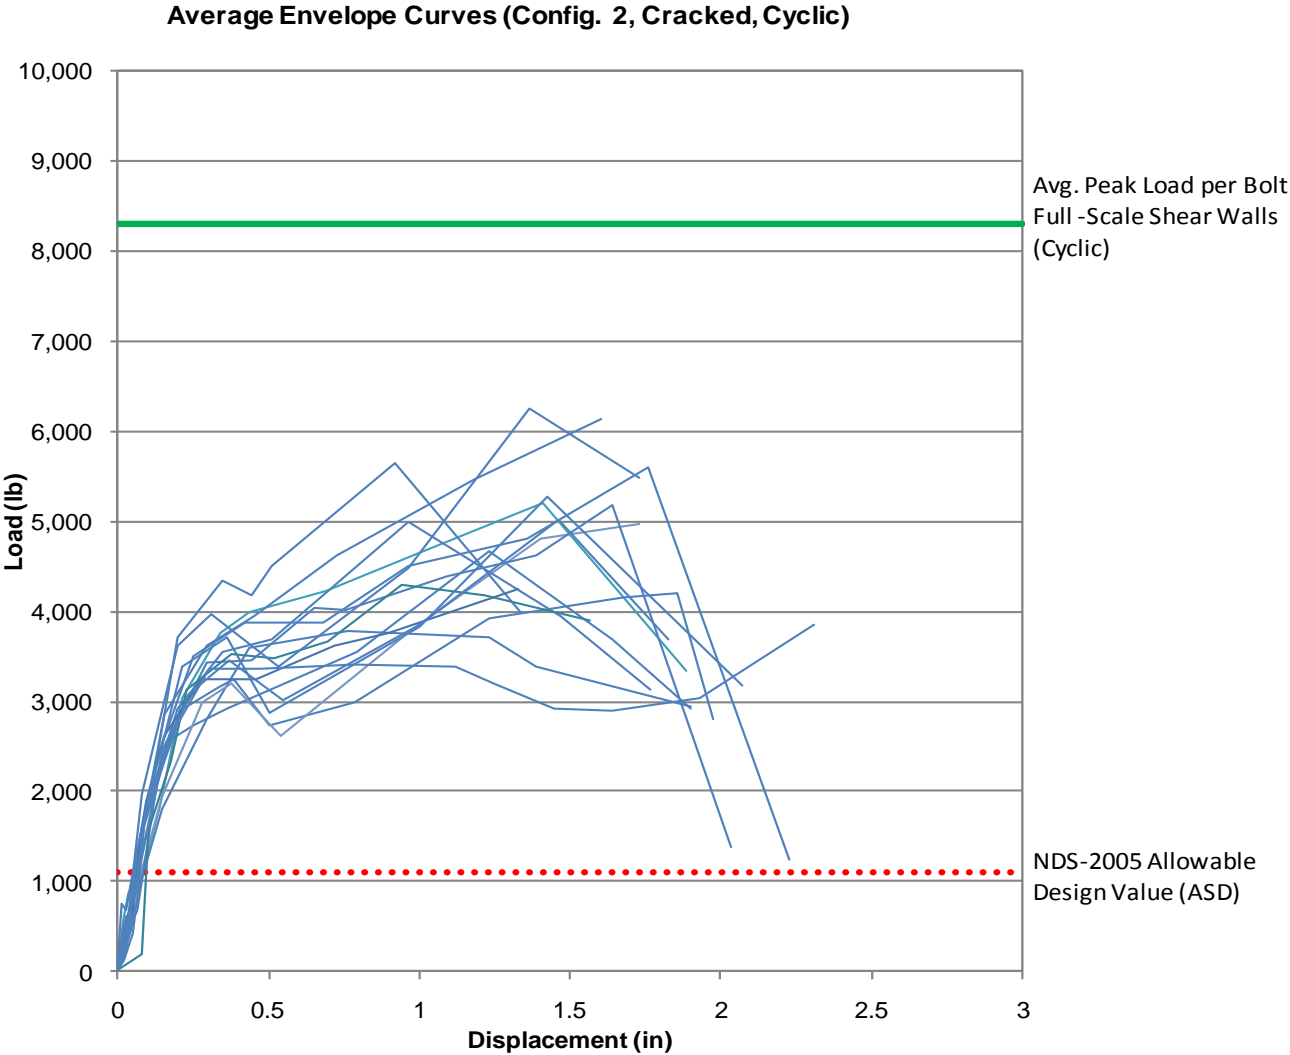
Figure 32 – Comparison of NDS-2005 allowable design values to cracked cyclic test results

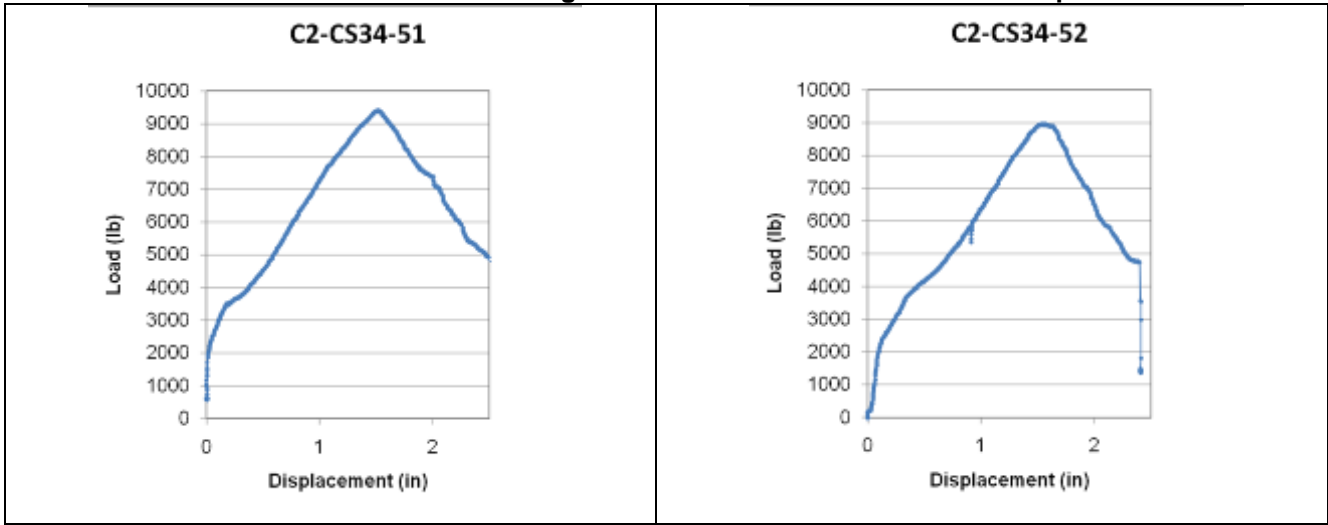
Table A2 – Load-deflection curves of Configuration 2 monotonic tests of 2x6 with plate washer
