EVALUATION OF WOOD SOLE PLATE ANCHORAGE TO CONCRETE UNDER MONOTONIC AND CYCLIC LOADING

Prepared for
NAHB and FPL

Prepared by
NAHB Research Center
400 Prince Georges Boulevard
Upper Marlboro, MD 20774-8731

March 2010

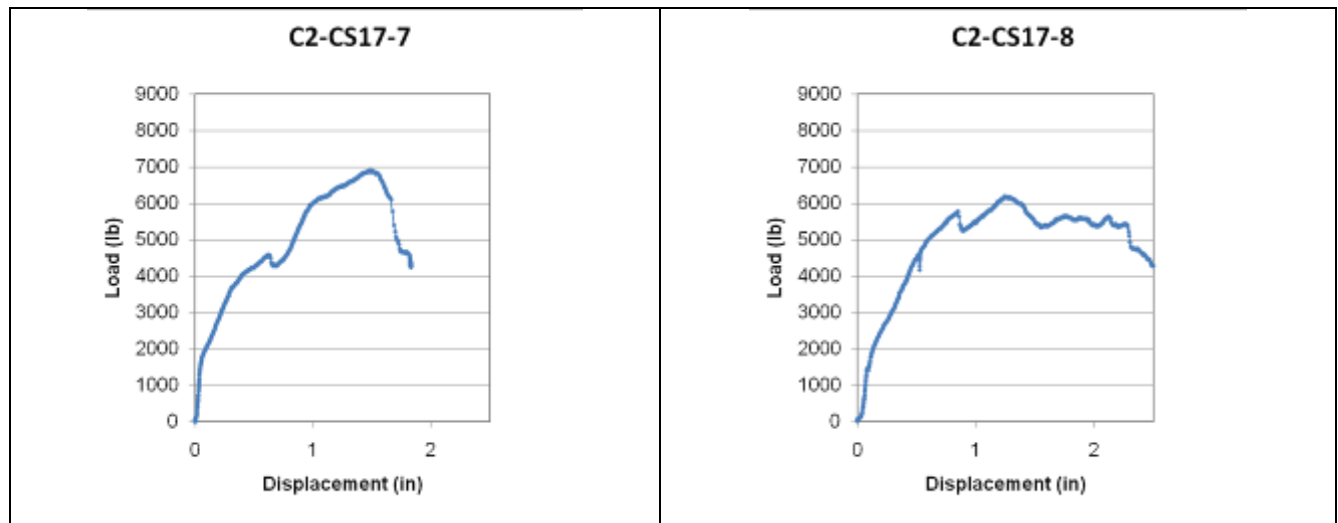
Table A3 – Load-deflection curves of Configuration 2 monotonic tests of 2x4 with plate washer & uncracked concrete

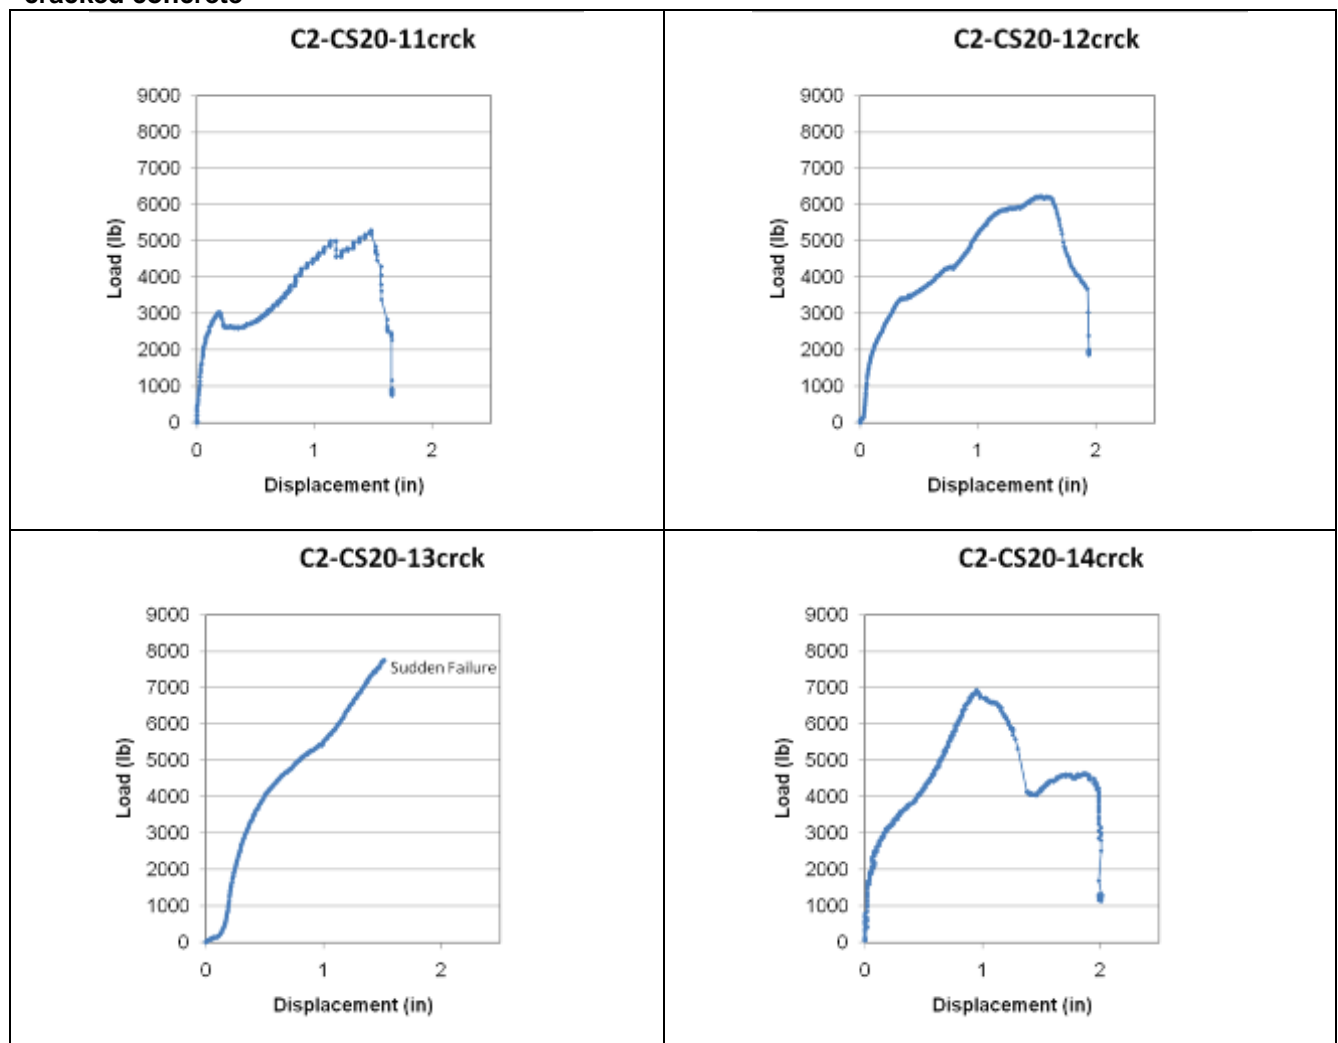
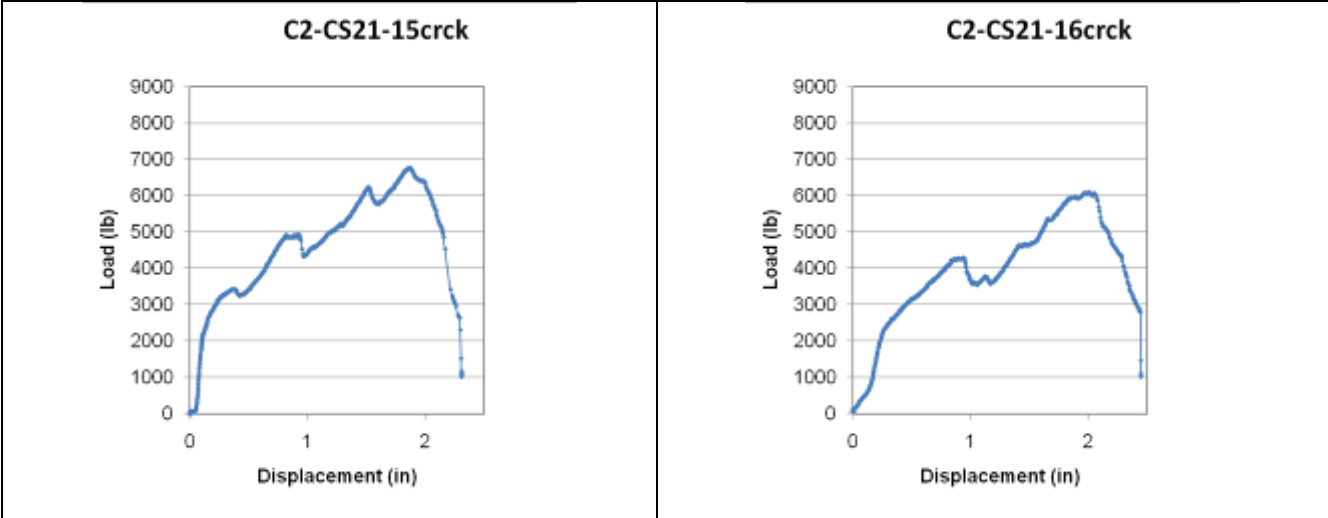
Table A4 – Load-deflection curves of Configuration 2 monotonic tests of 2x4 with plate washer & cracked concrete

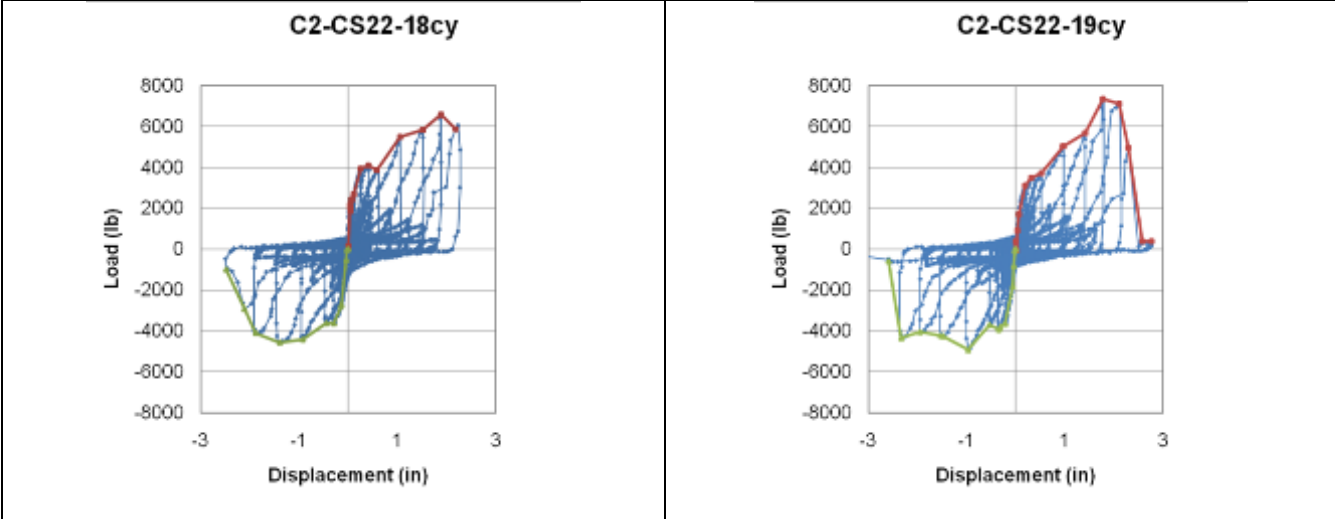
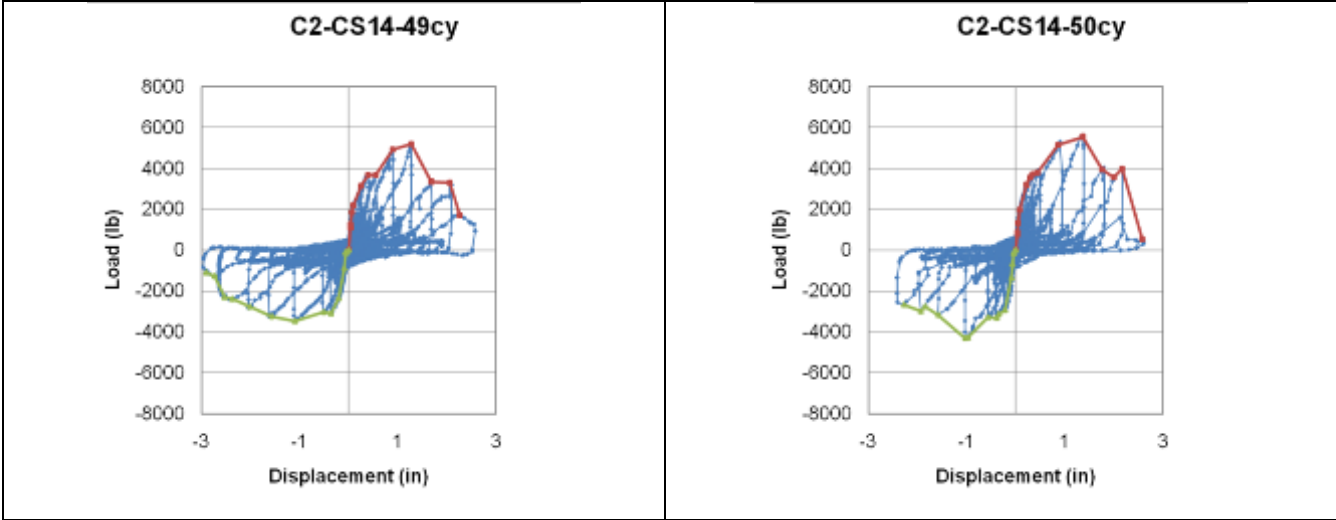
Table A5 – Load-deflection hysteresis and envelope curve of Configuration 2 cyclic tests of 2x4 with plate washer & un-cracked concrete

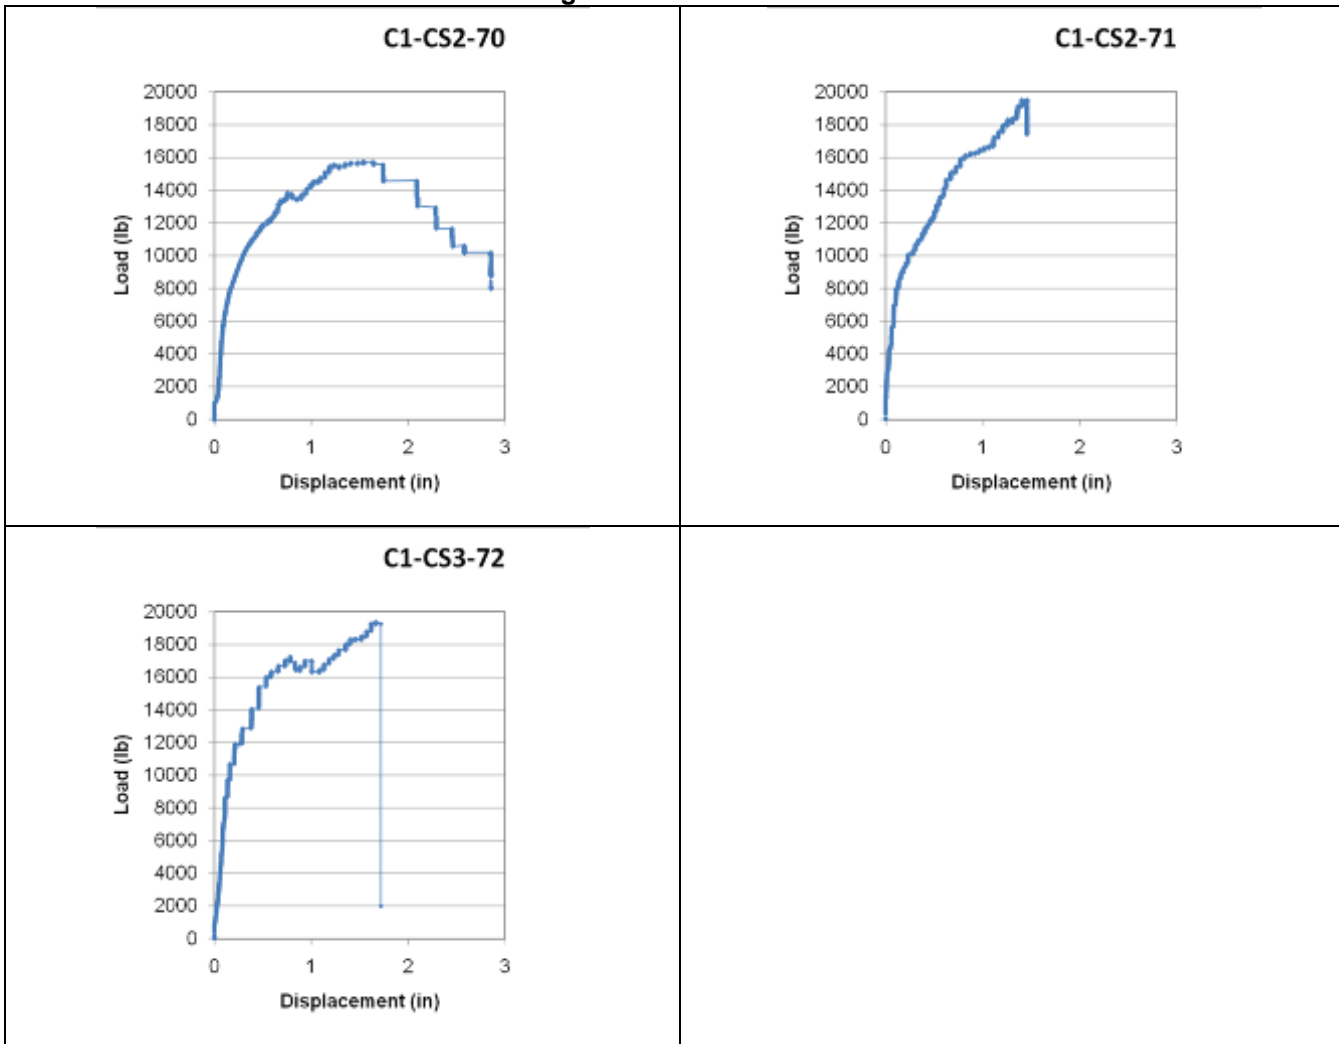
Table A9 – Load-deflection curves of Configuration 1 monotonic tests of full-scale shear walls

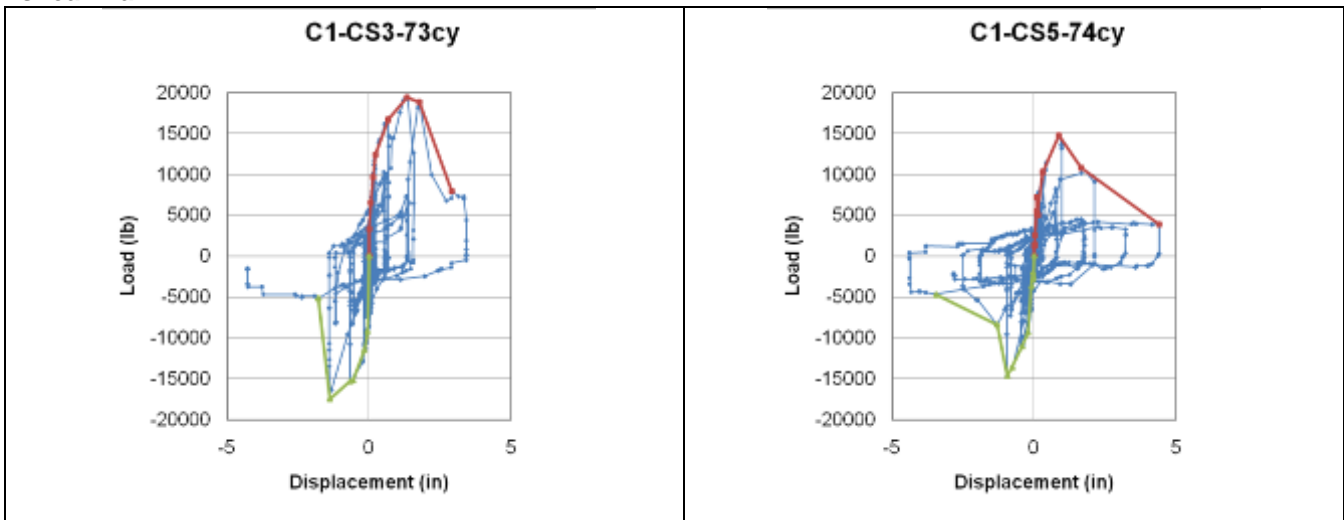
Table A10 – Load-deflection hysteresis and envelop curve of Configuration 1 cyclic tests of full-scale shear wall
