EVALUATION OF INNOVATIVE LIGHT FRAMED WALL BRACING OPTIONS

Prepared for
NAHB

Prepared by
NAHB Research Center, Inc.
400 Prince George's Boulevard
Upper Marlboro, MD 20774

June 8, 2010

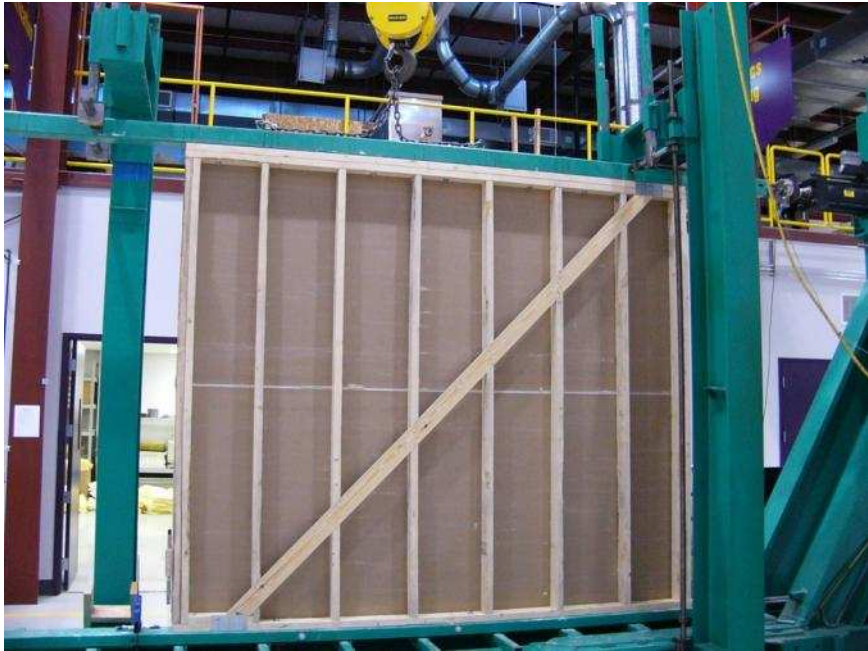
Figure 2 – Shear wall test specimen
(Specimen D)

Figure 1 shows the schematic of the test set up used with Specimen A to illustrate the location of the instrumentation and loading apparatus. Figure 2 provides a photograph of the test setup for Specimen D.

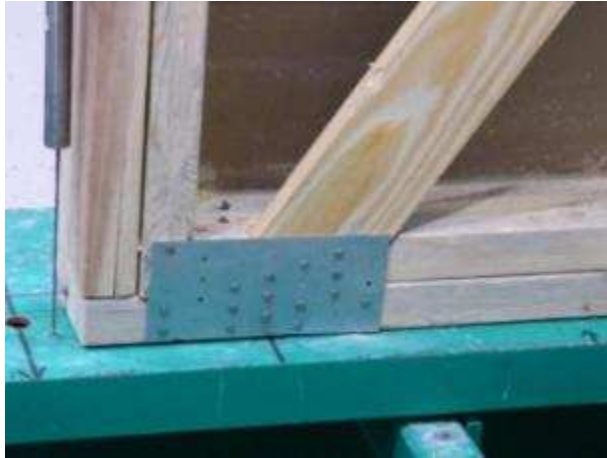
Figure 3 – Reinforcing mending plate and blocking of wood let-in brace

The mending plates in Specimen A were installed using a total of (18) hand-driven 8d box nails; (12) nails through the mending plate, brace, and top (or bottom) plate of the wall and (6) through only the mending plate into the top (or bottom) plate. This attachment schedule is the practical upper limit on the number of nails that can be installed in the field. Specimen A exhibited a peak test load of 8,956 lb (or peak unit shear of 1,119 lb/ft) with a primary failure mode of buckling between the stud and the additional blocking (Figure 5). (Note that the unit shear capacity is based upon the let-in brace's nominal length of 8 feet). This peak load capacity is 2.1 times greater than the peak load achieved in the baseline tests [1].

Since the mending plates did not fail in Specimen A, the number of nails used to attach the mending plate and brace in Specimen B (and all subsequent specimens utilizing a mending plate and wood let-in brace) were reduced to (16) to improve constructability. The angle of the brace in Specimen B was increased to 60°. Specimen B achieved a peak capacity of 5,675 lb (1,218 lb/ft), or 2.3 times greater load than the baseline results [1] and the primary failure mode of Specimen B was a splitting of the brace in the last bay at the compression end of the wall (Figure 6). The construction of Specimen C was similar to Specimen B except that the spacing of the wall framing was increased to 24" on center. Specimen C reached a peak load of 5,295 lb (1,136 lb/ft) and failed in a fashion similar to Specimen A.

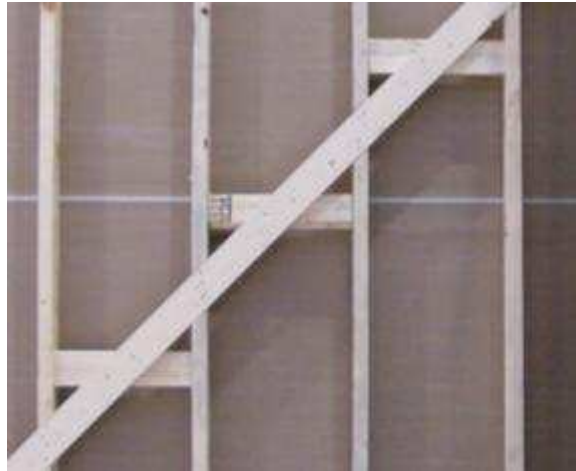
Figure 4 – Out-of-plane blocking of wood let-in brace

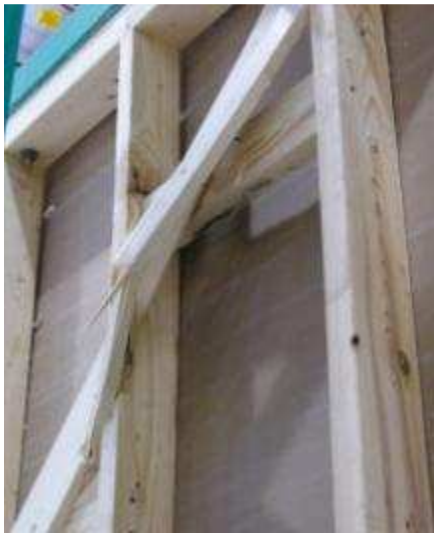
Figure 5 – Buckling failure of wood brace (Specimen A)

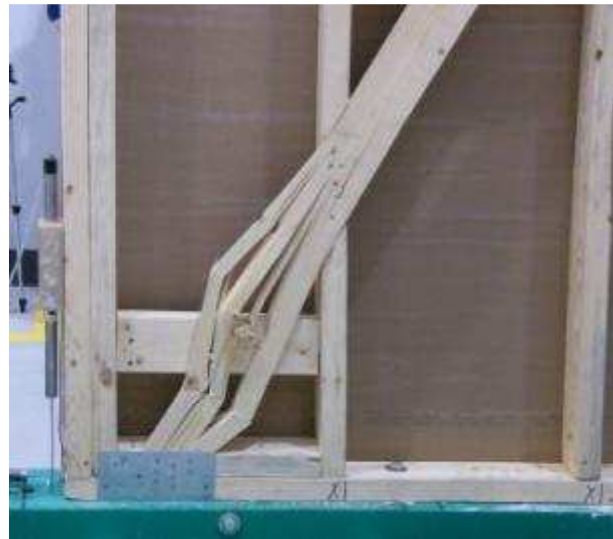
Figure 6 – Splitting failure of wood brace (Specimen B)

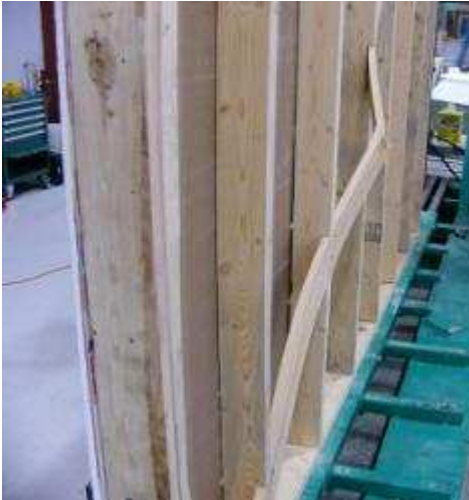
Figure 7 – Buckling failure of wood brace (Specimen D)

Specimens D and E were constructed with 1x4 let-in braces at angles of 45° and 60°, respectively. Specimen D reached a peak unit shear of 1,054 lb/ft while exhibiting a brace buckling failure mode at the mid-span of the center stud bay (Figure 7). Comparing to the Specimen A test that reached a peak unit shear of 1,119 lb/ft, the Specimen D results were only slightly less (about 6%), indicating that the ring shank nailing schedule provides sufficient end fixity to be used as an alternative bracing option in lieu of 2x4 blocking for a 1x4 brace at 45° and 16-inch on center framing.

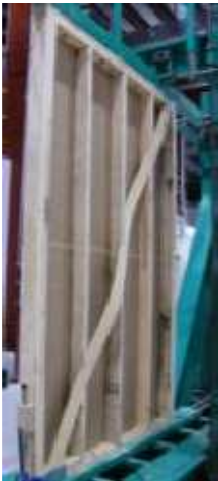
Figure 8 – Out-of-plane bending of wood brace (Specimen E)

Specimen E achieved a peak unit shear of 854 lb/ft with a combined failure mode of shear plug failure at the compression end of the wall and significant out-of-plane bending of the brace (Figure 8). It should be noted that the bracing material used in Specimen E had an SG well above the average SG of the bracing material used in this testing program (SG of 0.62 compared to the average SG of 0.48).

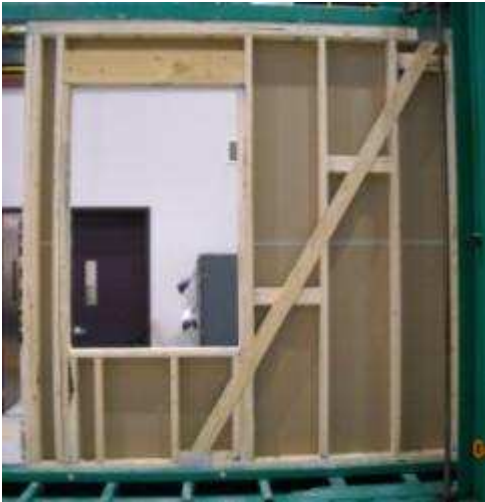
Figure 9 – Specimen G wall construction

The next two specimens evaluated the performance of a reinforced 1x4 let-in brace located so that the bottom end of the brace extended beneath a window opening (Figure 9). This option allows for greater versatility in the placement of let-in bracing. Specimen G was tested in compression and Specimen H was tested in tension. Specimen G exhibited a brace buckling failure mode at the blocking in the center stud bay and diagonal cracking of the gypsum around the opening (Figure 10). The specimen reached a peak unit shear of 1,295 lb/ft, a capacity 2.4 times greater than the baseline [1] and a 6% increase over the Specimen B results, indicating that the placement of an opening above the end of a reinforced let in brace has negligible impact on the strength of that brace in compression. Specimen H achieved a peak unit shear capacity of 523 lb/ft, an increase of 43% over the baseline results of a 1x4 brace in tension [1]. The primary failure mode of Specimen H was nail withdrawal at the connection of the brace and mending plate to the bottom plate of the wall (Figure 11). Significant cracking of the gypsum sheathing was also observed at the corners of the opening (Figure 12), as well as at the horizontal joint between gypsum panels (Figure 13). This amount of cracking is similar to the gypsum sheathing damage observed in previous testing of conventional let-in bracing near window openings [1]. The average peak unit shear capacity of the brace in compression (Specimen G) and the brace in tension (Specimen H) was 907 lb/ft. This unit shear capacity exceeds the current upper bound wall strength of 700 lb/ft used in the development of the 2009 IRC [2]. However, it is clear that the strength of these braces is asymmetric and, if the average of the tension and compression strength is to be used as a basis for design, the braces should be applied in opposing pairs. Otherwise, the bracing strength in compression and tension

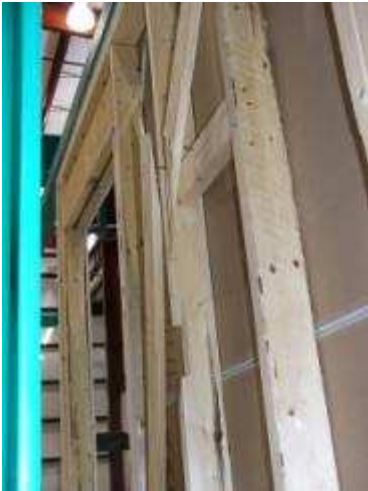
Figure 10 – Buckling failure of wood brace (Specimen G)

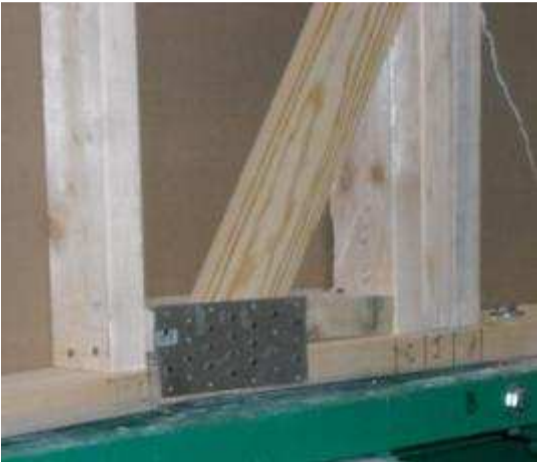
Figure 11 – Withdrawal failure of wood brace (Specimen H)

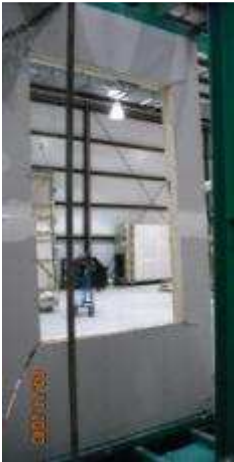
Figure 12 – Diagonal cracking of gypsum at opening (Specimen H)

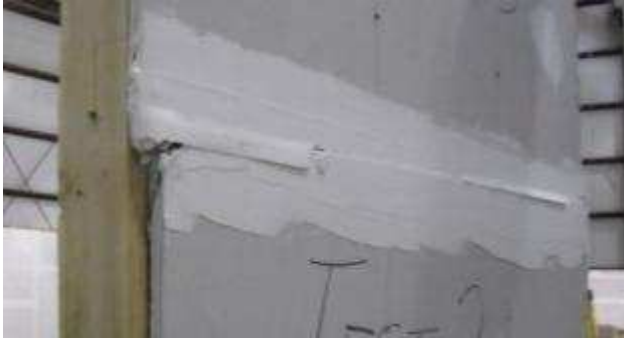
Figure 13 – Cracking of gypsum at horizontal joint (Specimen H)

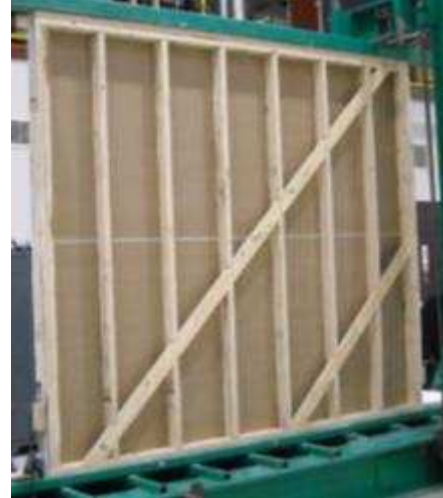
Figure 14 – Specimen I wall construction

Specimen I was tested to evaluate the performance of a system of two 1x4 let-in braces without any reinforcing details. Both braces were installed at a 45° angle with (3) 8d pneumatic nails at each end and every intermediate stud. The primary brace was in the typical location, beginning approximately 4 inches from the leading edge of the wall. The second brace began at mid-height of the leading edge of the wall (Figure 14) and was let into both end studs and the bottom plate of the wall. The peak test load for this specimen was 5,068 lb (608 lb/ft), a 12% increase over the baseline let-in brace strengths [1] and failed by buckling of the primary brace. Thus, the addition of a partial length brace provided only marginal benefits.

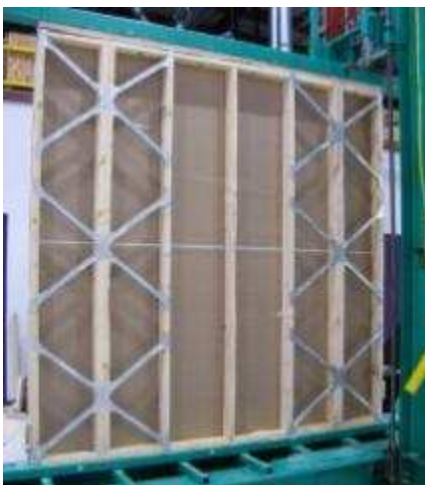
Figure 15 – Specimen L wall construction

Specimens K and L resist shear forces through vertical trusses constructed using POSI-STRUT® metal truss web members (Figure 15). Each specimen includes two 32-inch wide bracing units. The POSI-STRUT® product is a V-shaped stamped metal web member intended to connect the top and bottom chords of a Warren type, parallel chord wood floor or roof truss. The metal web member is connected to wood studs through integrated truss plates (Figure 16). The web members were installed only at the exterior face of the wall. The trussed stud bays were reduced by 3/4 of an inch to a 15.25-inch on center spacing and a double stud member was required in the middle of the truss bracing unit to accommodate the web members (note that off-the-shelf metal web members were configured for floor truss applications). These double stud members were spliced at 12 inches on center using (2) 16d pneumatic framing nails. This nailing schedule was increased from the (1) 10d nail at 24-inch on center required in the 2009 IRC in order to provide greater shear load transfer capacity between the studs and prevent slippage of the studs relative to each other. Specimen K also included additional rectangular truss plates at the top and bottom of the double studs to reinforce the connection of the bracing unit to the top and bottom plates of the wall (Figure 17).

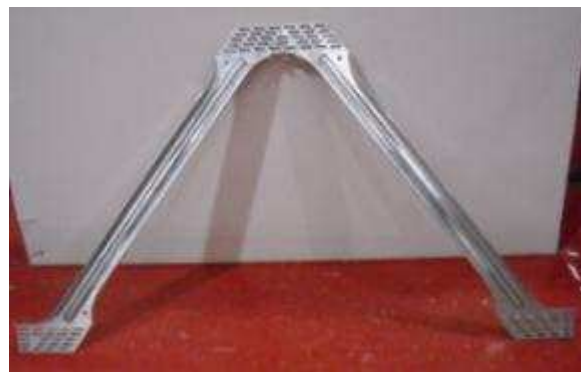
Figure 16 – POSI-STRUT® web member

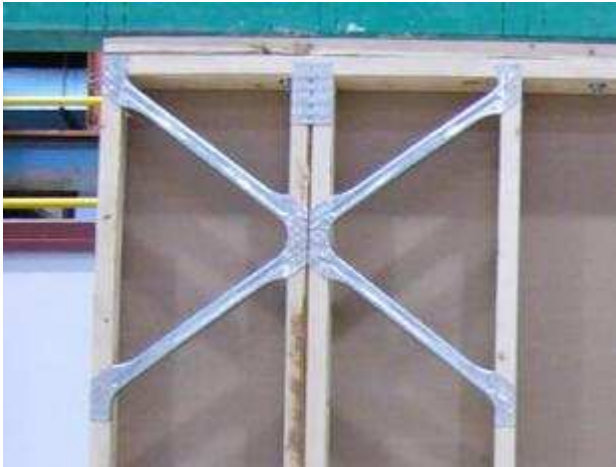
Figure 17 – Additional truss plates between double studs and top plate (Specimen K)

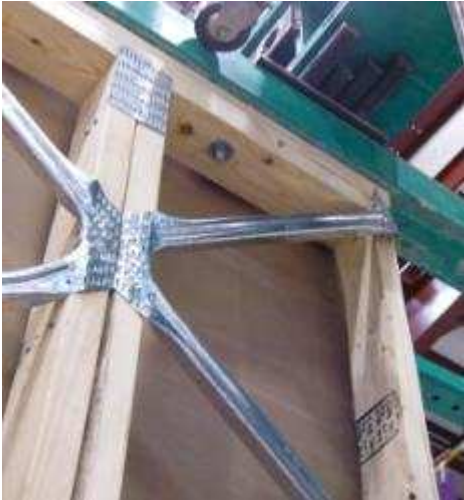
Figure 18 – Combined buckling and withdraw failure at leading edge of wall (Specimen K)

Specimen K attained a peak load of 4,511 lb (or peak unit shear of 777 lb/ft over the 5 feet 1 inch length of trussed stud bays). The primary failure mode was a buckling of the web members and withdrawal of the integrated truss plates at the top and bottom plates (Figures 18 and 19). Some splitting of the single studs was observed in locations where web members were spaced apart from each other as shown in Figure 20. Specimen L was tested without the additional truss plate connection between the double studs and the wall plates. This specimen reached a peak load of 4,247 lb (or peak unit shear of 725 lb/ft, over the 5 feet 1 inch length of trussed stud bays) with a primary failure mode of integrated truss plate withdrawal along the top plate of the wall (Figure 21). Both Specimen K and Specimen L exceeded the 700 lb/ft upper bound strength of the IRC bracing methods [2] demonstrating viability of truss walls for wall bracing applications.

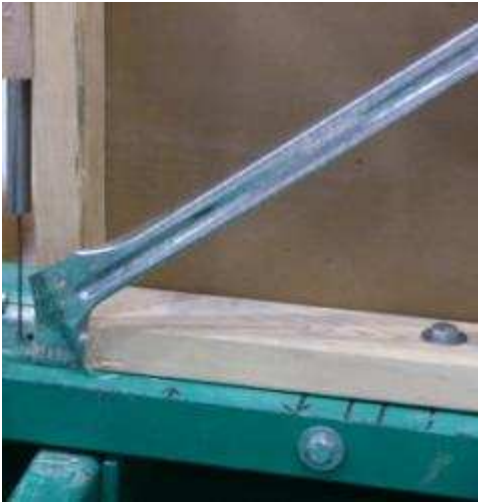
Figure 19 – Combined buckling and withdraw failure at trailing edge of wall (Specimen K)

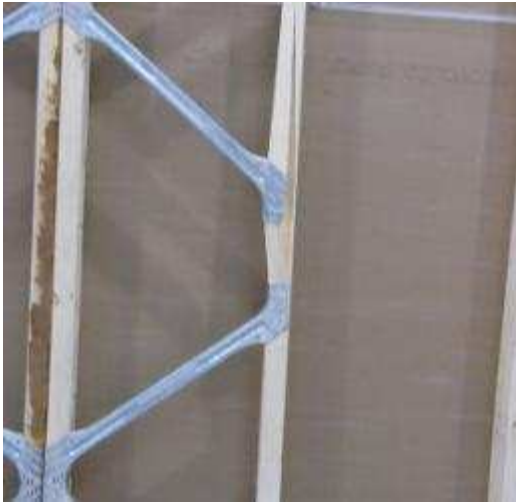
Figure 20– Splitting failure of stud (Specimen K)

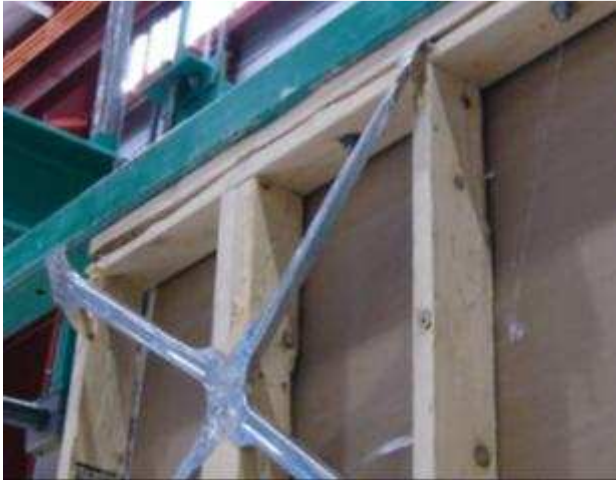
Figure 21 – Withdrawal failure of web members (Specimen K)

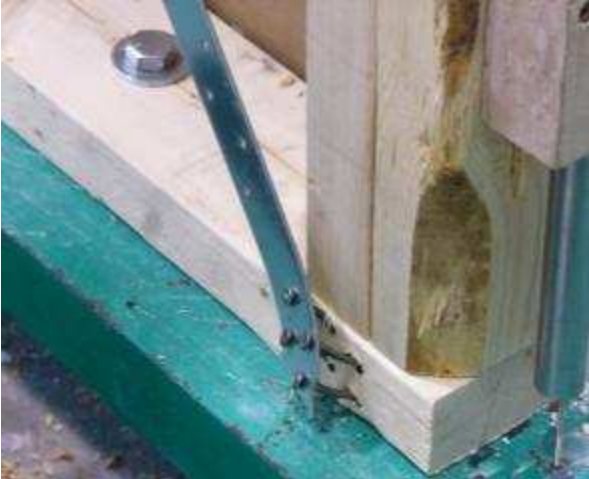
Figure 22 – Withdrawal failure of metal brace (Specimen M)

The purpose of Specimen M was to establish baseline performance for a typical diagonal metal strap brace. A basic 1.25-inch, 16-gauge pre-cut strap manufactured by USP Structural Connectors was installed per the manufacturer's instructions [7] at a 60° angle. The strap was attached using (4) 8d common nails at the top and bottom plates and a single 8d common nail at each intermediate stud. This baseline specimen was tested in tension and reached a peak unit shear of 427 lb/ft with a nail withdrawal primary failure mode at the strap ends as shown in Figure 22.

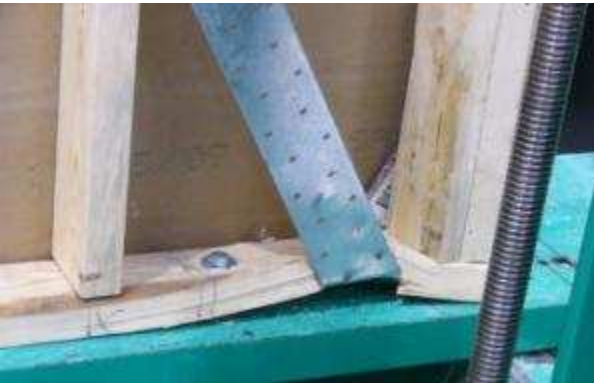
Figure 24 – Flexural and cross grain failure of bottom plate (Specimen N)

In an effort to preclude this failure mode, Specimen N was constructed using a longer and wider metal strap supplied in a coil. The strap was cut to length to allow the brace to be wrapped around the top and bottom plates of the wall specimen as shown in Figure 23. The brace was attached to wall framing at each end with a total of (6) 8d common nails: (2) nails into the interior face of the plate, (2) nails into the wide face of the plate, (1) nail into the exterior face of the plate, and (1) nail into the exterior face of the double end stud. (2) 8d common nails were also installed at each intermediate stud. The peak unit shear in tension for this wrapped metal strapping was 685 lb/ft, a 60% increase in capacity over the baseline metal strap capacity. The primary failure mode was a flexural and cross-grain bending failure of the bottom plate in the stud bay where the brace was attached (Figure 24). This bracing option, however, proved difficult from a constructability standpoint due to the heavier gauge of the product and its resistance to bending around the plates of the wall. The cross-grain bending induced by wrapping the brace around the plates is also a concern.

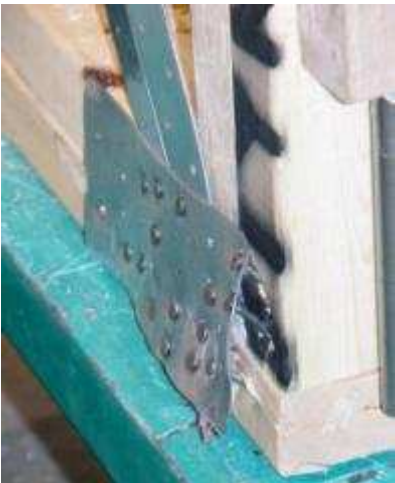
Figure 26 – Withdrawal failure of metal brace (Specimen O)

Specimen O was tested to evaluate the performance of two 1.25-inch straps installed side by side and reinforced at each end with mending plates and additional nailing. The straps were installed with a total of (14) 8d common nails at each end: (4) nails through the mending plate and each brace into the top (or bottom) plate of the wall and (6) nails through only the mending plate into the top (or bottom) plate (Figure 25). The braces were also attached to each intermediate stud with (2) 8d common nails per brace. Specimen O reached a peak unit shear in tension of 804 lb/ft and displayed nail withdrawal at the bottom end of the brace as its primary failure mode (Figure 26). Some degradation of the gypsum sheathing connections was also observed at the bottom edge of the wall. The peak unit shear of Specimen O was an increase of 90% over the baseline strap results and also exceeds the 700 lb/ft upper bound shear strength in the current IRC [2].

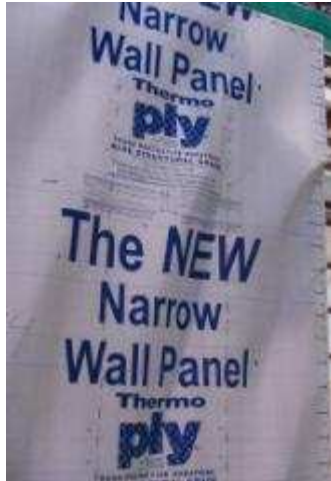
Figure 27 – Buckling failure of sheathing (Specimen P)

Specimen P was tested to provide the baseline performance of the Thermo Ply® sheathing attached to 24-inch on center framing without the SPF insulation in the cavities. It should be noted that Thermo Ply® sheathing is currently qualified as an alternative bracing option per ICC-ES Evaluation Report ESR-1122 [8] for use with wall framing at 16 inches on center or less. The purpose of this testing was to evaluate the 24-inch on center configuration due to its improved thermal characteristics. The Thermo Ply® sheathing was fastened to framing per the manufacturer’s instructions using 16 gage staples spaced at 3 inches on center around the panel perimeter and in the panel field. Specimen P attained a peak load of 4,687 lb (586 lb/ft) and displayed sheathing buckling as its primary failure mode (Figure 27).

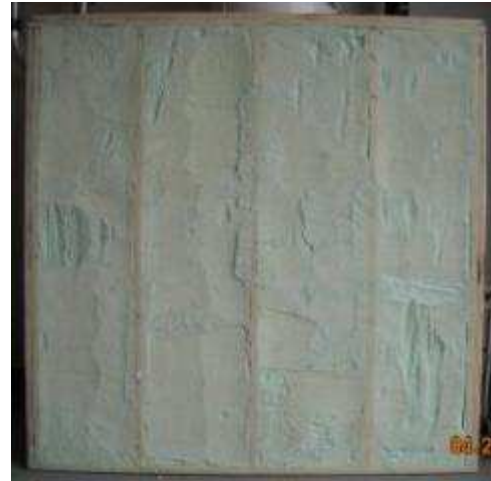
Figure 28 – Full cavity SPF application (Specimen Q)

Specimen Q was tested to measure the contribution from a full cavity application of closed-cell, high-density SPF insulation. Each stud bay was completely filled with SPF insulation and any excess was removed using a hand saw to keep the interior surface of the insulation flush with the interior face of the wall framing (Figure 28). Specimen Q achieved a peak load capacity of 8,881 lb (1,110 lb/ft), an increase of 89% over the baseline (Specimen P). The primary failure mode of Specimen Q was fastener tear through the sheathing along the top of the wall (Figure 29). There was also some slight separation of the SPF insulation from the studs (Figure 30). No fastener failure was observed at the bottom of the wall, indicating that the insulation added sufficient strength and stiffness to the wall to force an isolated shear failure of the connection between the sheathing and the top plate of the wall. Future efforts on further optimization of this system for IRC applications would include increasing fastener spacing to 4 or 6 inches on center.

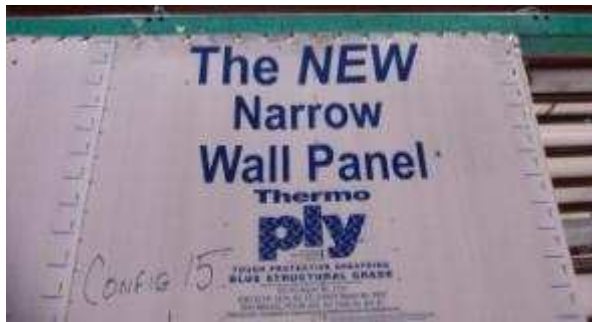
Figure 29 – Fastener failure of sheathing (Specimen Q)

- 14) Application of high density, closed cell spray foam insulation in combination with Thermo Ply® sheathed wall greatly increases the unit shear capacity compared to a similarly sheathed wall with no SPF insulation. Test specimens with closed cell SPF in a full cavity application achieved 89% higher unit shear capacities (1,110 lb/ft) versus the baseline Thermo Ply® sheathed specimen (586 lb/ft). The failure mode was also altered compared to the baseline test; the baseline test exhibited sheathing panel buckling, whereas the full cavity SPF insulated specimen exhibited fastener failure along the entire top plate.

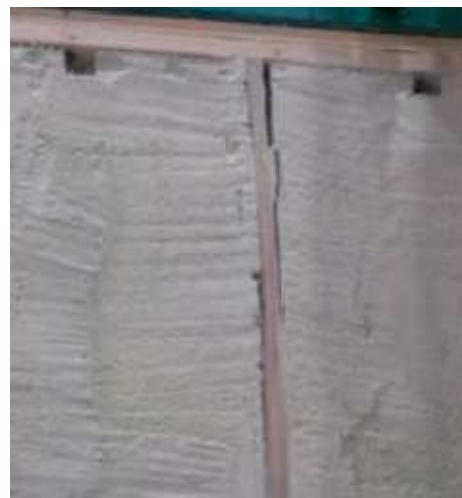
Figure 30 – Separation of SPF from studs (Specimen Q)

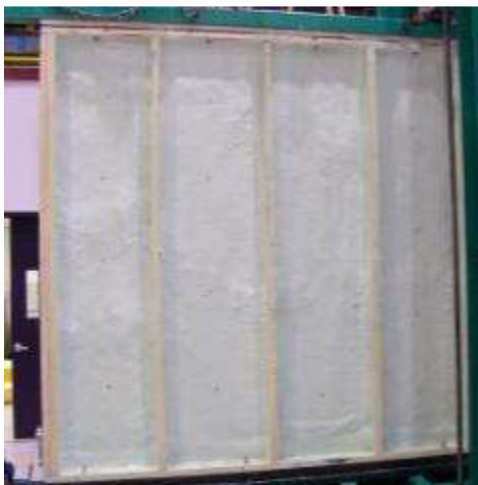
Figure 31 – Flash & batt application of SPF (Specimen R)

The next test (Specimen R) evaluated the contribution of the same closed-cell, high density SPF insulation applied using the “flash and batt” method. Figure 31 shows Specimen R after the application of the SPF insulation. The “flash and batt” method of application consists of a thinly applied layer of spray foam over the entire surface of the stud bays. This layer of SPF is meant as an air sealer as opposed to the primary insulating material. The majority of the insulating value of the wall comes from the batt insulation that is installed in the cavity over the SPF (note: the batt insulation was not installed in the tested specimen to allow for visual observation of the SPF during the testing). In the case of Specimen R, the layer of SPF between the studs ranged from 1/8-inch up to 1.5-inches in depth, with an average depth of 3/4-inch. Specimen R reached a peak load of 6,358 lb (795 lb/ft) with sheathing buckling, followed by fastener pull-through and pull-out failure modes (Figures 32 and 33). This failure behavior was similar to the failure behavior of the baseline test wall; however, Specimen R achieved a 36% increase in peak load compared to the baseline wall. The difference in failure modes between Specimen Q and Specimen R indicates that there may be a minimum depth of SPF insulation less than 3.5 inches that causes the failure mode of Thermo Ply[®] sheathing to change from panel buckling to fastener failure. (A fastener failure mode is assumed to be the strongest limit state for this type of sheathing and thus presumably would yield the highest capacity without increasing fastener spacing). This minimum depth could be found through a small number of additional walls tests at various SPF insulation depths.

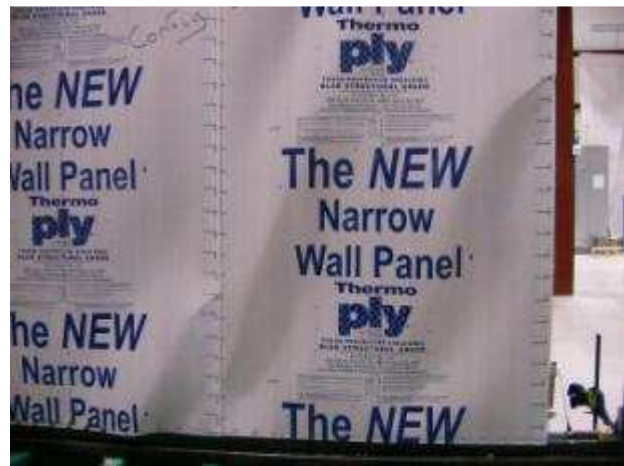
Figure 32 – Buckling failure of sheathing (Specimen R)

- 15) Reducing the amount of closed cell SPF insulation to an average depth of 3/4-inch in each stud cavity by using the “flash and batt” application method resulted in a 36% increase in capacity over the baseline while displaying a sheathing panel buckling failure mode.

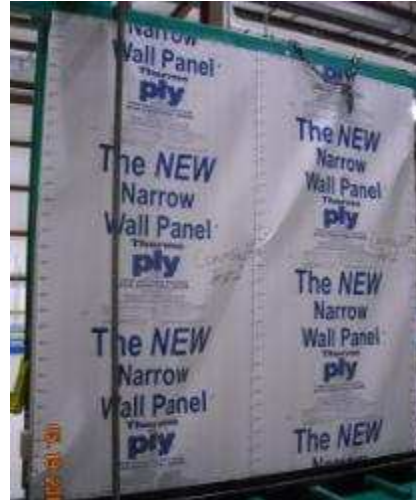
Figure 34 – Buckling failure of sheathing (Specimen S)

Specimen S was tested to evaluate the contribution of low density, open-cell SPF insulation applied to the full depth of the wall cavity. As with the closed-cell SPF, each stud bay was completely filled with the foam and the excess trimmed using a hand saw. The open-cell specimen reached a peak load of 4,980 lb (622 lb/ft), a 6% increase over the baseline test results, indicating that the application of open-cell SPF insulation has a negligible effect on the shear strength of Thermo Ply[®] sheathing. The primary failure mode of Specimen S was also similar to the baseline test failure mode, i.e., sheathing buckling followed by fastener degradation (Figure 34). The SPF foam did not separate from the studs as seen in the previous full cavity specimen. Instead, separation occurred between the foam and the sheathing in the first bay of the wall (Figure 35). This change in behavior is attributed to the lower stiffness and tensile strength of the open-cell foam which allowed it to deform as the wall deformed, but prevented it from restraining the sheathing from out-of-plane buckling.

- 17) The addition of low density, open cell SPF insulation applied to the full depth of the stud cavity provided only a marginal 6% improvement over the baseline tests and did not change the failure mode of the specimen.

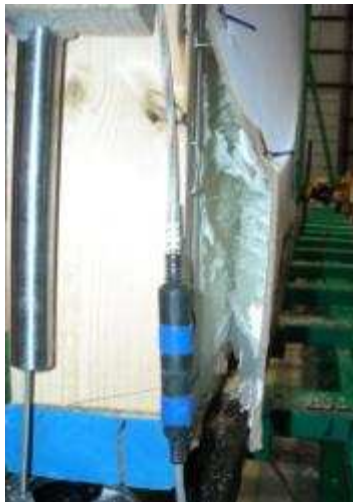
Figure 35 – Separation of SPF from sheathing (Specimen S)
