Evaluation of the Lateral Performance of Roof Truss-to-Wall Connections in Light- Frame Wood Systems

Prepared for
Forest Product Laboratory, Forest Service, U.S. Department of Agriculture
National Association of Home Builders

Prepared by
NAHB Research Center, Inc.
400 Prince George's Boulevard
Upper Marlboro, MD 20774

August 8, 2011

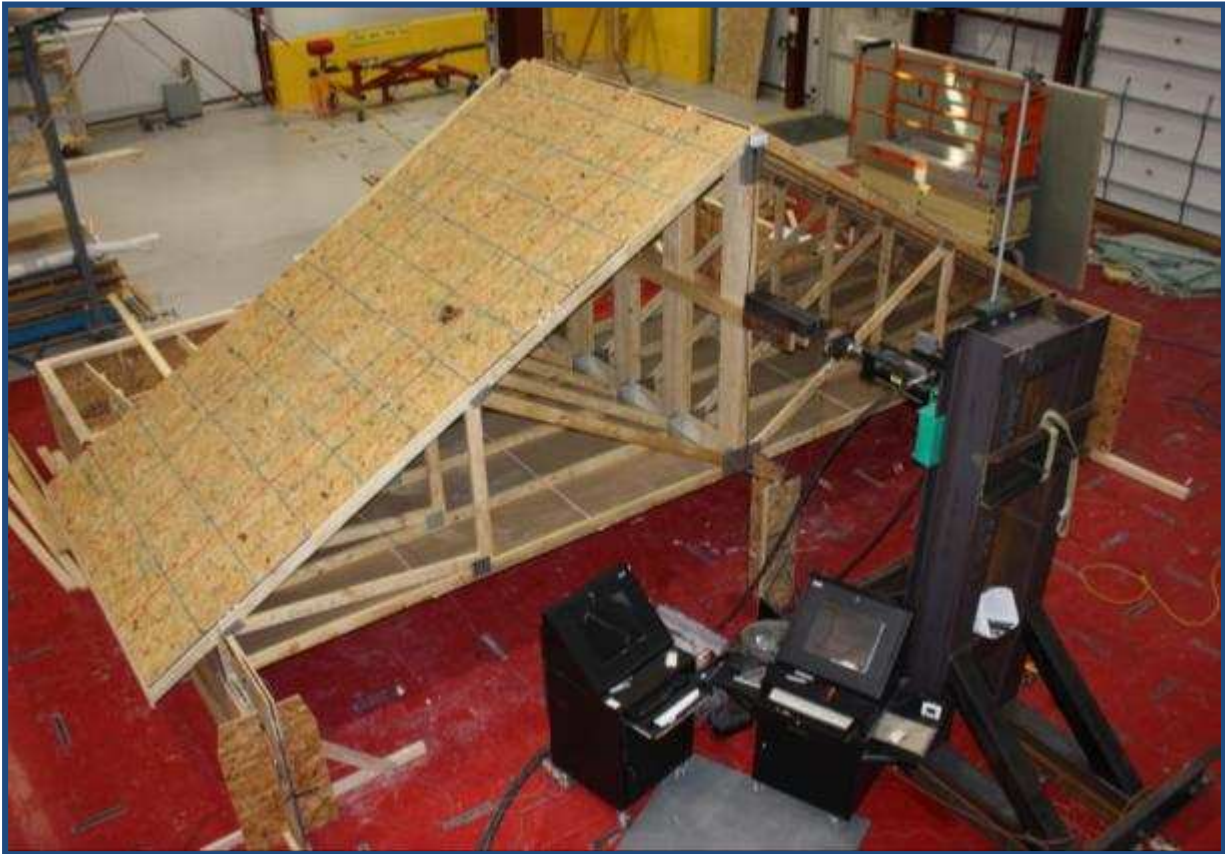
Figure 8 – Photo of test setup

Figure 7 shows the test set-up including the specimen, loading brace, and instrumentation. Figure 8 provides a photograph of the test set-up, reaction frame, and data acquisition system.

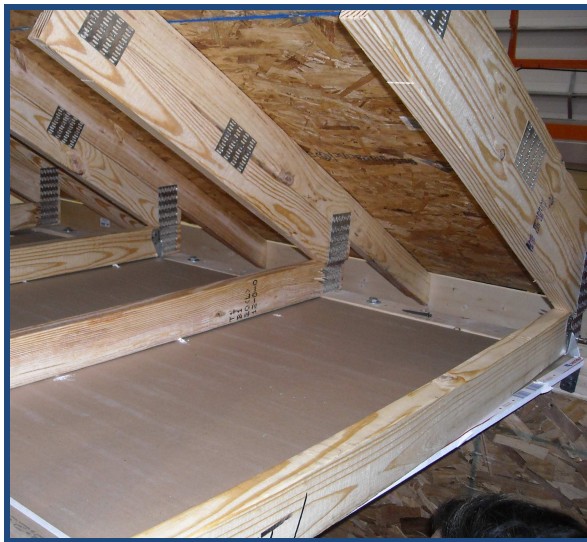
Figure 11 – Gypsum fastener tear-through (Specimen A)

Specimens A through C were intended to establish baseline capacities and performance characteristics for low- and high-heel roof systems without blocking or bracing the truss heel. The low-heel truss configuration (Specimen A) represents the highest allowable heel height by code that does not require blocking. Specimen A achieved a peak load of 5,140 lb (peak unit capacity of 255 lb/ft) and initial stiffness of 8,828 lb/in. Failure of Specimen A included initial fastener tear-through at the outer ends of the ceiling diaphragm near the knee walls followed by complete failure of the fasteners in the center gypsum panel (see Figures 11 & 12). Only minor rotation of the truss heels was observed during testing as well as minor rotation and buckling of the hurricane clips (Figure 13). Minor displacement of the truss top chord relative to the bottom chord at the heel joint was also observed; along with slight deformation of the metal connector plate at the heel joint (Figure 14).

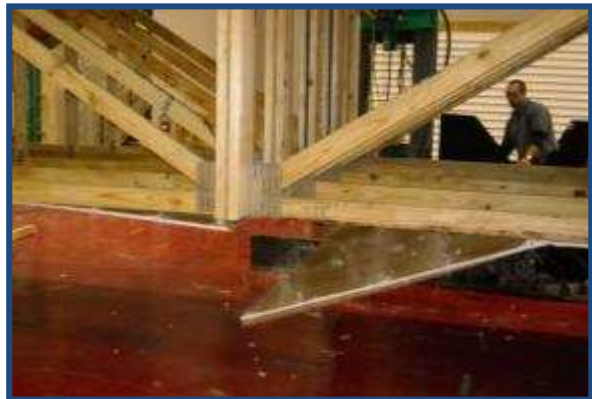
Figure 12 – Complete failure of gypsum fasteners (Specimen A)

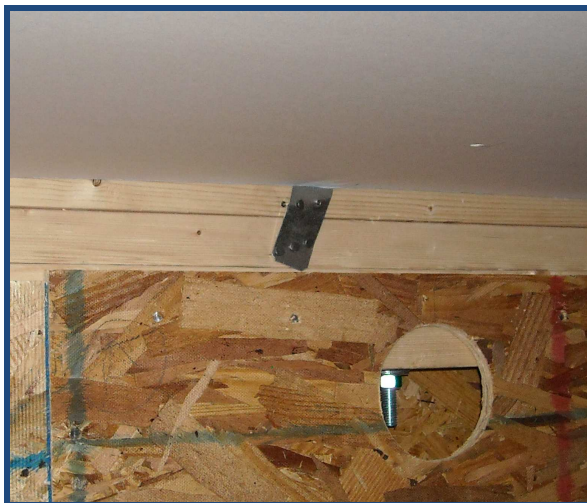
Figure 13 – Rotation of hurricane clip at failure (Specimen A)

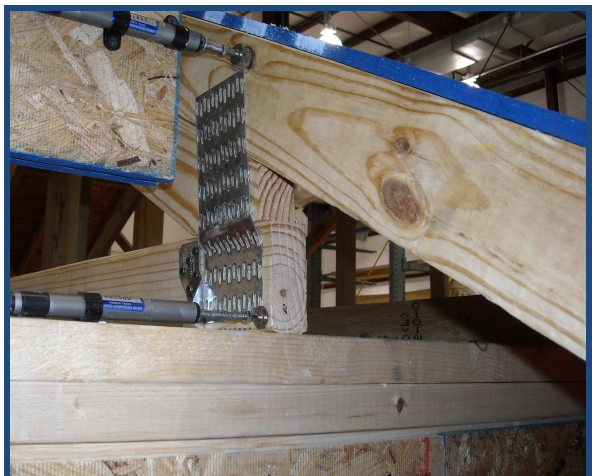
Figure 14 – Truss member displacement and metal connector plate deformation at heel joint (Specimen A)

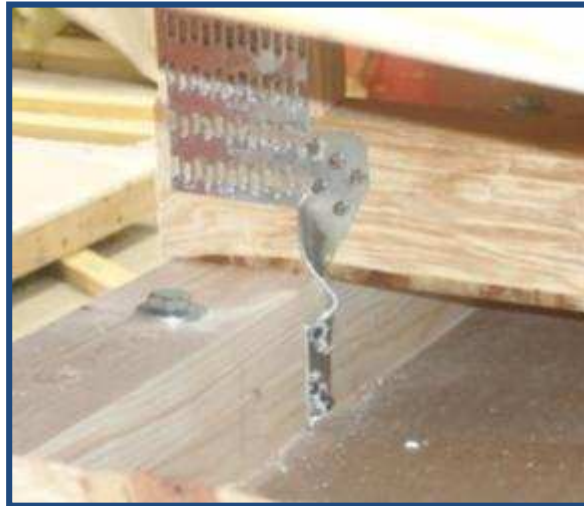
Figure 15 – Buckling of hurricane clip (Specimen C)

Specimen C was designed to evaluate the effect of a lower roof slope on the performance of the truss-to-wall connections. Specimen C was similar in construction to Specimen B and reached a peak capacity of 3,780 lb (peak unit capacity of 190 lb/ft) and initial stiffness of 3,950 lb/in. Specimen C exhibited similar damage and failure modes as Specimen B (i.e., gypsum fastener tear-through, significant rotation observed at truss heel). Additional damage was also observed in the form of buckled hurricane clips (Figure 15) and member separation at the heel joint metal plate connectors. Comparisons of both peak capacity and initial stiffness values between Specimen B (7:12 roof slope) and Specimen C (3:12 roof slope) yields a less than 10% difference in strength and stiffness performance between the two specimens, indicating that the degree of roof slope has a minimal effect on heel connection performance. Figure 16 provides a photo of the truss rotation observed in Specimen C at failure.

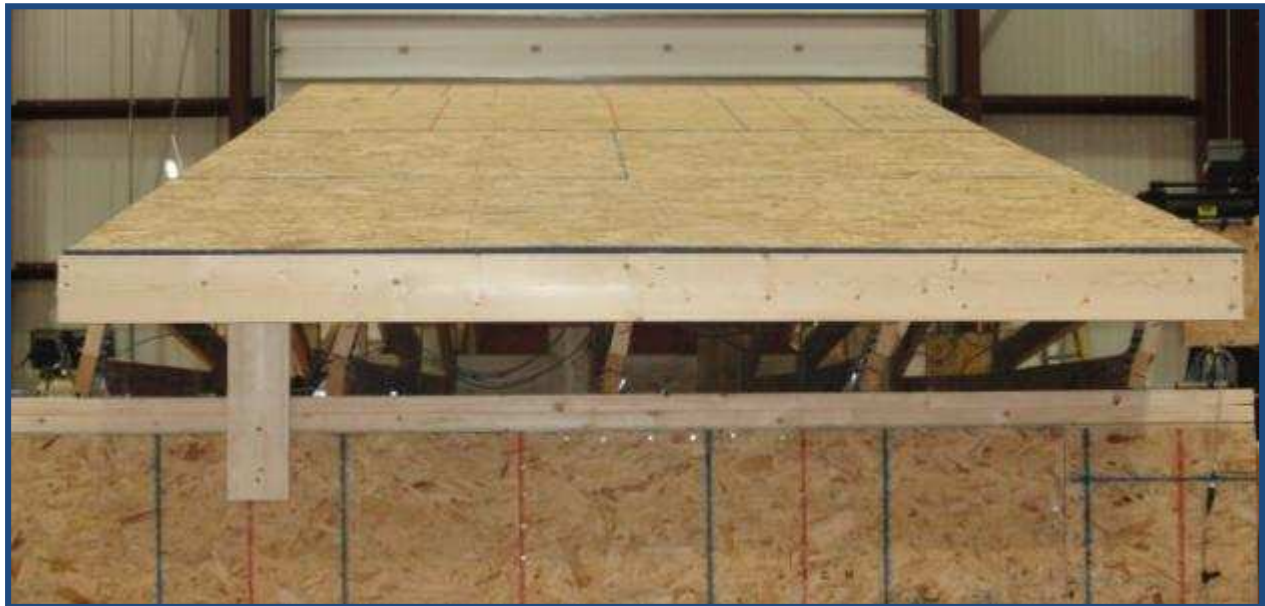
Figure 16 – Specimen C heel rotation at failure

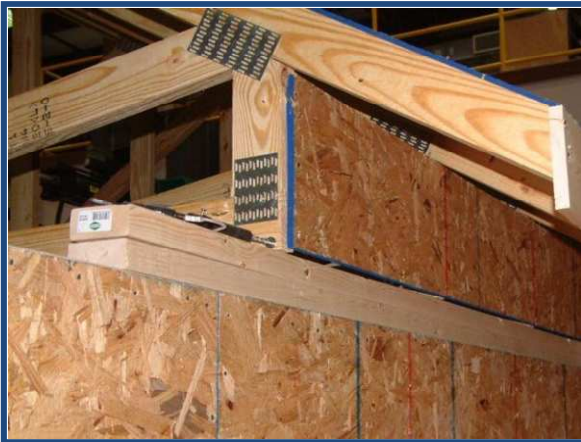
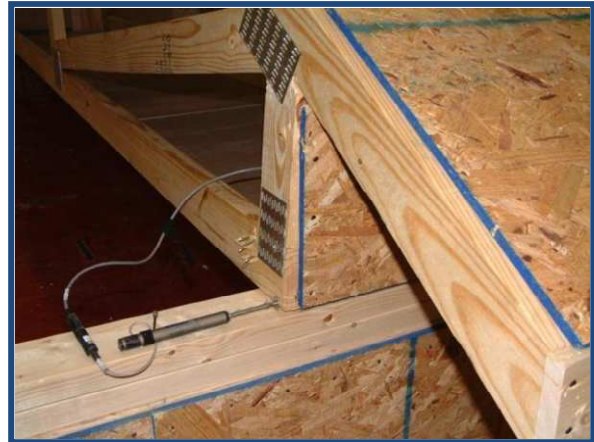
(a) Before test

(b) Post testing

Figure 17 – Comparison of rotation at Truss 5 (Specimen D)

occurred at the edges of the OSB bracing strip. The bracing of heel joints with OSB was also effective in controlling rotation of the truss. See Figure 17 for a comparison of the truss heel position prior to testing and after gypsum failure. Specimen E exhibited the same failure modes as Specimen D while achieving a peak capacity of 4,760 lb (or a peak unit capacity of 240 lb/ft) and initial stiffness of 32,224 lb/in. While this peak capacity from Specimen E is 7% less than the peak capacity of the low-heel configuration (Specimen A), the additional nailing of the OSB bracing strip to the supporting wall below in Specimen E increased the initial stiffness of the specimen threefold over both the OSB bracing strip without top plate nailing and the benchmark low-heel specimen (3.1 times and 3.6 times greater, respectively).

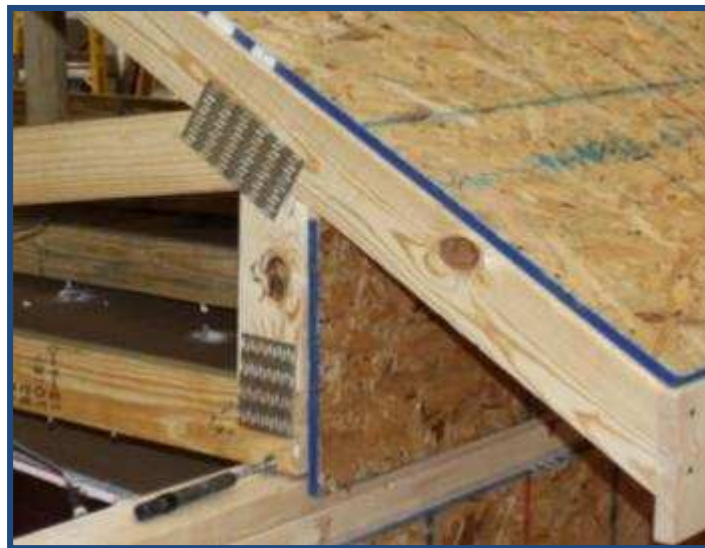
Figure 18 – Truss rotation of Specimen E at failure (Truss 5)

Specimens D and E were designed to investigate the contribution of OSB sheathing installed on the exterior face of the truss heel. The OSB sheathing in Specimen D was not attached to the top plates of the supporting knee walls and only provided rotational restraint to the truss heel. The OSB strip in Specimen E was extended down and nailed to the upper member of the wall double top plate, and as such provided both a rotational restraint for the trusses as well as an additional load transfer mechanism from the trusses to the supporting wall. Specimen D reached a peak capacity of 4,340 lb (peak unit capacity of 220 lb/ft) and an initial stiffness of 10,395 lb/in. This peak capacity is a 26% increase over the capacity of Specimen B and only 16% less than the peak capacity of the low heel configuration. The increase in performance due to the OSB bracing strip is also evident when comparing initial stiffness values; the addition of the OSB bracing strip increased the initial stiffness by 18% over the low-heel baseline specimen and by a factor of 2.3 over the unblocked high-heel baseline specimen. The primary failure mode was again fastener failure in the gypsum panels. Some fastener tear-through

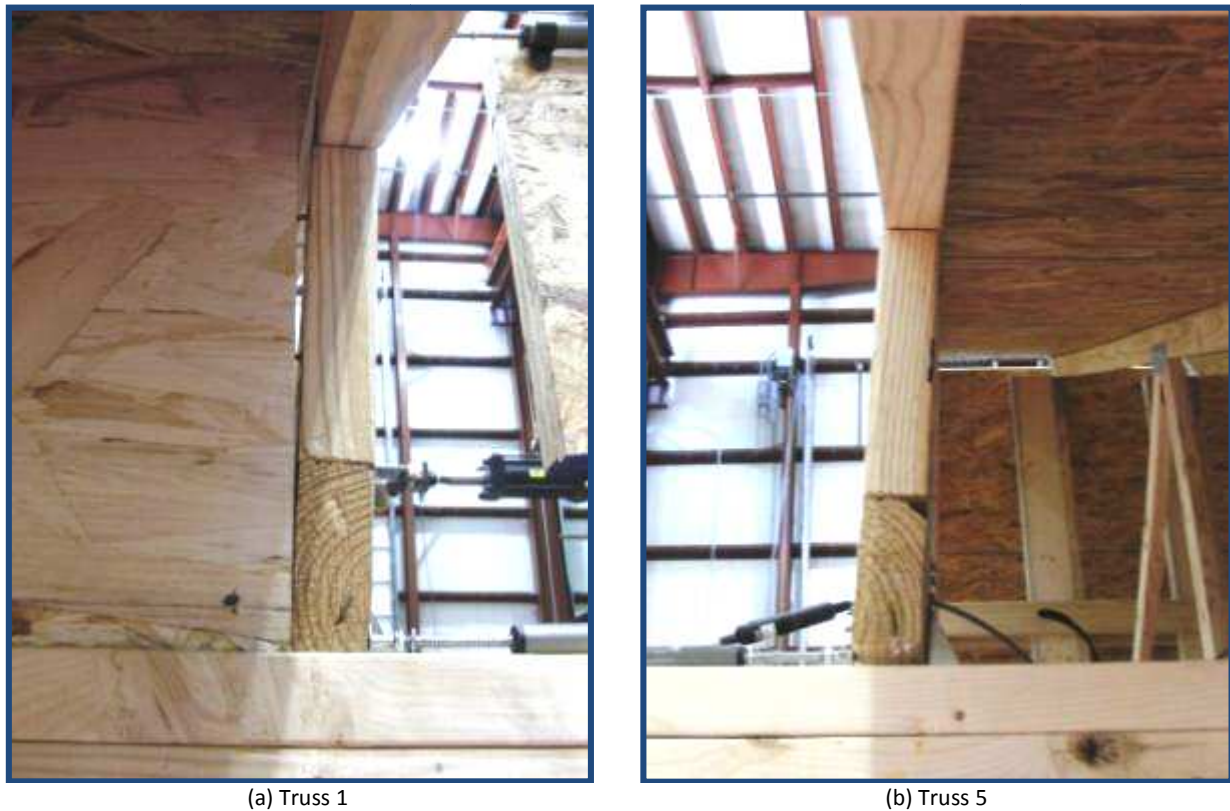
(a) Truss 1 (b) Truss 5
Figure 19 – Comparison of truss heel rotation (Specimen F)

observed and described for previous specimens. The same moderate rotation was observed at both the front two trusses (where blocking was installed) and the fourth (where no blocking was installed). This visual observation was confirmed through displacement measurements at both locations indicating that the single blocked bay provides rotational restraint to the entire specimen (i.e., the effect of the blocking is not localized). Figure 19 shows a comparison of the rotation of the first and last trusses.

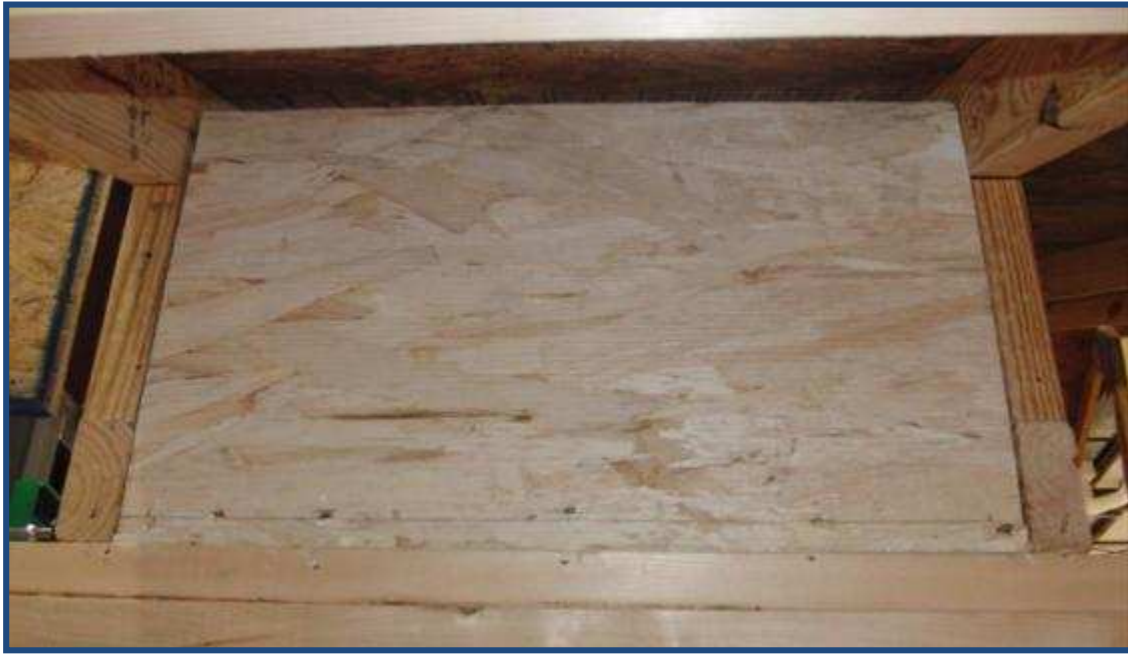
Figure 20 – Rotation of truss heel at blocking location (Specimen G)

The 50% blocked specimen (Specimen G) reached a peak load of 4,520 lb (unit peak capacity of 225 lb/ft) and an initial stiffness of 26,581 lb/in and exhibited similar failure modes as Specimen F, including the primary failure mode of gypsum fastener tear-through. Some rotation of the trusses relative to the blocking panels was also observed, as shown in Figure 20. When compared to the tested benchmark capacities of Specimens A and B, the 50% blocked specimen exhibited a 28% increase in capacity over the unblocked high-heel specimen and showed a 12% decrease in capacity compared to the unblocked low-heel specimen. Interestingly, the addition of the second blocking panel only resulted in a 12% increase in stiffness over the 25%-blocked specimen (Specimen F). Both blocked specimens, however, exceeded the low-heel baseline configuration by more than a factor of 2.5.
