Addendum to the May 2018 Report “Moisture Performance of High-R Wall Systems” by Home Innovation Research Labs

September 2018

Purpose

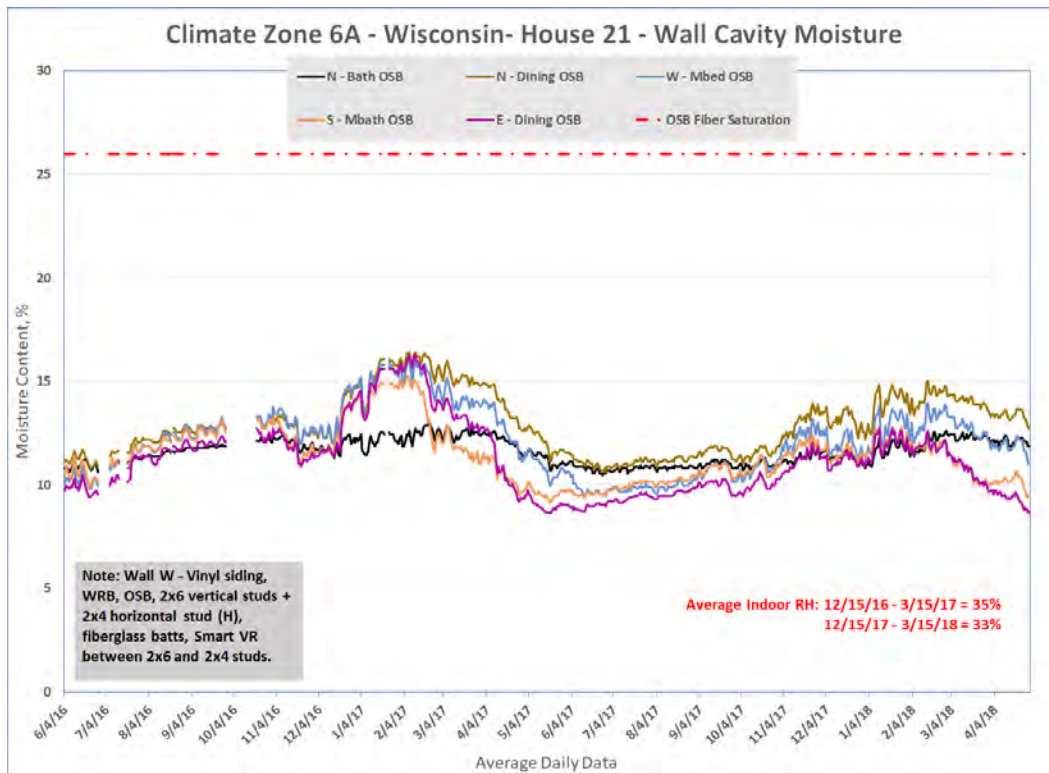
- The interior RH levels during the winter season were 38% on average for the first winter and 42% for the second winter. This is within the range observed in this and other monitoring studies for this climate zone.

- The interior paint was at 16 perm (dry-cup)—above the upper limit for a Class III vapor retarder. The house wrap is also highly permeable (54 perm). This wall is effectively a vapor-open wall with the ability to dry toward indoors and outdoors. As a result, the OSB dried out quickly as the outdoor temperatures began to rise in March.

Figure A26. OSB sheathing moisture content for Climate Zone 6A, Wisconsin (1), House 21

- Field quality control measures are recommended to ensure that the specified spray foam product is installed. Although spray foam is often selected for its insulative and air sealing characteristics, its vapor permeability is an important property for the entire wall or roof system.

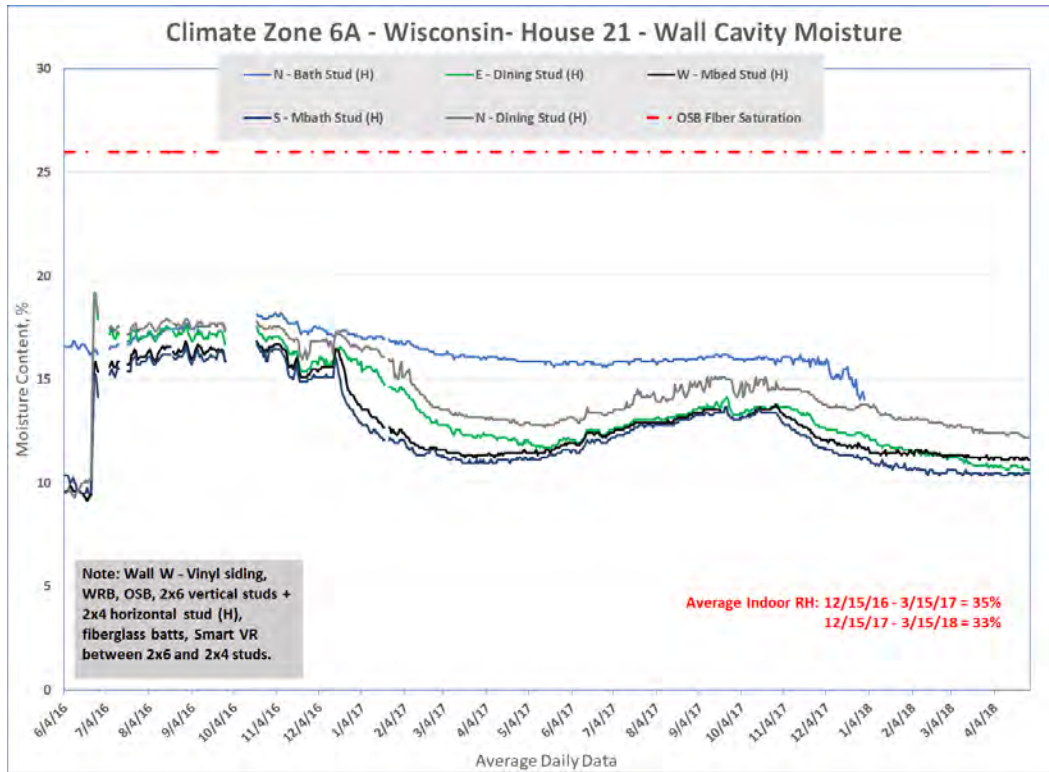
Figure A27. Studs (outside of the vapor retarder) moisture content for Climate Zone 6A, Wisconsin (1), House 21

- The OSB moisture content is stable with a muted seasonal trend raising from 9-11% summer levels to as high as 15-16% during heating seasons.
- The moisture content of studs located outside of the smart vapor retarder ranges trending down over the entire course of the monitoring period from about 16-18% initially to 10-12% following a somewhat unique pattern. The observed shape of the curve is likely the result of the smart vapor retarder limiting drying to the inside that would be present in a more traditional wall. The sensors in the south and west orientation indicate quickest drying – due to solar drive promoting drying to the outside.

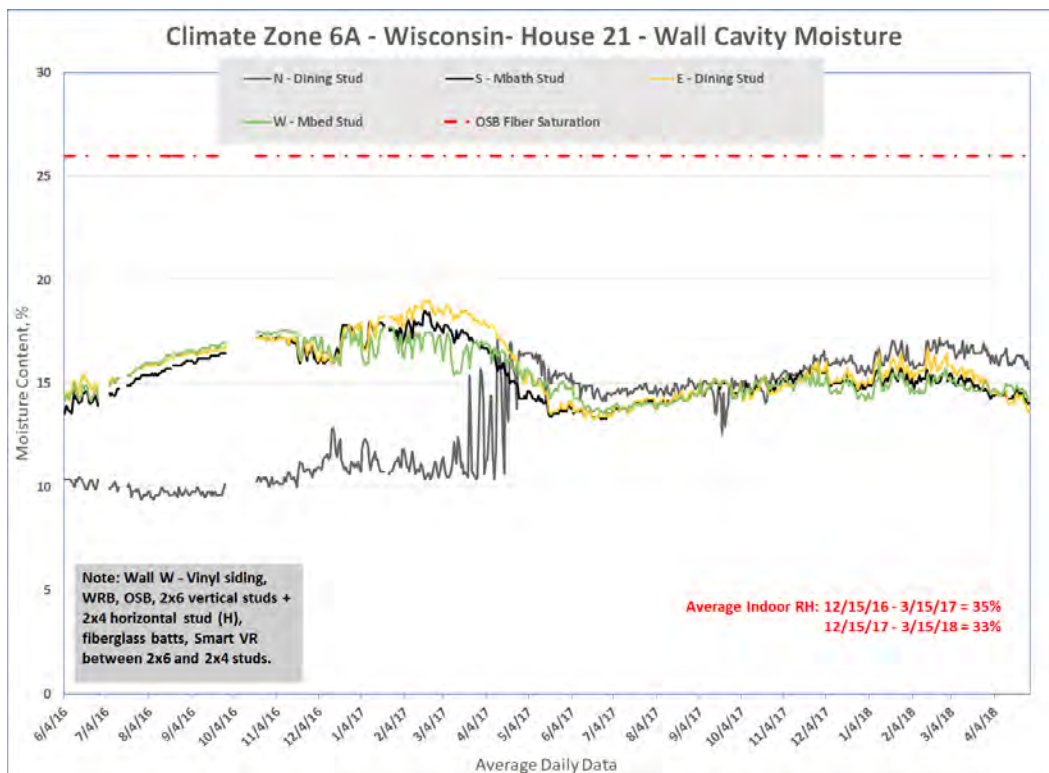
Figure A28. Studs (inside of the vapor retarder) moisture content for Climate Zone 6A, Wisconsin (1), House 21

- The moisture content of framing located inside of the smart vapor retarder ranges fluctuates between 14% and 19% following a more typical seasonal pattern with upward trends during the heating season. This performance is consistent with the framing reacting to the vapor drive from the inside of the building.

- Overall, this unique wall shows stable behavior with moisture levels well below the fiber saturation point.
- ~~• Wall W is a unique system that effectively consists of two walls—an exterior 2x6 wall and an interior 2x4 wall—separated by a sheet of a smart vapor retarder. Both walls are insulated with fiberglass batts.~~

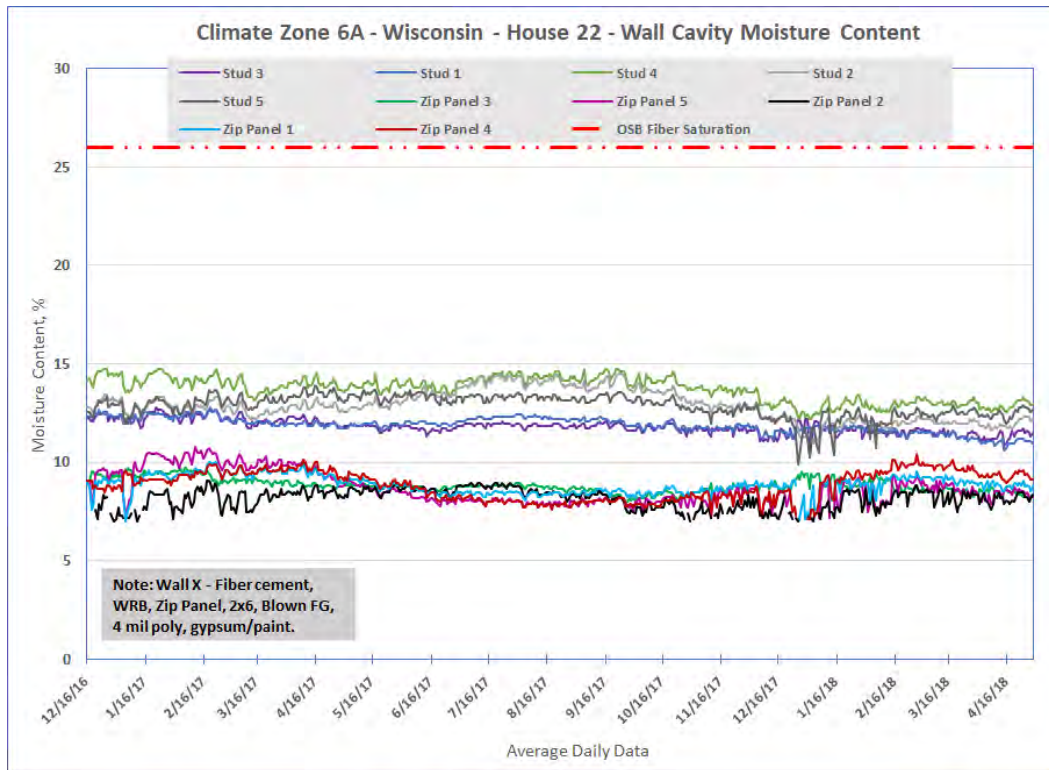
Figure A29. OSB sheathing and stud moisture content for Climate Zone 6A, Wisconsin (2), House 22

Figure A29 shows the summary results for the ZIP sheathing and stud daily moisture content for House 22, located in Wisconsin, Climate Zone 6A. The following observations can be made:

- As with other walls with polyethylene as an interior vapor retarder, the moisture content levels were very stable throughout the entire monitoring. No fluctuations were observed during the winter or spring in studs or ZIP panels, even as the outdoor winter temperatures dropped as low as -94°F in the winter.

- There is a delineation between the OSB and stud moisture levels. OSB oscillated around or less than 10%, and lumber was in the range of 12%–15%. Unlike many other wall assemblies, the OSB moisture content was lower than the framing moisture content. This behavior is likely because the wall is vapor closed and airtight and was able to keep the moisture levels of the materials at the same level as at the time of installation. Note that vapor permeability of the ZIP panels was-is lower than that of the OSB and fiber cement is an unvented cladding.

- The data indicates that the materials were not subjected to moisture during installation. At the time when walls were enclosed and the monitoring period began all sensors were at below 15% moisture content. This is an important consideration for this wall assembly. Enclosing this wall assembly after a rain event would likely lead to extended period of elevated moisture levels inside the wall as there is no clear drying path.

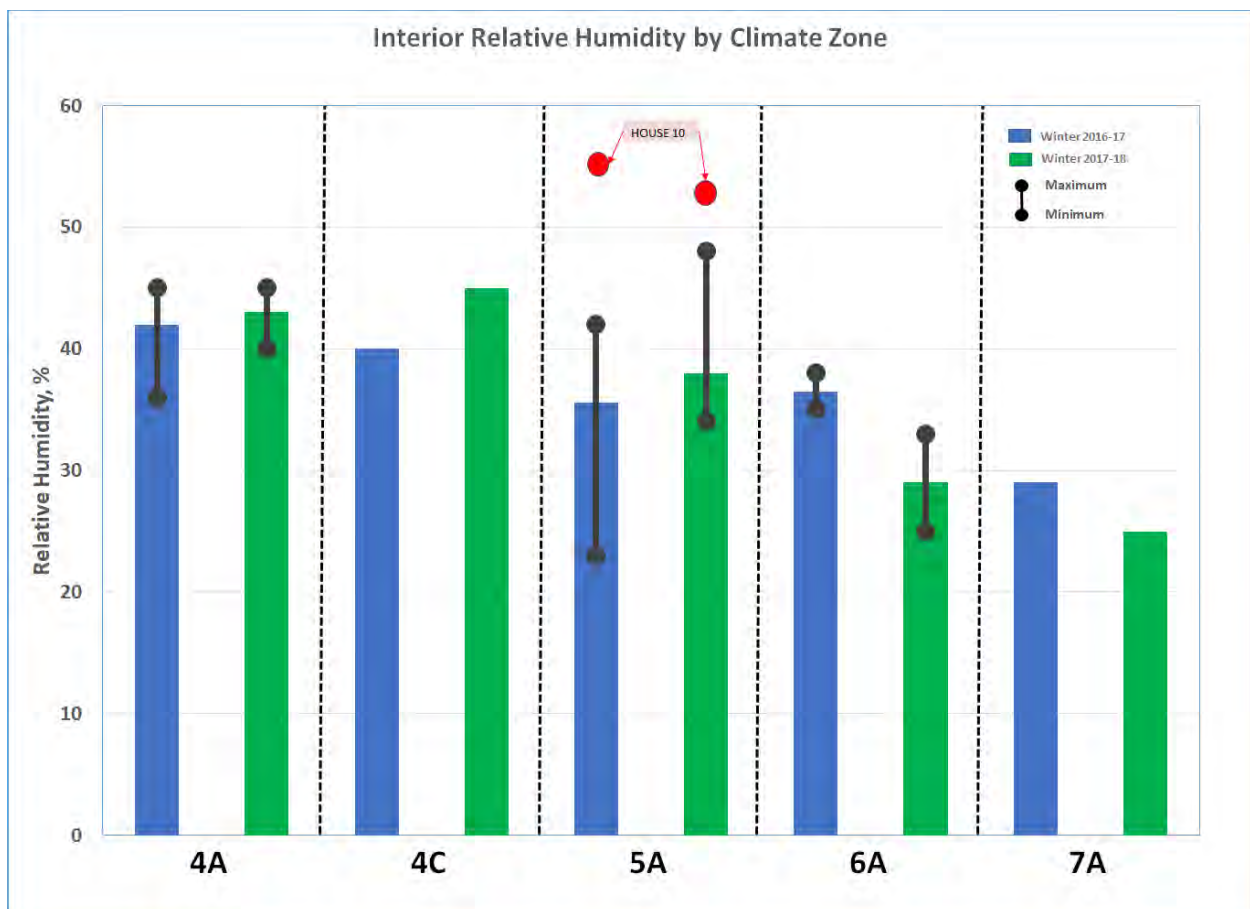
The average RH level remained at less than 45% for all homes with the majority of homes at below 45%. Therefore, the combinations of the building enclosure, ventilation system, and occupant behavior in all monitored homes resulted in acceptable interior RH levels. The observed levels were generally consistent with the levels measured in previous studies.

One outlier is House 10 in Climate Zone 5A. This is the only house in the study that is a renovation rather than new construction. A new addition to this existing house was monitored. The owner also indicated that they were running a humidifier. The interior RH averaged in the low to mid 550s% during the winter and peaked at 62% each time. Although this is an older housea renovation, the more likely cause of the elevated RH levels is the humidifier.

Figure A31. Summary: seasonal peak and averages moisture content of rim joists
