Performance of Windows in Walls With Continuous Insulation

March 2023

Partnership for Home Innovation
Home Innovation Research Labs
400 Prince George's Blvd.
Upper Marlboro, MD 20774

John Peavey and Nay Shah. 2023. Performance of Windows in Walls With Continuous Insulation. Upper Marlboro, MD. DOE/GO-102023-5719. www.nrel.gov/docs/fy23osti/82494

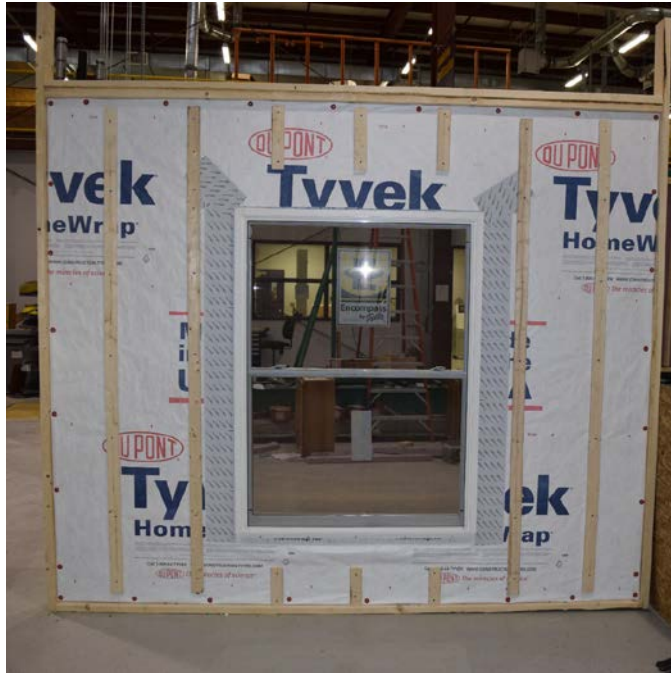
Figure 22. Housewrap and OSB – Single DH

Test Protocols	Observations
Initial water penetration resistance test	Leakage to interior face was observed at 3.76 psf for the step portion of the water penetration resistance test. The leakage was present at the sill region.
Temperature cycling	No leakage observed during the cyclic water test.
Service-condition loading	No deformation or degradation of window observed.
Service-conditioned water penetration resistance test	Leakage to interior face was observed at 3.76 psf for the step portion of the water penetration resistance test. The leakage was present at the sill region. No leakage observed during the cyclic water test.
Vertical displacement monitoring	No movement was observed. 0.0"
Final water penetration resistance test	No leakage observed during any of the water penetration resistance tests.
Structural performance test	Window opens and closes properly. No damage to window or WRB.

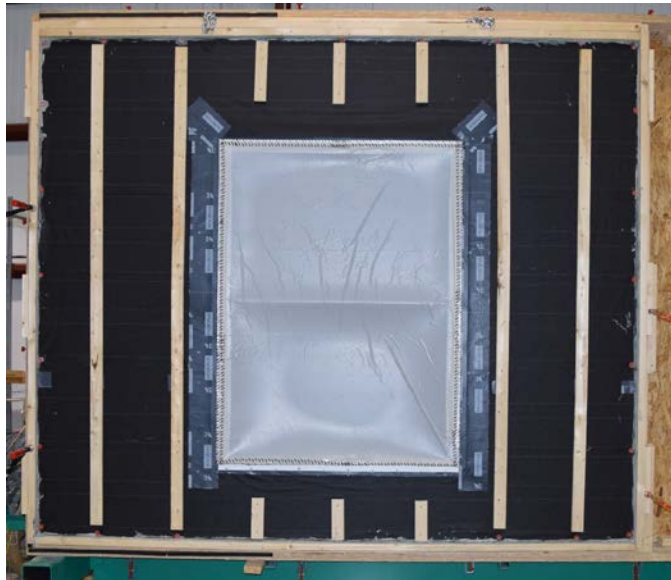
Figure 23. #15 Felt and OSB Undergoing Structural Performance Test

Structural performance test	Window opens and closes properly. No damage to window or WRB.

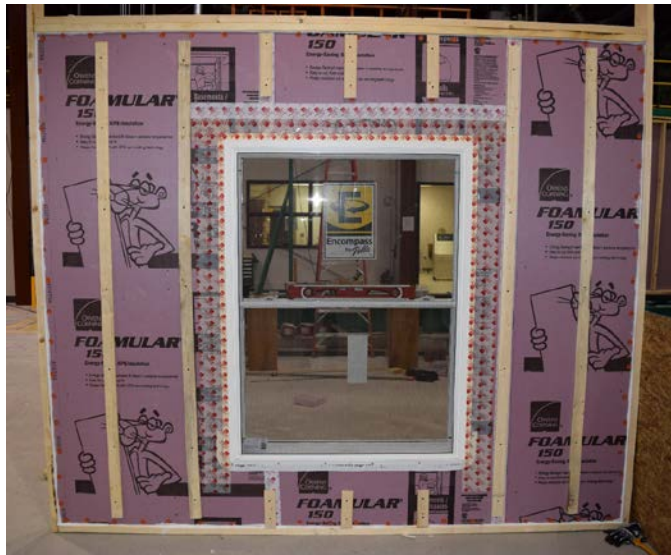
Figure 26. 1 in. of 15-psi XPS and OSB - Single DH

Structural performance test	Positive direction: No deformation or degradation of window observed. Negative direction: The top sash of the double-hung window slides down after it is unlocked. The counterbalance mechanism disengages from the balance key causing the top sash to slide down.

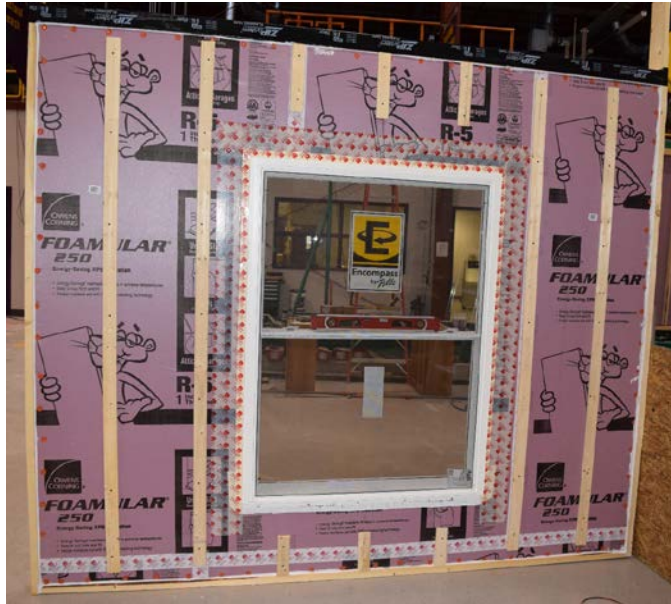
Figure 27. 1 in. of 25-psi XPS and OSB - Single DH

Test Protocols	Observations
Initial water penetration resistance test	Water bubbling under the sill at 5.43 psf for the step portion of the water penetration resistance test. No water bubbling or leakage observed during the cyclic water test.
Temperature cycling	No deformation or degradation of window observed.
Service-condition loading	No deformation or degradation of window observed.
Service-conditioned water penetration resistance test	Water bubbling under the sill at 5.43 psf for the step portion of the water penetration resistance test. No water bubbling or leakage observed during the cyclic water test.
Vertical displacement monitoring	Maximum total displacement: 0.025 in.
Final water penetration resistance test	Water bubbling under the sill at 5.43 psf for the step portion of the water penetration resistance test. No water bubbling or leakage observed during the cyclic water test.
Structural performance test	Positive direction: No deformation or degradation of window observed. Negative direction: The top sash of the double-hung window slides down after it is unlocked. The counterbalance mechanism disengages from the balance key causing the top sash to slide down.

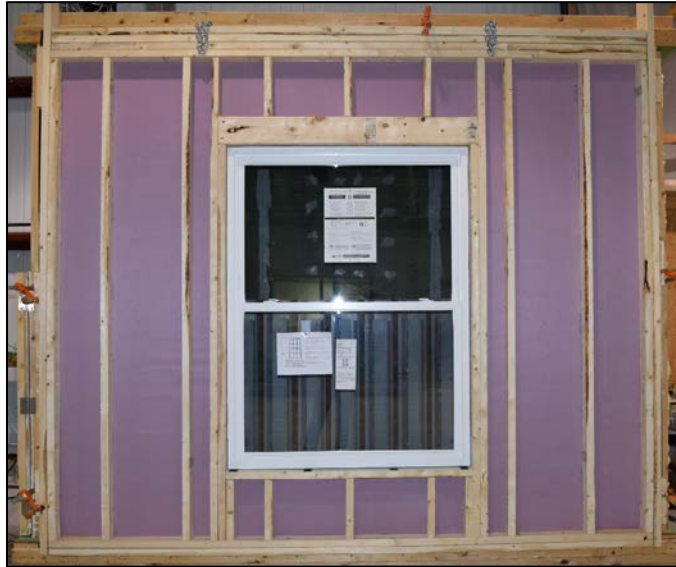
Figure 28. 1 in. of 25-psi XPS and No OSB - Single DH

Structural performance test	Positive direction: No deformation or degradation of window observed. Negative direction: The top sash of the double-hung window slides down after it is unlocked. The counterbalance mechanism disengages from the balance key causing the top sash to slide down.

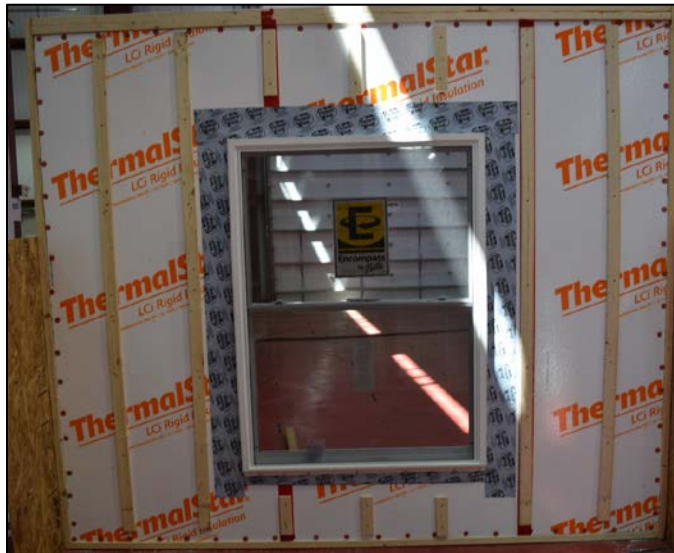
Figure 29. 1 in. of 15-psi EPS - Single DH

Test Protocols	Observations
Initial water penetration resistance test	Water bubbling under the sill at 5.43 psf for the step portion of the water penetration resistance test and the cyclic water test.
Temperature cycling	No deformation or degradation of window observed.
Service-condition loading	No deformation or degradation of window observed.
Service-conditioned water penetration resistance test	Water bubbling under the sill at 5.43 psf for the step portion of the water penetration resistance test and the cyclic water test.
Vertical displacement monitoring	Not applicable. Vertical displacement monitoring was not performed on this wall specimen based on results from other wall specimens.
Final water penetration resistance test	Not applicable. Vertical displacement monitoring not performed
Structural performance test	Positive direction: No deformation or degradation of window observed. Negative direction: The top sash of the double-hung window slides down after it is unlocked. The counterbalance mechanism disengages from the balance key causing the top sash to slide down.

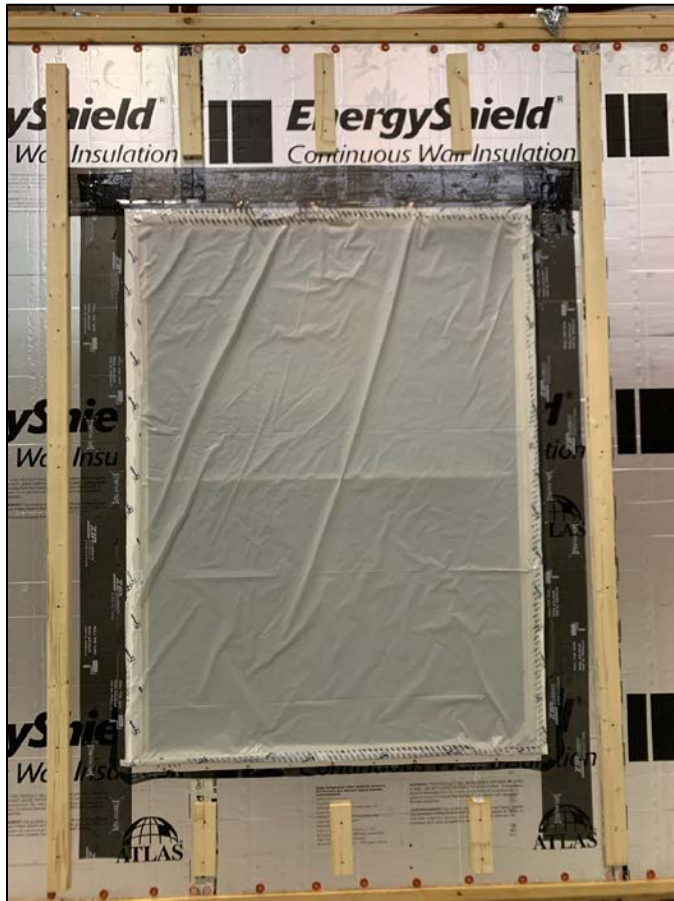
Figure 30. 1 in. of 16-psi PIR - Single DH

Structural performance test	Positive direction: No deformation or degradation of window observed. Negative direction: The bottom sash of the double-hung window slides down when the window is opened. The counterbalance mechanism disengages from the balance key causing the top sash to slide down.

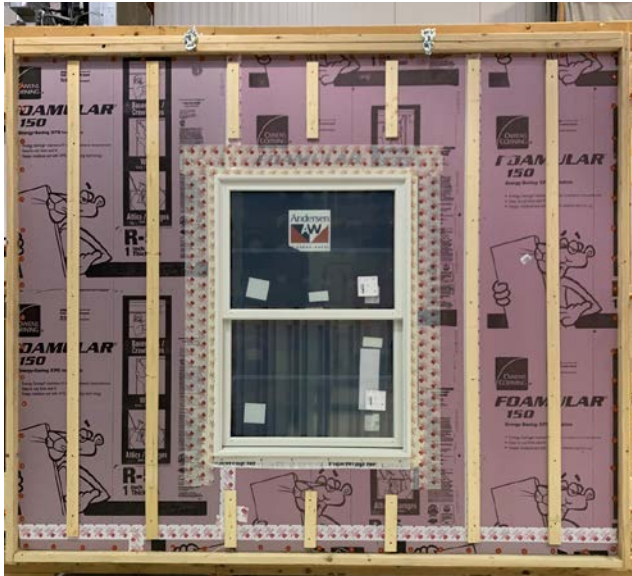
Figure 31. 1 in. of 15-psi XPS - Single DH (Non-Structural Flange)

For Wall 9, the window experienced a structural failure when it was loaded to 24 psf in the positive direction. The window buckled at approximately 23 psf. The window sash had cracks and the sash was displaced from the window frame. Based on the 14 other walls tested, this failure is most likely unrelated to the foam sheathing. It could have been defect/damage caused during production or shipping.

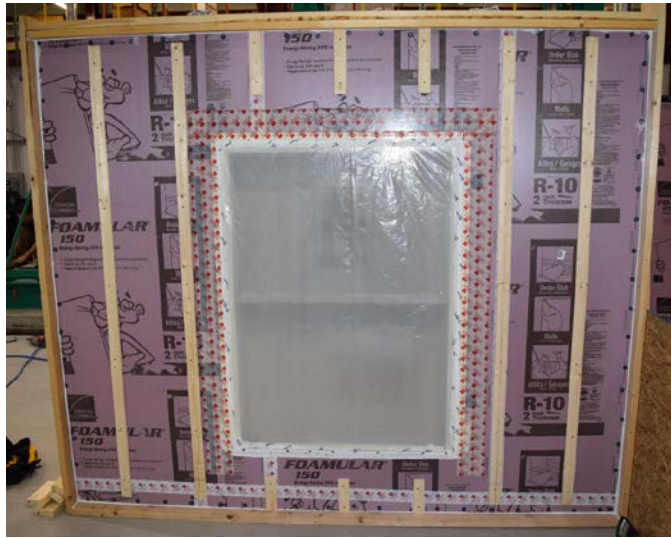
Figure 33. 2 in. of 15-psi XPS - Single DH

Test Protocols	Observations
Initial water penetration resistance test	No water bubbling or water leakage for the step portion of the water penetration resistance test. Water bubbling and slight pooling observed during the cyclic water test at 5.43 psf.
Temperature cycling	No deformation or degradation of window observed.
Service-condition loading	No deformation or degradation of window observed.
Service-conditioned water penetration resistance test	No water bubbling or water leakage for the step portion of the water penetration resistance test. Water bubbling and slight pooling observed during the cyclic water test at 5.43 psf.
Vertical displacement monitoring	Maximum total displacement: 0.020 in.
Final water penetration resistance test	No water bubbling or water leakage for the step portion of the water penetration resistance test. Water bubbling and slight pooling observed during the cyclic water test at 5.43 psf.

Structural performance test	Positive direction: No deformation or degradation of window observed. Negative direction: The top sash of the double-hung window slides down when the window is opened. The counterbalance mechanism disengages from the balance key causing the top sash to slide down.

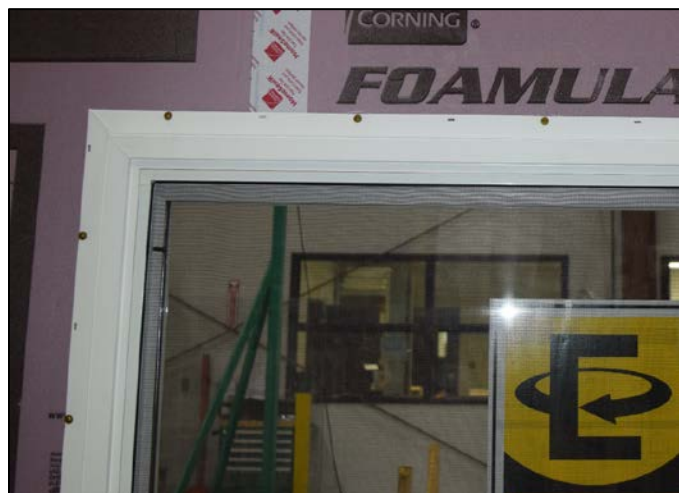
Figure 34. Cabinet Screw Installed on 2 in. of 15-psi XPS - Single DH

Test Protocols	Observations
Initial water penetration resistance test	Water bubbling under the sill at 5.43 psf for the step portion of the water penetration resistance test. Water bubbling and slight pooling observed during the cyclic water test at 5.43 psf. Water recedes once the pressure drops.
Temperature cycling	No deformation or degradation of window observed.
Service-condition loading	No deformation or degradation of window observed.
Service-conditioned water penetration resistance test	Water bubbling under the sill at 5.43 psf for the step portion of the water penetration resistance test. Water bubbling and slight pooling observed during the cyclic water test at 5.43 psf. Water recedes once the pressure drops.
Vertical displacement monitoring	Maximum total displacement: 0.025 in.
Final water penetration resistance test	Water bubbling under the sill at 5.43 psf for the step portion of the water penetration resistance test. Water bubbling and slight pooling observed during the cyclic water test at 5.43 psf. Water recedes once the pressure drops.

Structural performance test	Positive direction: No deformation or degradation of window observed. Negative direction: The top sash of the double-hung window slides down when the window is opened. The counterbalance mechanism disengages from the balance key causing the top sash to slide down.

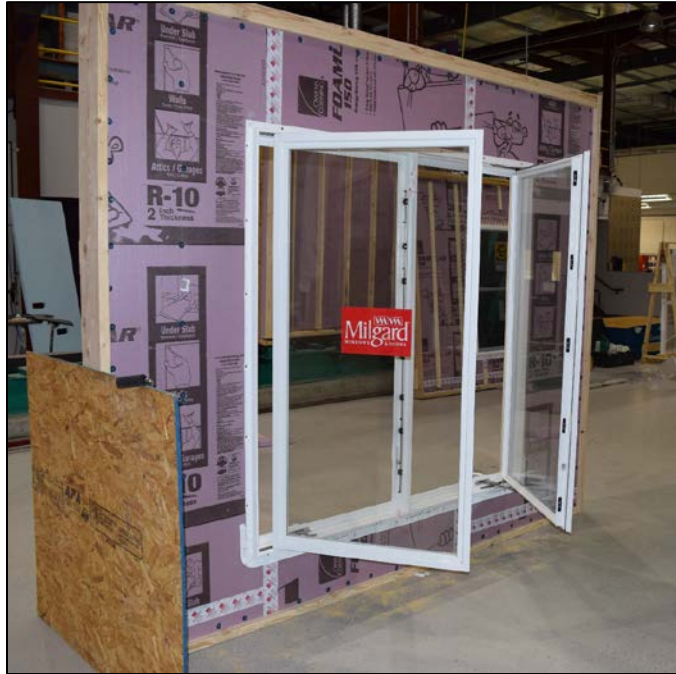
Figure 35. Muller Casement Window on 2 in. of 15-psi XPS

Test Protocols	Observations
Initial water penetration resistance test	No water bubbling in any water tests.
Temperature cycling	No deformation or degradation of window observed.
Service-condition loading	No deformation or degradation of window observed.
Service-conditioned water penetration resistance test	No water bubbling in any water tests.
Vertical displacement monitoring	Maximum total displacement: 0.022 in.
Final water penetration resistance test	No water bubbling in any water tests.
Structural performance test	No deformation or degradation of window observed. Window is functional and operable.

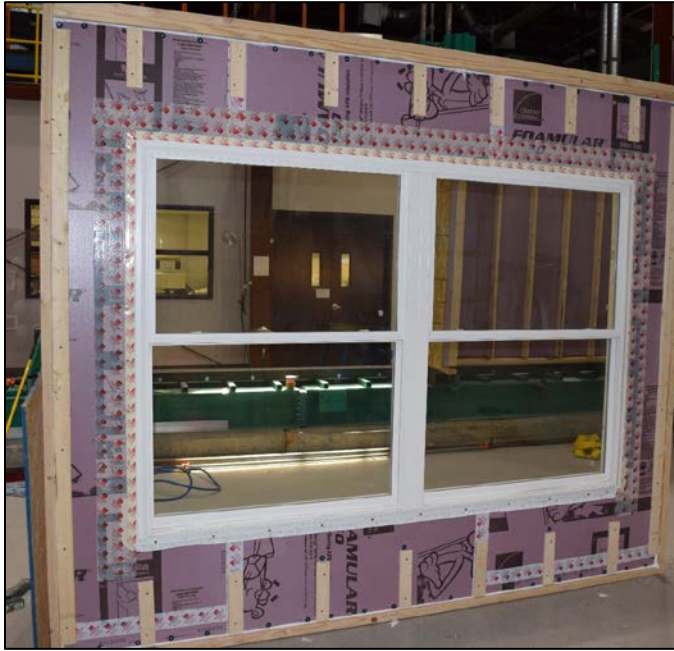
Figure 36. Mullered Double-Hung Window on 2 in. of 15-psi XPS

Test Protocols	Observations
Initial water penetration resistance test	Slight water bubbling at 5.43 psf for both the step portion of the water penetration resistance test and the cyclic water test.
Temperature cycling	No deformation or degradation of window observed.
Service-condition loading	No deformation or degradation of window observed.
Service-conditioned water penetration resistance test	Slight water bubbling at 5.43 psf for both water tests.
Vertical displacement monitoring	Maximum total displacement: 0.032 in.
Final water penetration resistance test	Slight water bubbling at 5.43 psf for both water tests.
Structural performance test	Positive direction: No deformation or degradation of window observed. Negative direction: The top sash of the window slides down when the window is opened. The counterbalance mechanism disengages from the balance key causing the top sash to slide down.

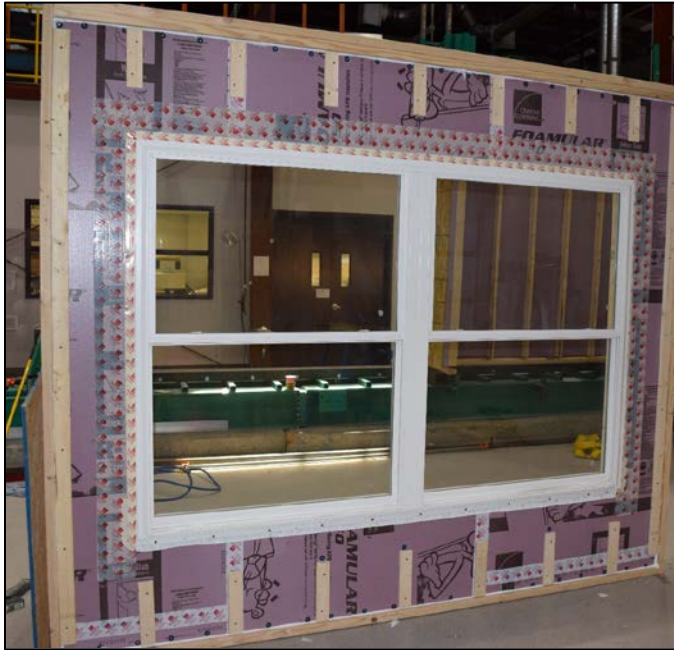
Figure 37. Mullered Double-Hung Window on 2 in. of 15-psi XPS

Test Protocols	Observations
Initial water penetration resistance test	Slight water bubbling at 5.43 psf for both the step portion of the water penetration resistance test and the cyclic water test.
Temperature cycling	No deformation or degradation of window observed.
Service-condition loading	No deformation or degradation of window observed.
Service-conditioned water penetration resistance test	Slight water bubbling at 5.43 psf for both water tests.
Vertical displacement monitoring	Maximum total displacement: 0.016 in.
Final water penetration resistance test	Slight water bubbling at 5.43 psf for both water tests.
Structural performance test	Positive direction: No deformation or degradation of window observed. Negative direction: The top sash of the double-hung window slides down when the window is opened. The counterbalance mechanism disengages from the balance key causing the top sash to slide down. At the mullion region, there is damage to the balance key mechanism and damage to the sash hook. The counterbalance mechanism in the mullion region fell out.

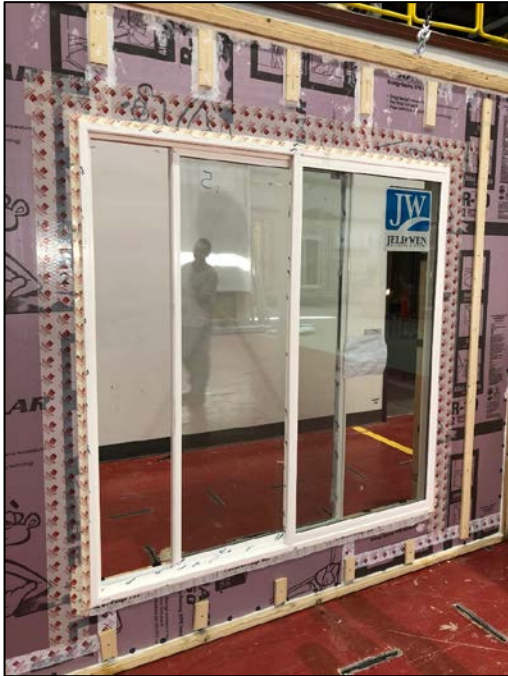
Figure 38. Large Slider Window

Test Protocols	Observations
Initial water penetration resistance test	Significant amount of water pooling and overflowing at 5.43 psf for both the step portion of the water penetration resistance test and the cyclic water test.
Temperature cycling	No deformation or degradation of window observed.
Service-condition loading	No deformation or degradation of window observed.
Service-conditioned water penetration resistance test	Significant amount of water pooling and overflowing at 5.43 for both the step portion of the water penetration resistance test and the cyclic water test.
Vertical displacement monitoring	Not applicable. Vertical displacement monitoring was not performed on this wall specimen based on results from other wall specimens.
Final water penetration resistance test	Significant amount of water pooling and overflowing at 5.43 psf for both the step portion of the water penetration resistance test and the cyclic water test.

Structural performance test	Positive direction: Significant deformation and degradation of window observed. The glass shattered at 32.5 psf. The window sashed popped out of frame. Negative direction: Not performed as the window became inoperable.
