ENERGY PERFORMANCE REMODELING

Case Study:

Habitat for Humanity Montgomery County (HFH-MC) Montgomery County, MD

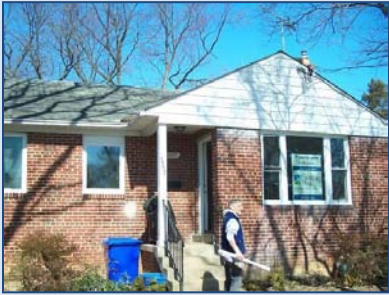
Figure 1 - HFH-MC Block Wall Remodeling Process

Removal of the original wall coverings revealed large gaps between the floor and the wall structure as well as the ceiling framing and the wall structure (note that these deficiencies are not typical in standard construction methods today). These areas can be sealed with a combination of rigid foam panels that provide the primary air barrier and spray foam products that expand to fill the remaining gaps. This detail is less prone to moisture problems since it adds moisture-resistant insulation adjacent to the block wall but still allows the wall to breathe allowing moisture vapor to pass through the materials as needed.

A significant advancement in the energy performance of these older homes was HFH-MC’s development of details for upgrading the insulation of the existing block and brick and existing frame walls. For the block walls, the original R-4.7 walls were upgraded to R-20 walls (R value is provided on a whole-wall basis). The wall upgrade process included 1) removing the drywall and furring strips, 2) attaching 1” rigid foam adjacent to the block and air-seal, 3) constructing a 2x4 wall on the interior of the rigid foam, 4) insulating the 2x4 cavity with R-13 batt insulation, 5) installing drywall and painting the interior walls as depicted in the photo sequence below.
