Initial Study of the Moisture Performance of OSB-Sheathed Walls in Homes in Climate Zones 4 and 5

Interim Report

6/30/2010

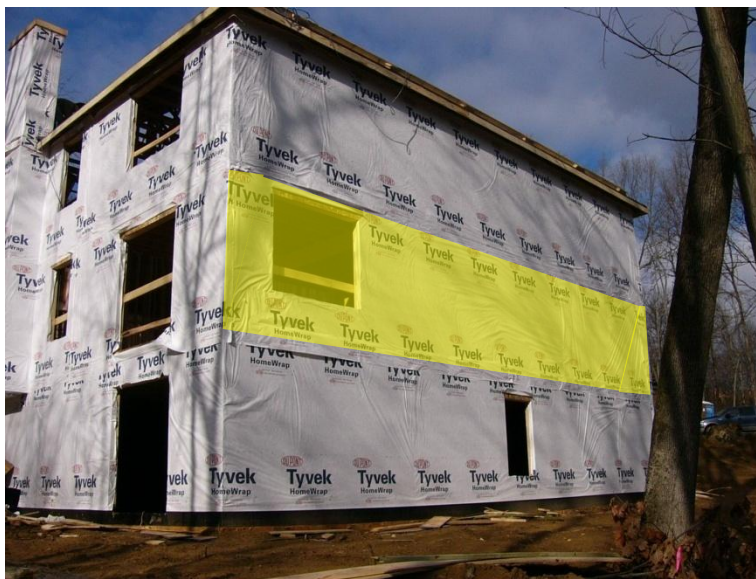
Figure 13 – Jobsite #2 east wall (test wall highlighted) three stories framed

The home located in Valencia, PA (Jobsite #2) had a wood framed walk-out basement such that one end of the home had three framed stories. The test wall for this home was at the second level as shown in Figure 13.

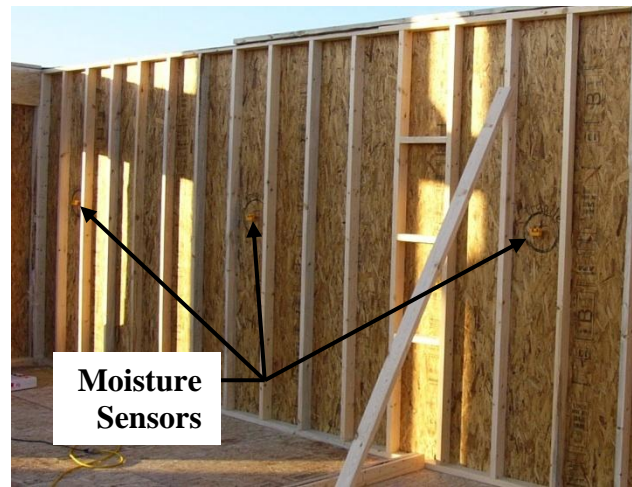
Figure 15 – Installed test wall moisture sensors

The temperature (T) and relative humidity (RH) are measured by an internal sensor located inside the plastic housing. The wood moisture content (MC) is measured through two screws driven into wood based on resistivity of the OSB material. The sensors transmit measurements at set intervals (30 minutes) wirelessly to a gateway (router). The gateway then uploads the measurements to a central location for storage and acquisition on the Omnisense website. Figure 15 shows a typical installation of a sensor before enclosing with insulation.
