Extended Plate and Beam Wall System

May 2018

Patti Gunderson
Home Innovation Research Labs
EP&B Wall System Project Team
400 Prince George's Blvd.
Upper Marlboro, MD 20774

This report, "Extended Plate and Beam Wall System," explores the extended plate and beam wall system to determine its structural performance, moisture durability, constructability, and cost-effectiveness for use as a high-R enclosure system for energy code minimum and above-code performance in climate zones 4–8.

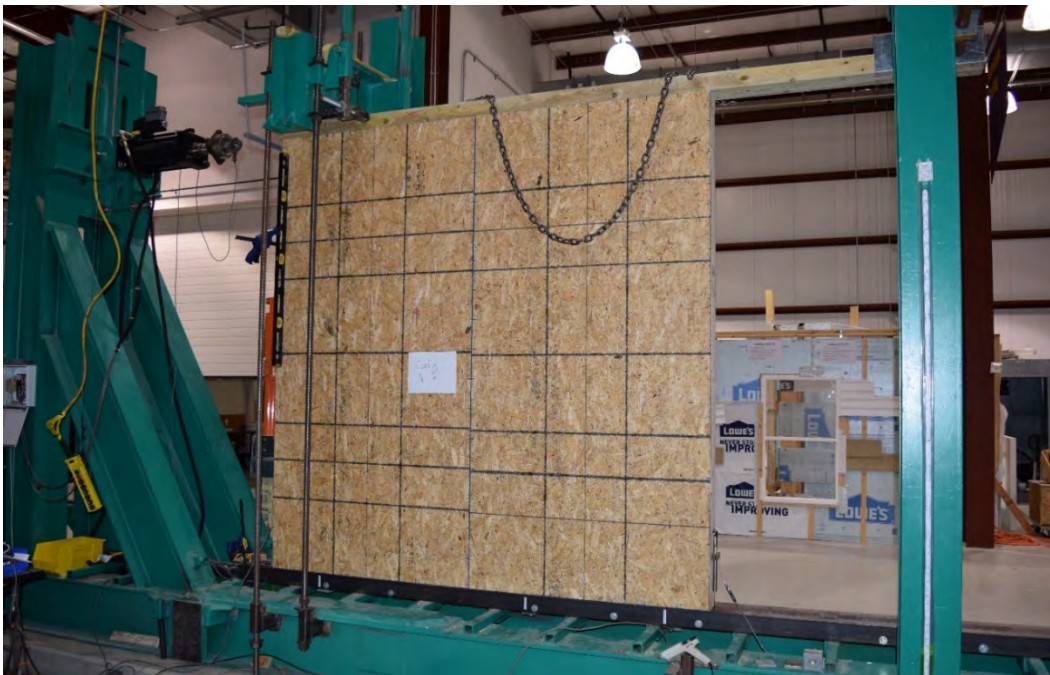
Figure 4. A 2x6 standard reference wall in testing apparatus prepared for an ASTM 72 test

Racking shear performance testing of the EP&B wall system was conducted in two phases. Phase I of the test plan applies American Society for Testing and Materials (ASTM) E72 Section 14 procedures per AC269.1 Section 4.1 to qualify the wall system for intermittent bracing. Phase II of the test plan applies ASTM E564 procedures per AC269.1 Section 4.2 to qualify the wall system for continuous bracing. See Figure 4 for an example of a wall specimen installed in the testing apparatus.

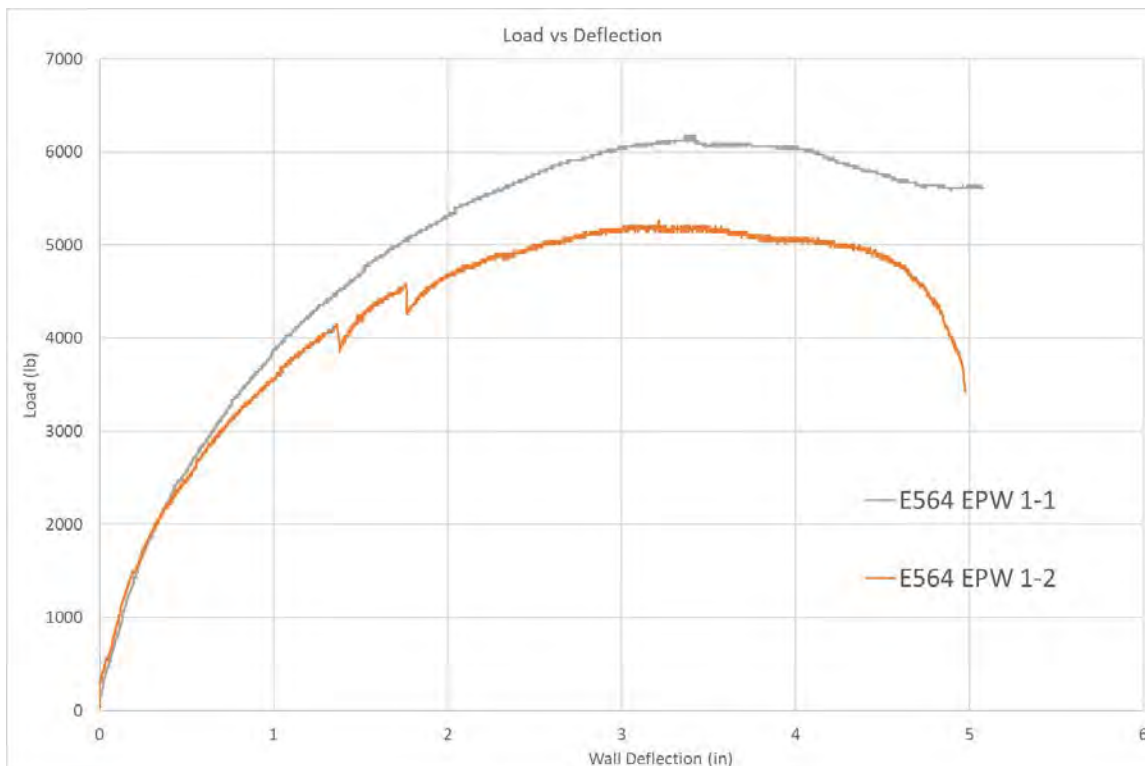
Figure 6. Shear load deflection curves: E564 test—baseline EP&B walls (spruce-pine-fir)

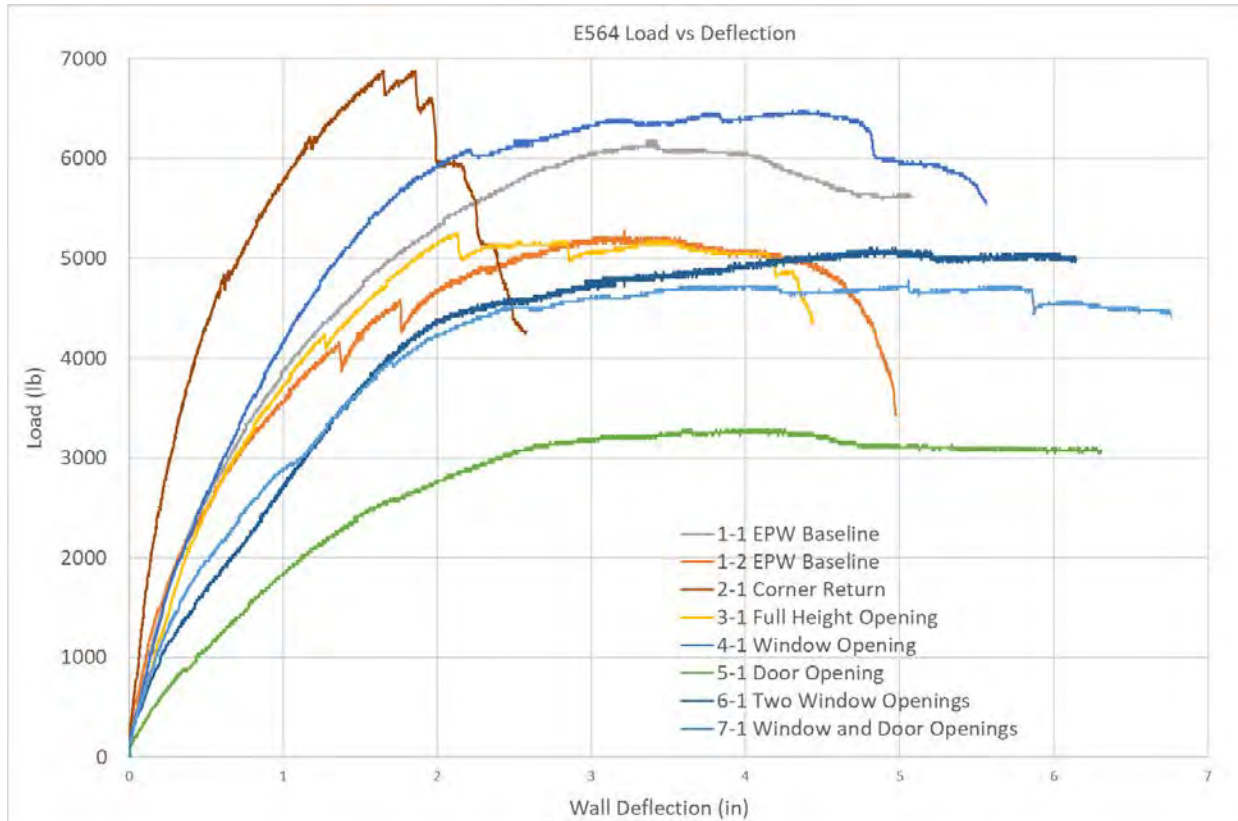
Figure 7. Load deflection curves: E564 test—EP&B walls (spruce-pine-fir)

Figure 7 graphs the load deflection curves for the EP&B wall specimens of the ASTM E564 tests for IRC continuous braced wall equivalency. Tested values for wall types 2–7 meet all target performance values for both strength and stiffness (drift at reference shear load) per AC269.1. See Table 8.

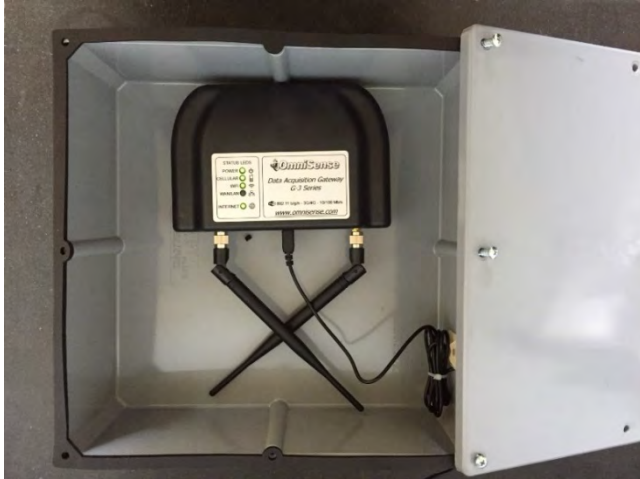
Figure 10. Omnisense Gateway data acquisition unit

Figure 10 and Figure 11 itemize the equipment used in both Grand Rapids demonstration house to monitor wood moisture, temperature, and RH.

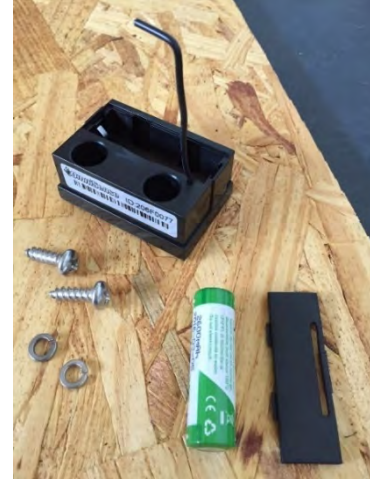
Figure 11. Omnisense T/RH%/MC% sensor

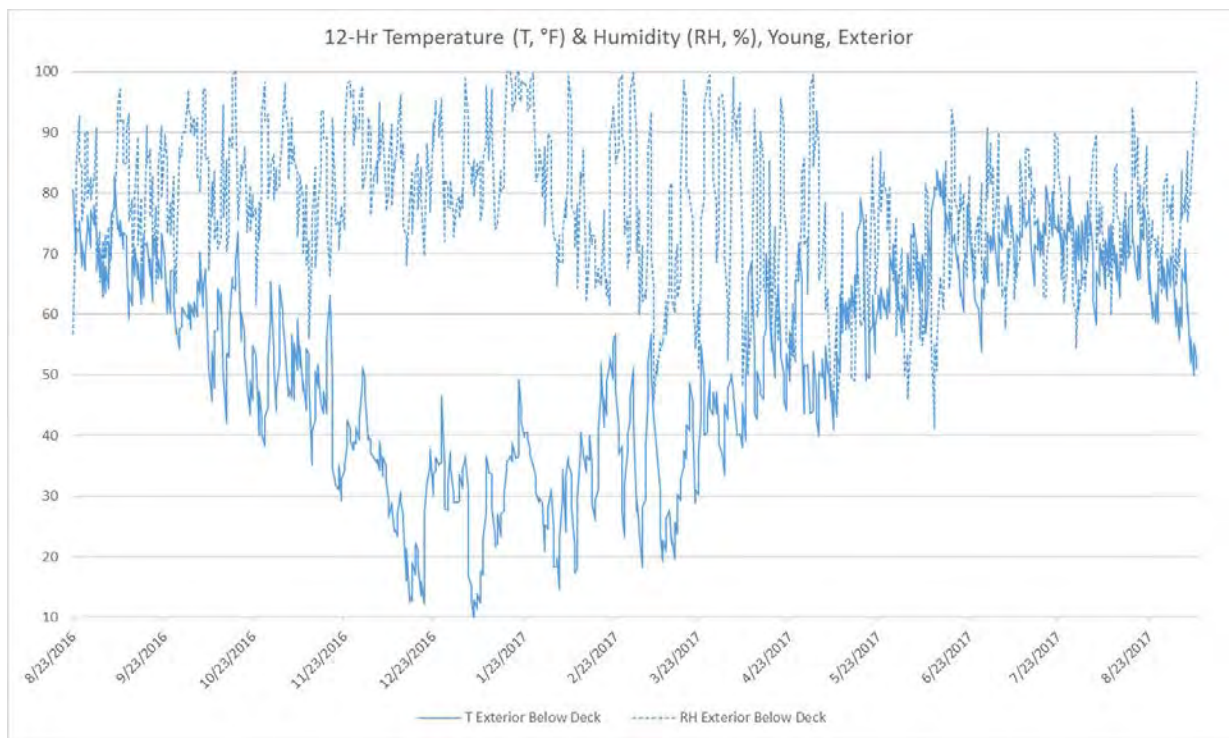
Figure 17. Exterior ambient temperatures, House 2

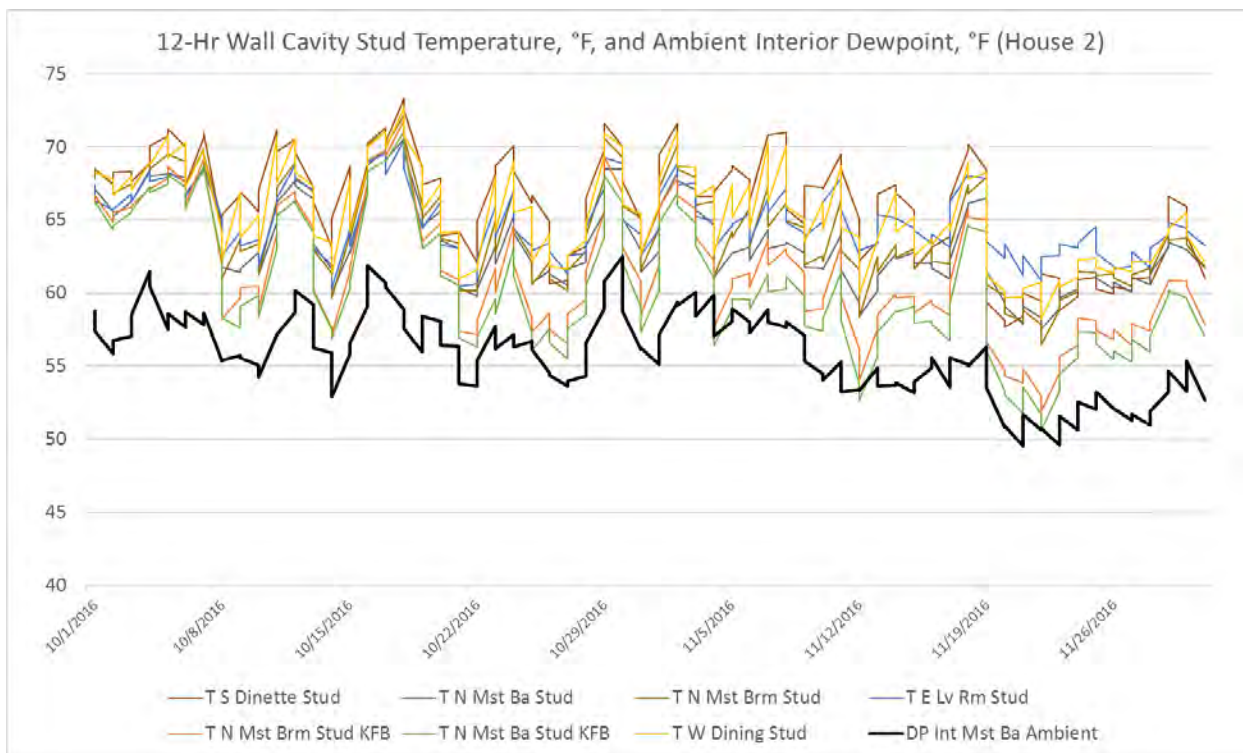
Figure 21. Wall cavity temperatures and house interior ambient dew point, House 2

Theoretically, if the interior vapor retarder were to be breached, moisture-laden air from the interior might enter the wall cavity. The following pair of graphs (Figure 20 and Figure 21) shows that even intrusion by the worst-case interior air (bathroom areas—solid black line) is not likely to produce condensation. Again, except for very brief periods, the local temperature for all wall cavities in both houses remained safely above the coincident interior ambient dew point of air from within the house, indicating that the EP&B provides good moisture protection. The solid lines in Figure 20 and Figure 21 show the wall cavity dry bulb temperatures for each house; the solid black line shows the dew point temperature of the air inside the building for the two most challenging months: October and November.

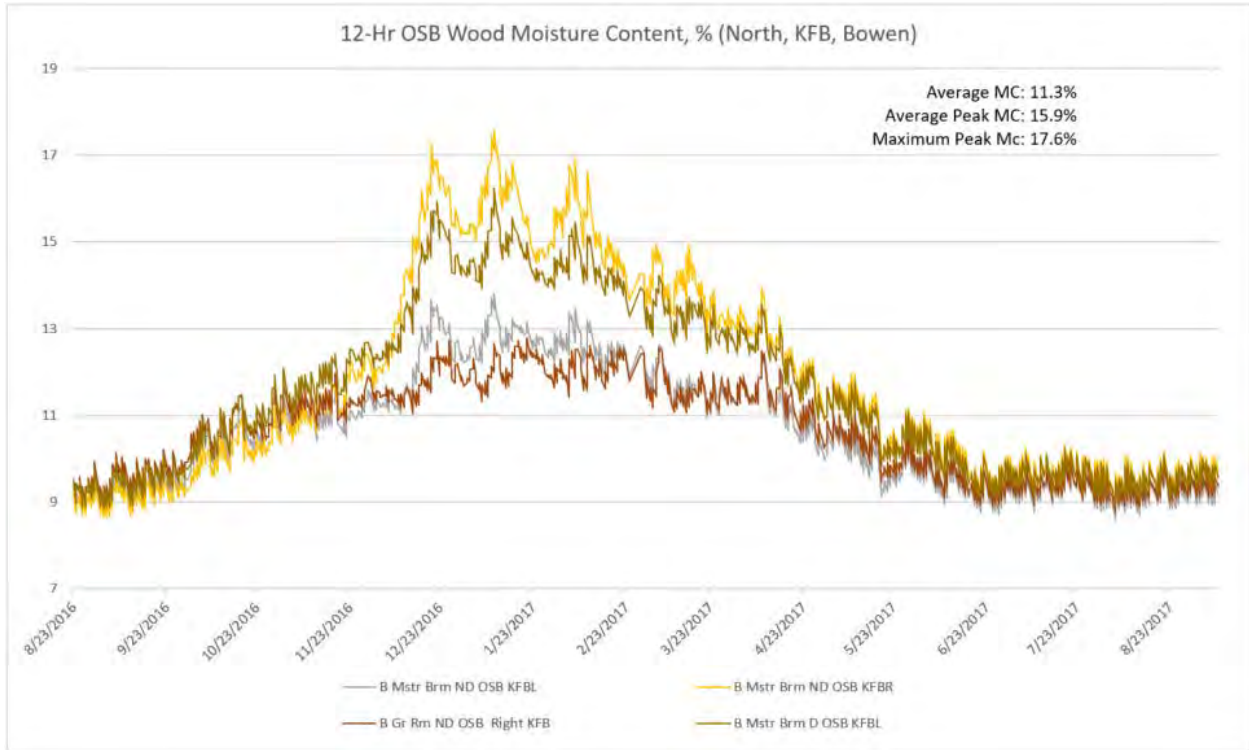
Figure 25. Moisture content for OSB in EP&B walls with ccSPF, north orientations, House 1

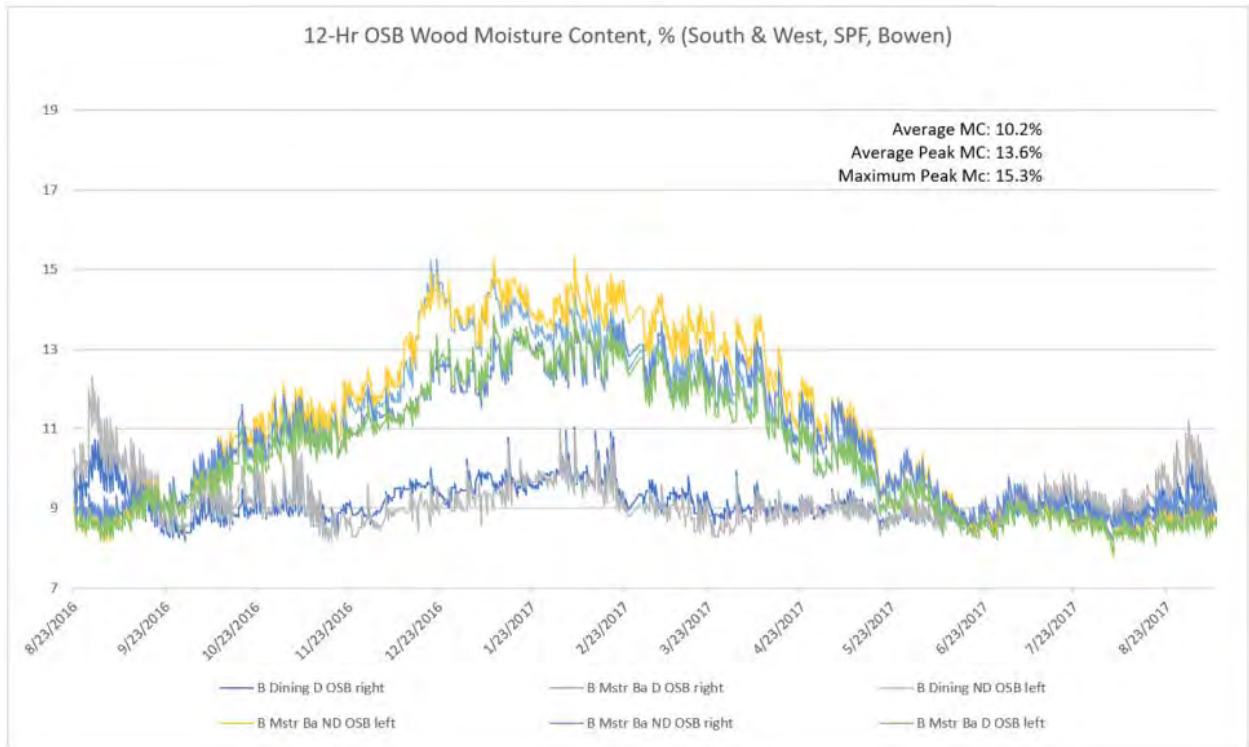
Figure 26. Moisture content for OSB in EP&B walls with ccSPF, non-north orientations, House 1

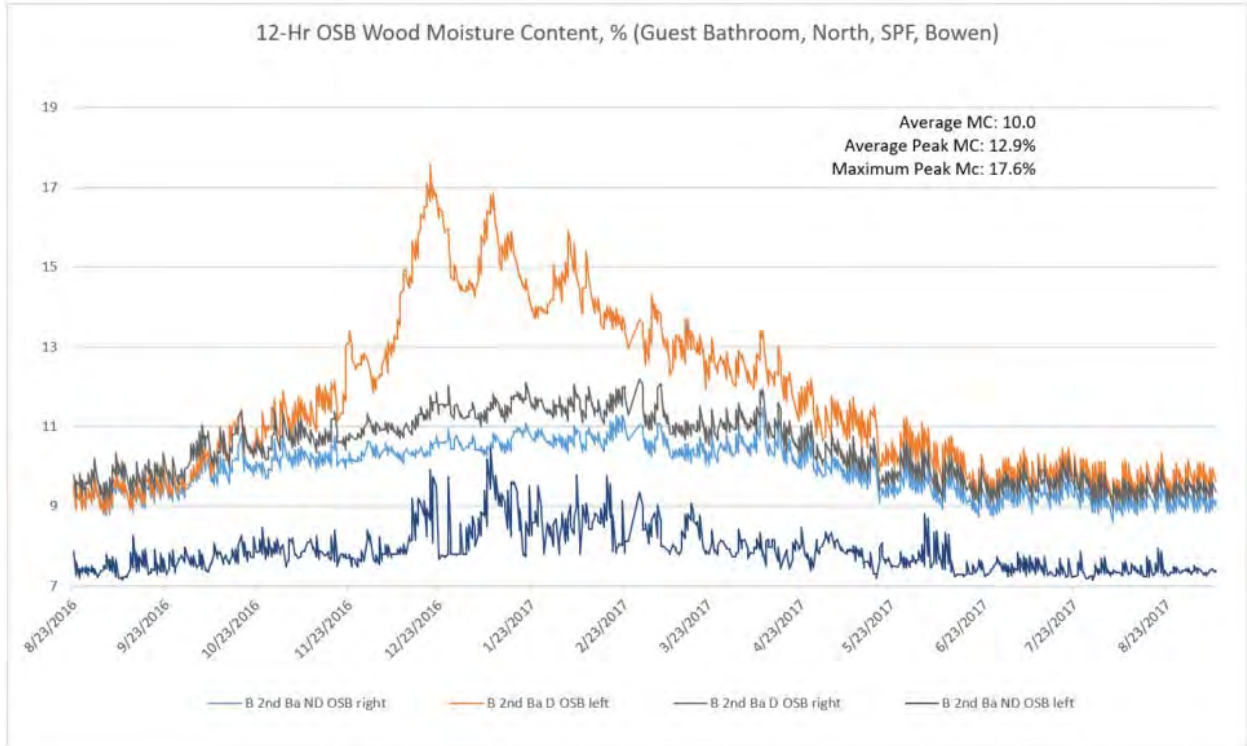
Figure 27. Moisture content for OSB in north-facing guest bathroom, ccSPF, House 1

Figure 27 and Figure 28 Bathroom Wall Moisture Content. House 1 has two bathrooms: a master bath with a west orientation and a guest bath with a north orientation. The owner of House 1 is a single adult male; the guest bathroom is very seldom used for bathing. The moisture performance of the four OSB sensors in the guest bathroom appears to vary gradually with seasonal changes. The master bathroom appears to be more varied and responsive to daily and weekly changes, presumably because of more frequent bathing activities.

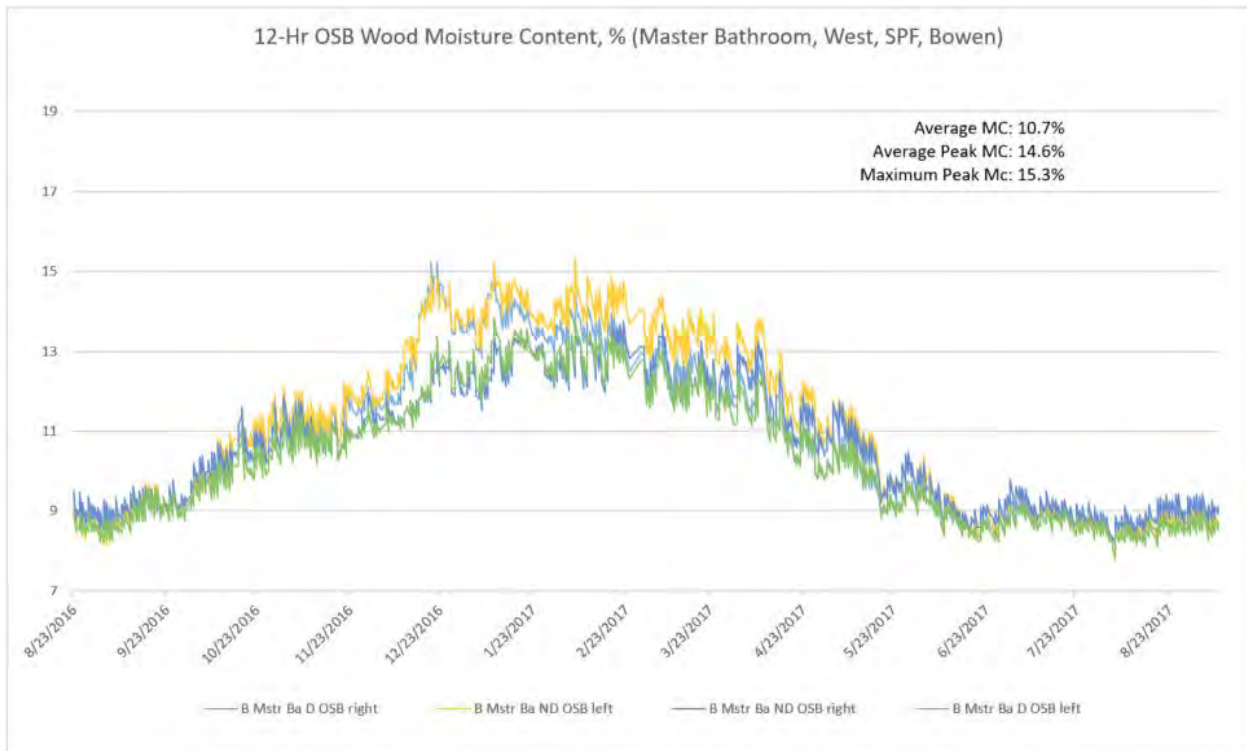
Figure 28. Moisture content for OSB in west-facing master bathroom, ccSPF, House 1

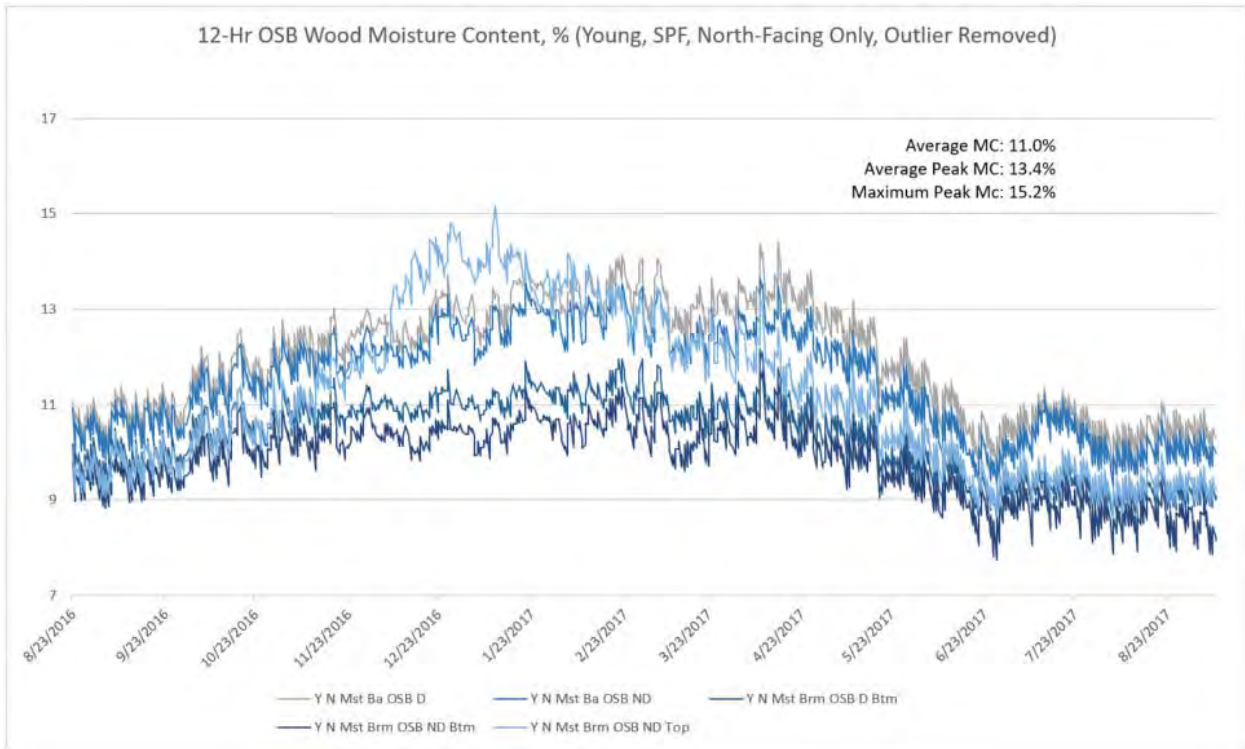
Figure 33. Moisture content for OSB in EP&B walls with ccSPF/blown fiberglass, North only, House 2

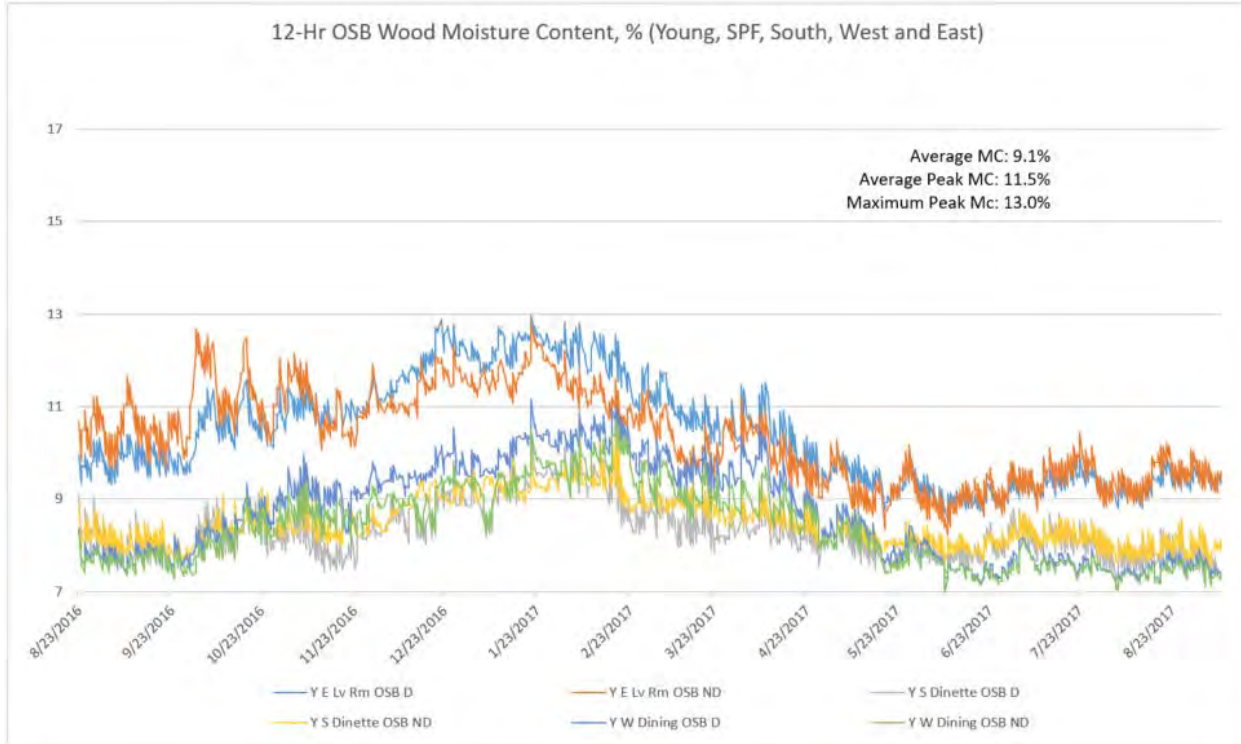
Figure 34. Moisture content for OSB in EP&B walls with ccSPF and blown fiberglass, non-north orientations, House 2

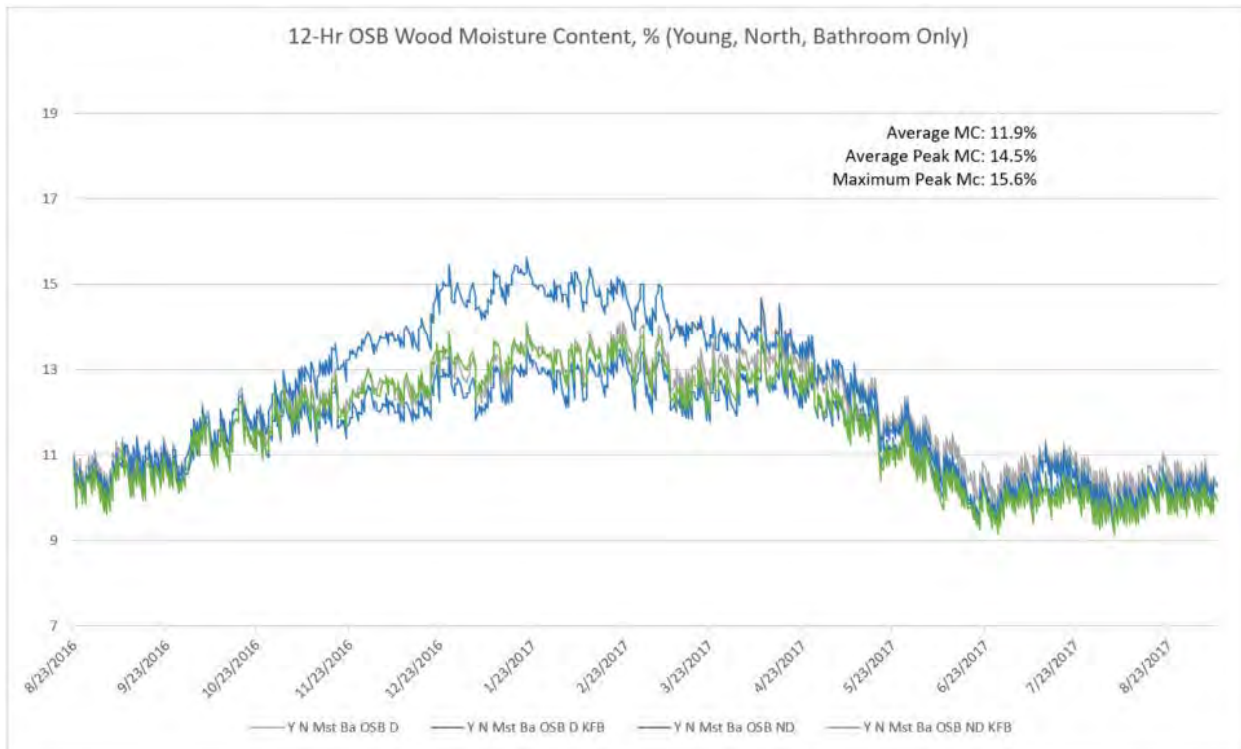
Figure 35. Moisture content for OSB in EP&B bathroom walls, north orientation only, House 2

Figure 35 and Figure 36 Comparing Bathrooms to Bedrooms. When controlled for room type, north-facing EP&B walls in the master bathroom exhibit very similar MC averages to north-facing EP&B walls in the master bedroom. The bathroom OSB exhibits a lower subset maximum peak than the bedroom OSB as well as somewhat more stable behavior over time.

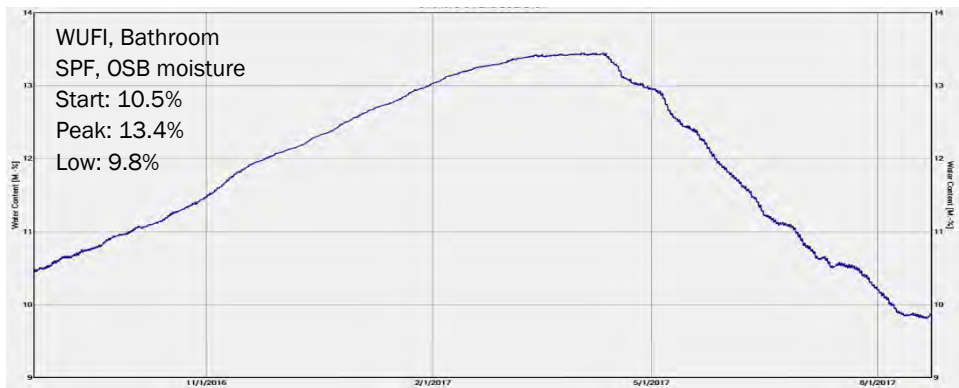
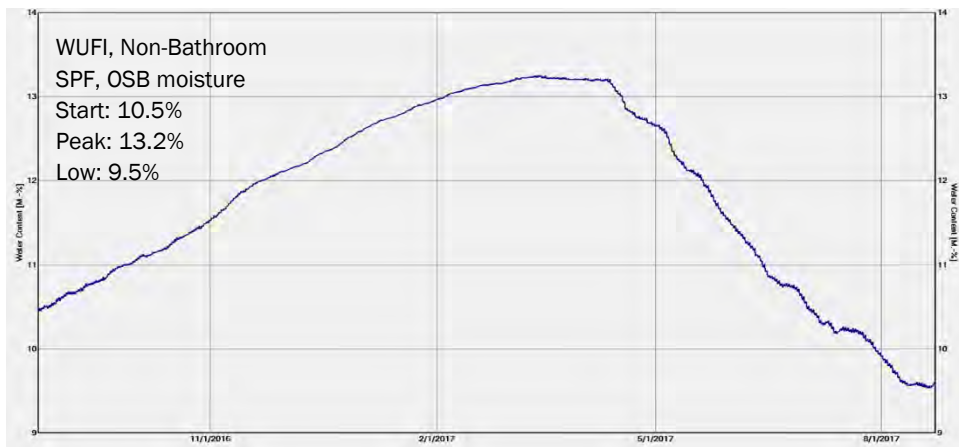
Figure 38. Comparing actual OSB MC to WUFI simulation, Grand Rapids test houses, spruce-pine-fur

- For walls with ccSPF flash coat with blown fiberglass insulation, the WUFI model prediction for peak OSB MC was very near to the recorded values.
- For walls with R-15 Kraft-faced batt fiberglass insulation, the WUFI model underpredicted actual peak OSB MC by 1.5 to 2 percentage points.
- For both insulation methods and both houses, MC under actual conditions peaked several months sooner than the WUFI simulation predicted.
- For both insulation methods and both houses, OSB dried out during the summertime to average MC very similar to the WUFI model prediction (between 9% and 10%).
- The bathroom conditions caused wintertime MC peaks in bathrooms that were slightly higher than non-bathroom peaks by less than 0.5% and lows that were higher than non-bathroom lows by less than 0.5%. These values are too small to be significant for WUFI.

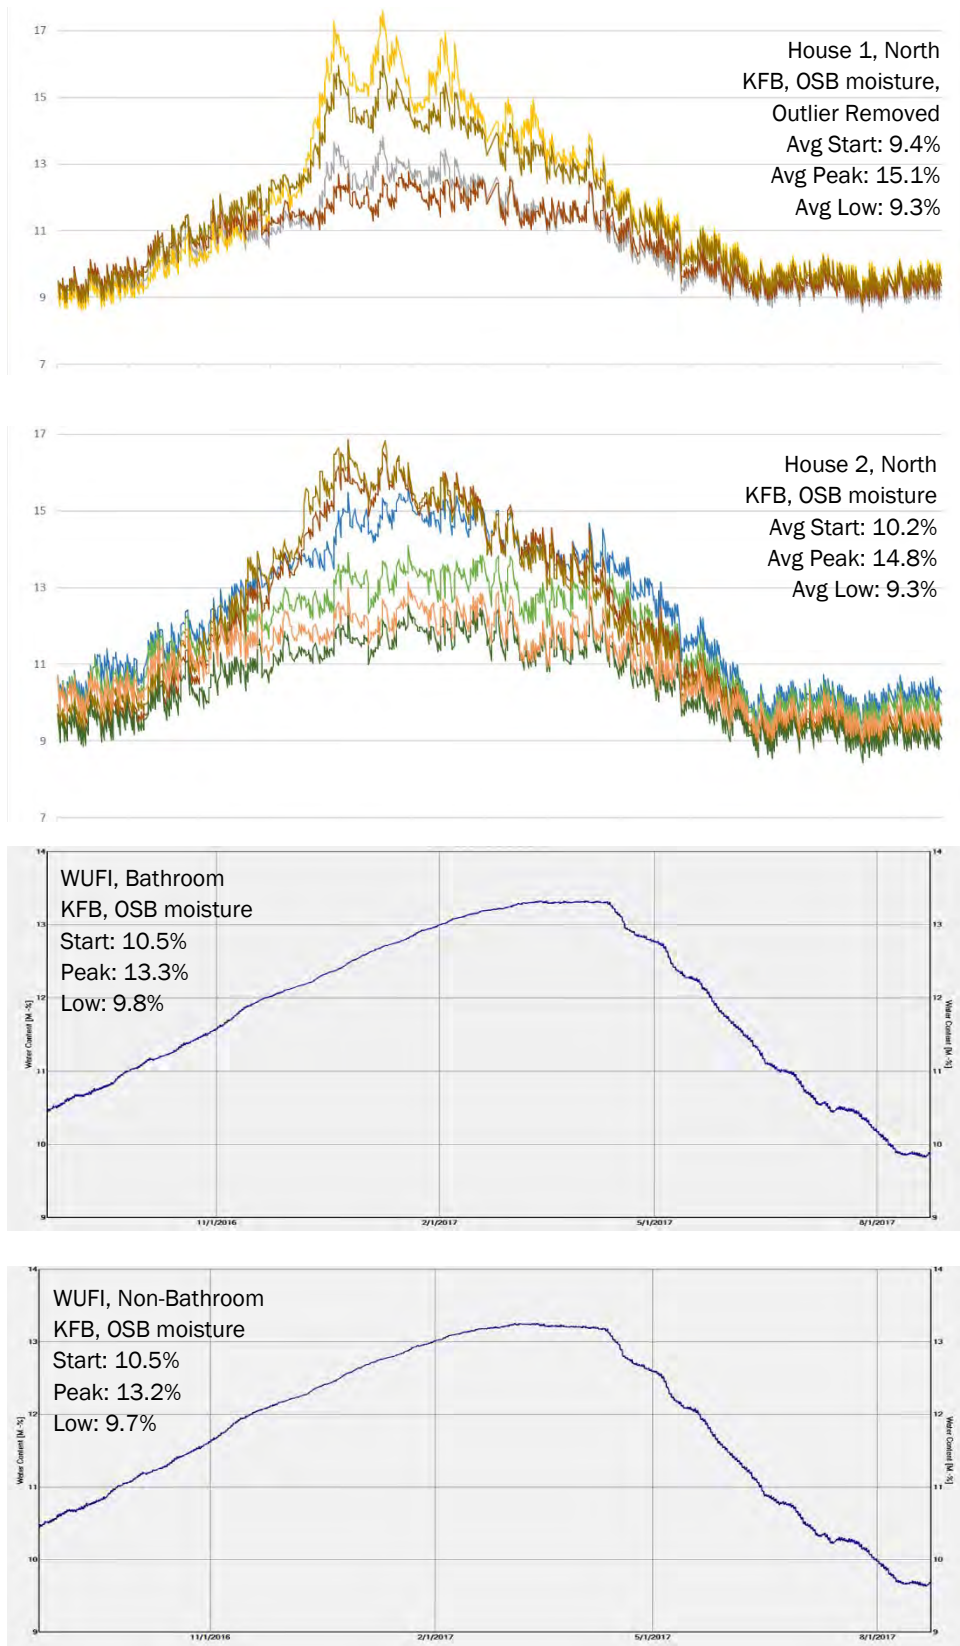
Figure 39. Comparing actual OSB MC to WUFI simulation, Grand Rapids test houses, Kraft-faced batt insulation

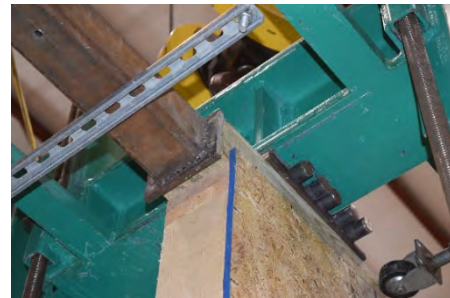
Note hold-down, rollers

Figure 43. ASTM E72 Section 14.3.2 hold-down provisions, 2x6 standard reference wall in testing apparatus

Figure 43 and Figure 44 show the 2x6 IRC reference wall mounted in the racking shear test apparatus for the E72 test. Figure 45 shows an EP&B wall mounted in the racking shear test apparatus for an E564 test.

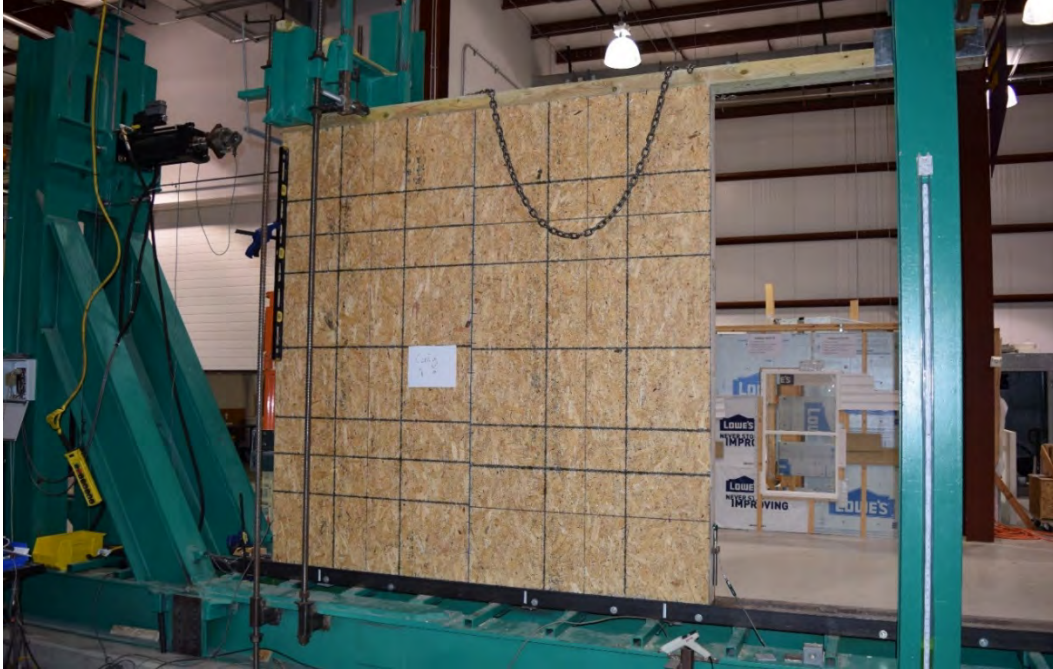
Figure 44. A 2x6 standard reference wall in testing apparatus prepared for ASTM 72 test

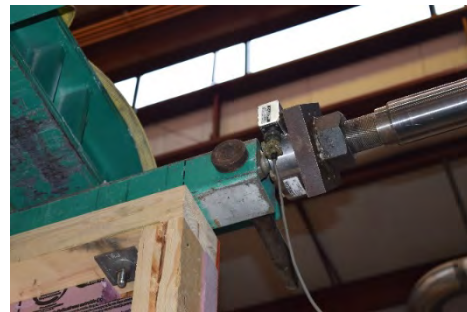
Boundary conditions:
loading beam, plate anchors

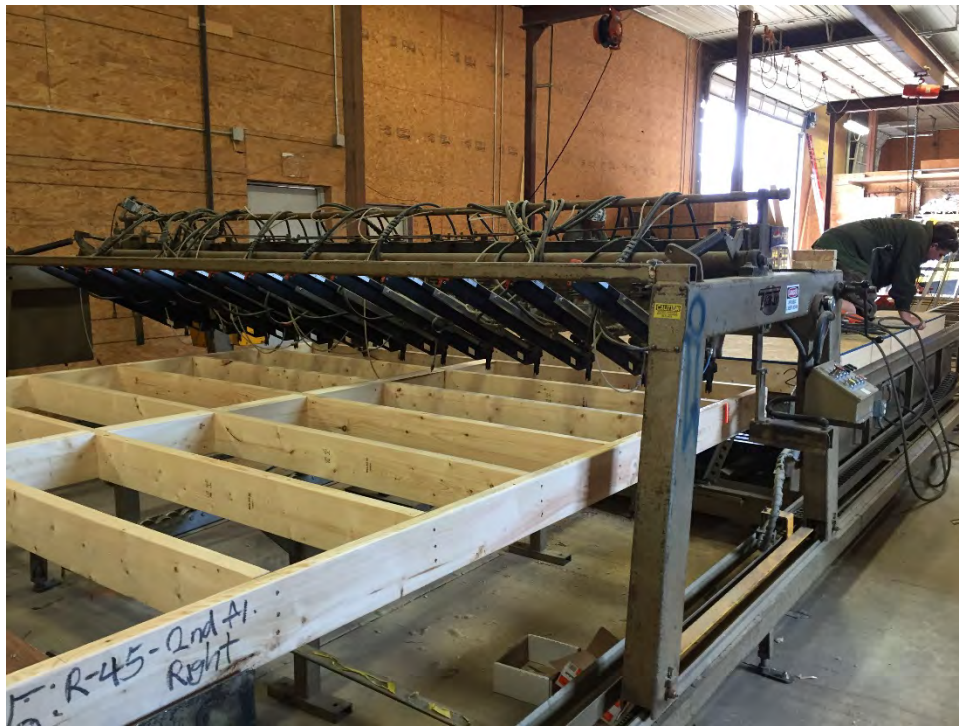
Figure 48. Bridge nailer, Zeeland Truss & Components

Figure 48 through Figure 50 illustrate the Zeeland wall panel production plant.

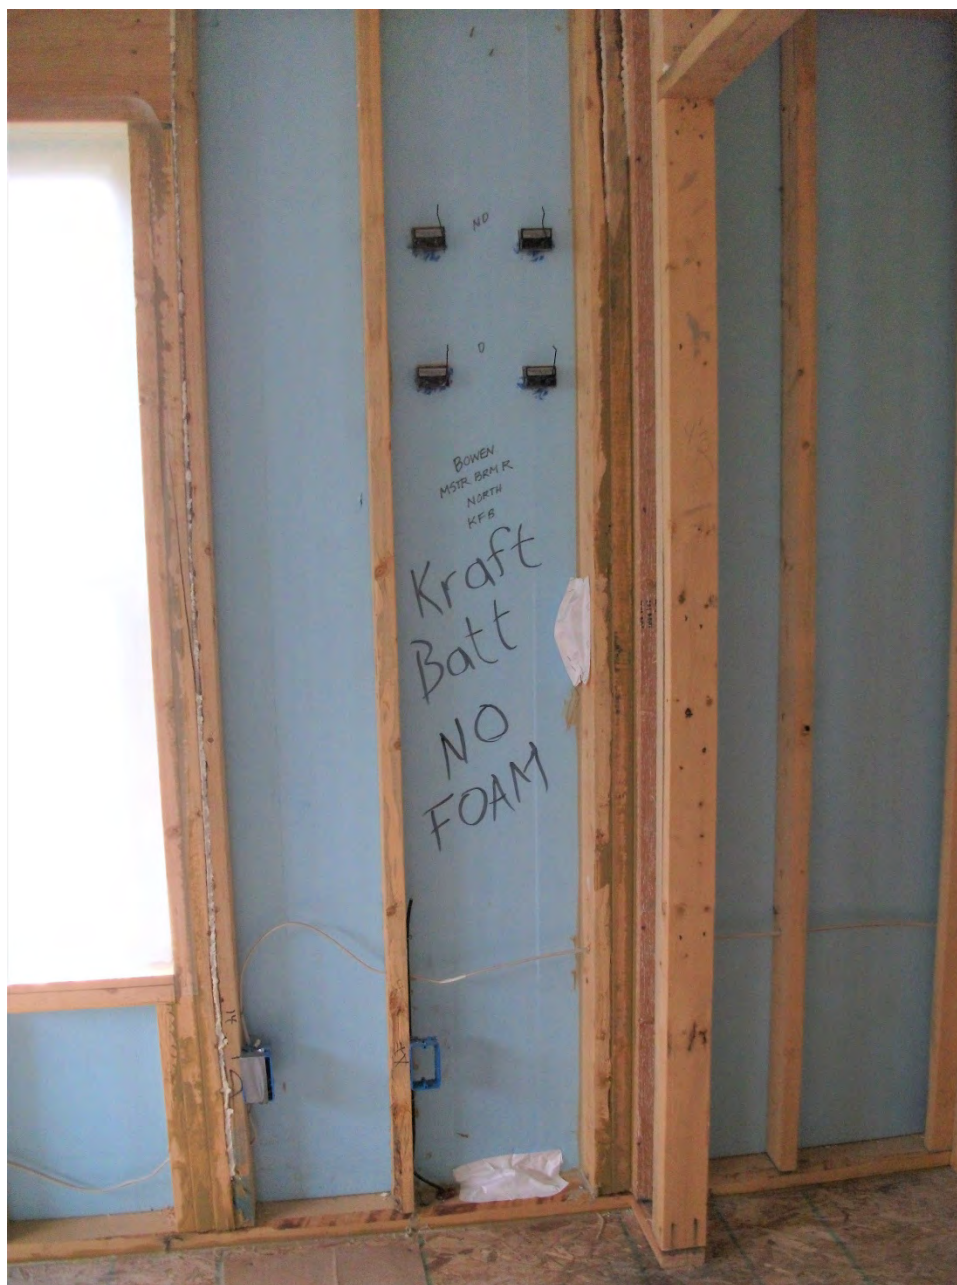
Figure 66. Bay containing outlier OSB sensor, House 1

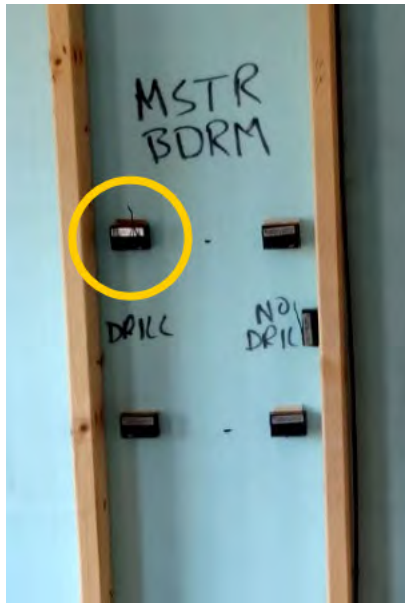
Figure 69. Detail of outlier OSB sensor, House 2

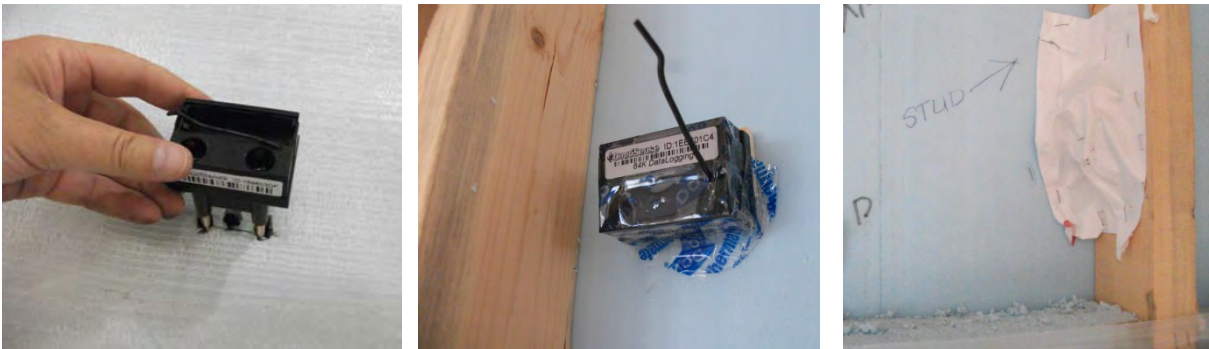
Figure 72. Sensor cabinets are protected from intrusion of moisture and debris with WRB tape
